Pond Survey Summary

The LakeRidge Falls (LRF) Roads & Grounds (R&G) Committee Pond's Crew conducted a physical inspection and prepared an individual survey of 13 stormwater ponds in the community, during the early part of 2023. We did not survey Pond # 7 (by the back gate) as it is not connected to the other 15 ponds, is not maintained as a pond, and has been planted as a wetland. In addition, we did not have sufficient time to complete surveys of Ponds 2 and 16 before late spring rains limited our full access to these two ponds. The Ponds' Crew recommends conducting inspections and preparing surveys of these two ponds during the next dry season in 2024. The 13 individual surveys, for the most part, reflect our observations and are, therefore, the "facts" we found. These individual surveys stand on their own as direct observations, supported by photos and measurements. The recommendations we make, therein, are those that are obvious, such as burying, or redirecting pipes, and adding catch basins.

Pond Crew 2023

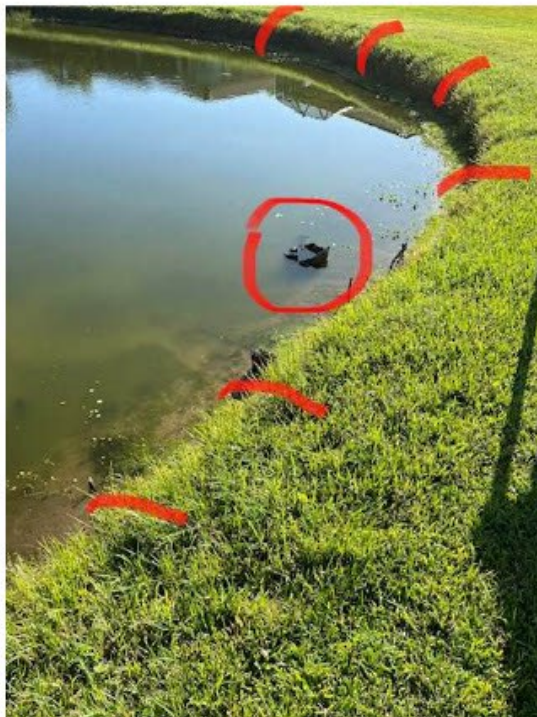
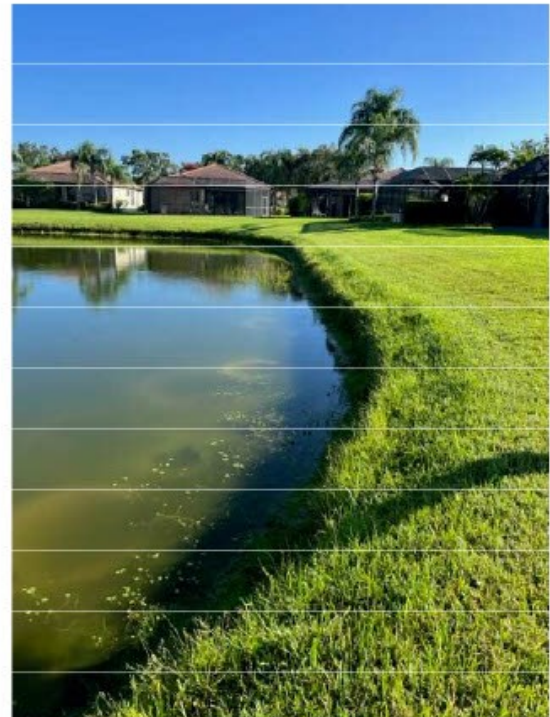
Top: Several piles of rocks (coral?) located around the pond. Culvert from the street, Note the silt buildup covering the lower portion of the pipe. One of several tree stumps found in the water. Bottom: 6" thick grass "waterfall" over the bank to the water around most of the pond. This, as well as the aquatic plants, would greatly buffer the effects of bank erosion.

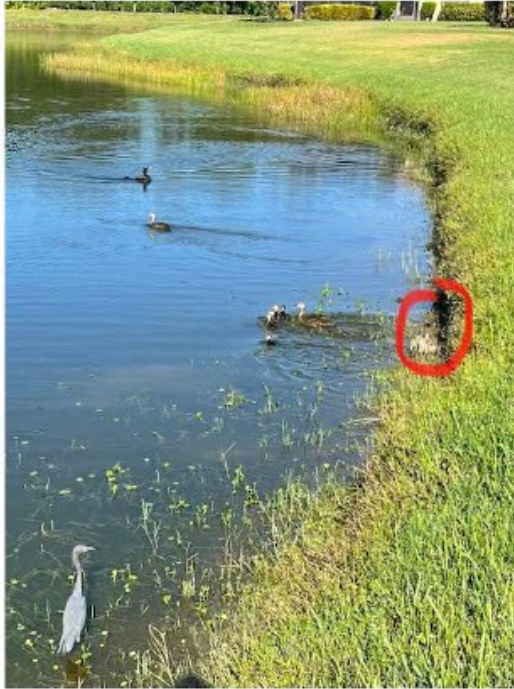
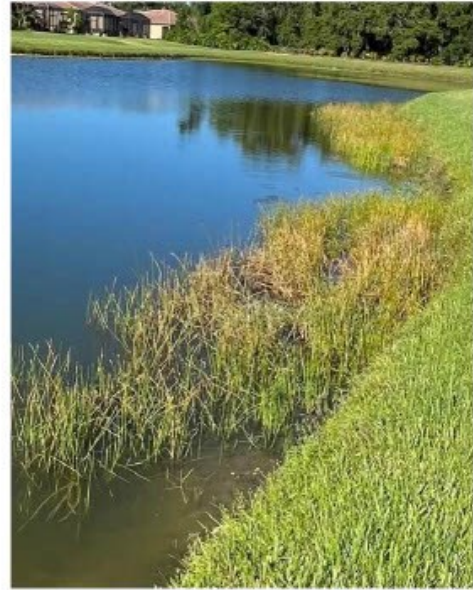
Grasses and other aquatic plants found all around the pond. Numerous turtles, ducks, and other birds...also, a stump in the water.

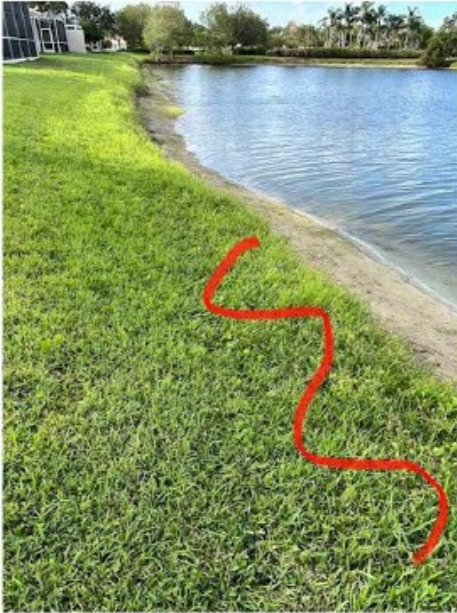
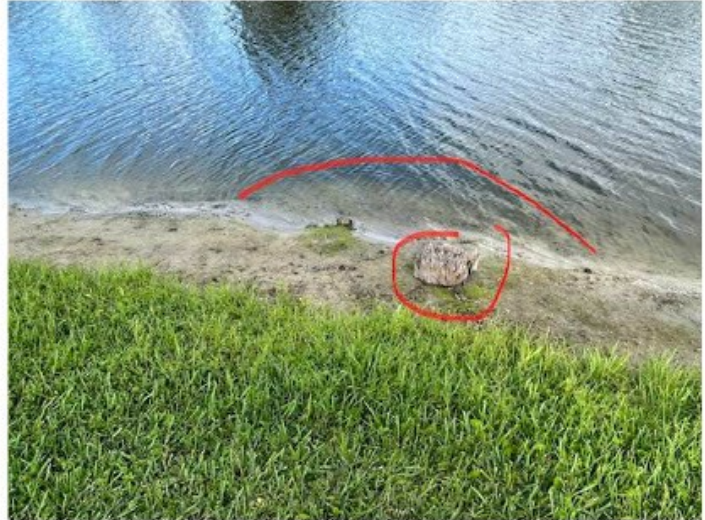
East side of lower N/S arm Pond #3. Bank collapsing at 8131 Victoria. 8127 Stump in water. Silt build-up from collapsed bank

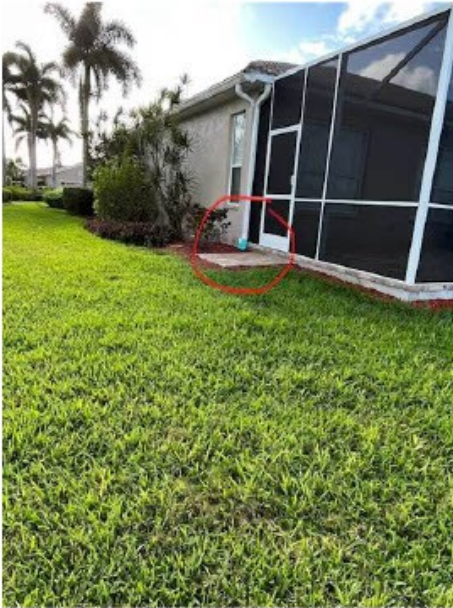
East side of lower N/S arm Pond #3. Dbl buried downspouts. Force of water from buried pipe eroding a trough in littoral shelf. This is an improper way to bury the downspout as it is increasing erosion on pond floor.

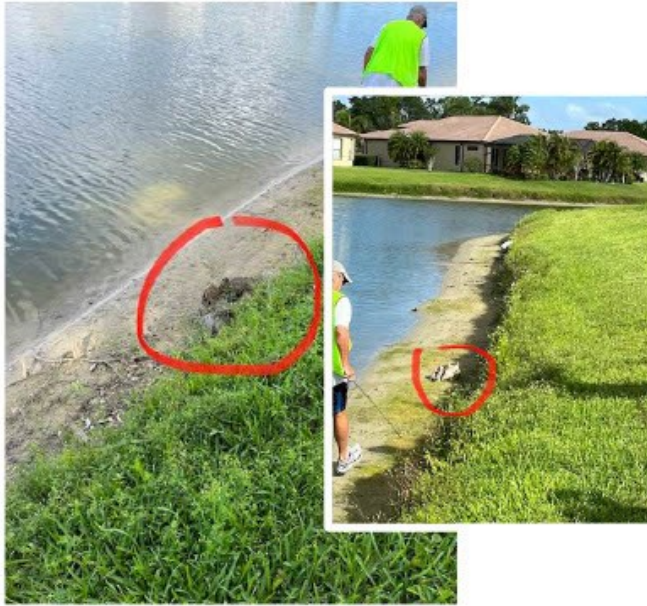
East side of upper N/S arm of Pond #3 at 4371 Kariba. . Waterline stumps at 4371 & 4403 Kariba (L). Angle of buried downspout at 4407 causing a deep washout rut in pond bottom (R).

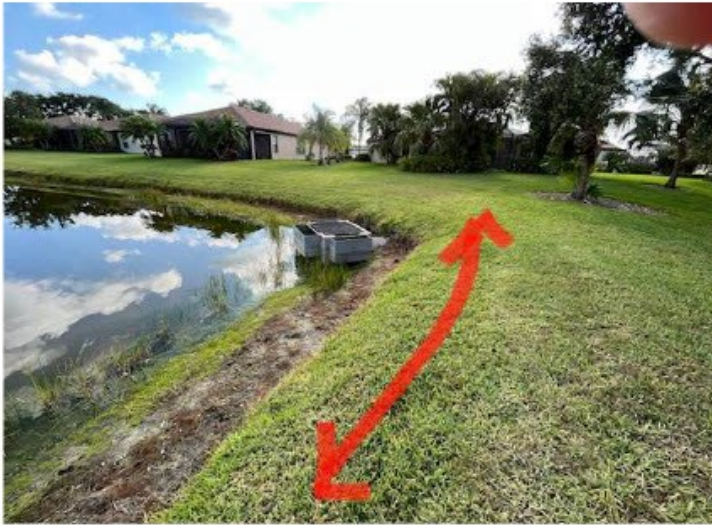
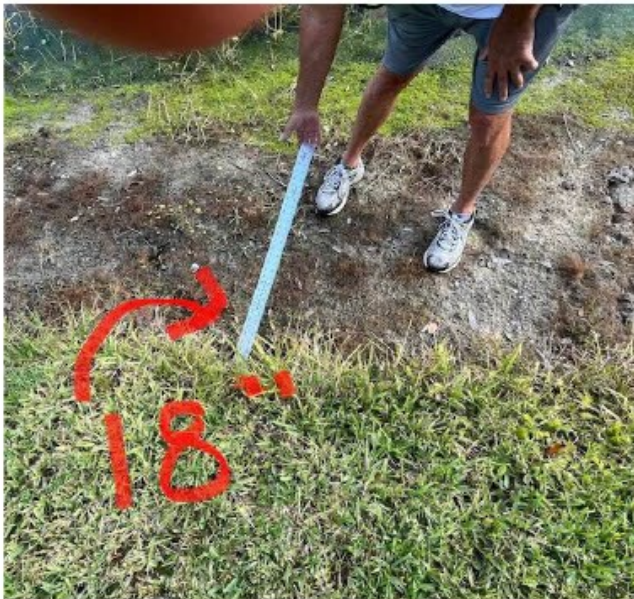
The gentle sloping of the pond bank would lend itself to the use of plants as an inexpensive preventative measure to forestall future damage. The area to the left of the overflow culvert has 14 – 24" cavities under the southside bank extending well beyond what is shown in the photo below. This area is of no threat to homes, roads, or sidewalks, therefore a collapse, should it occur would do no harm. Plants could keep it from getting worse.

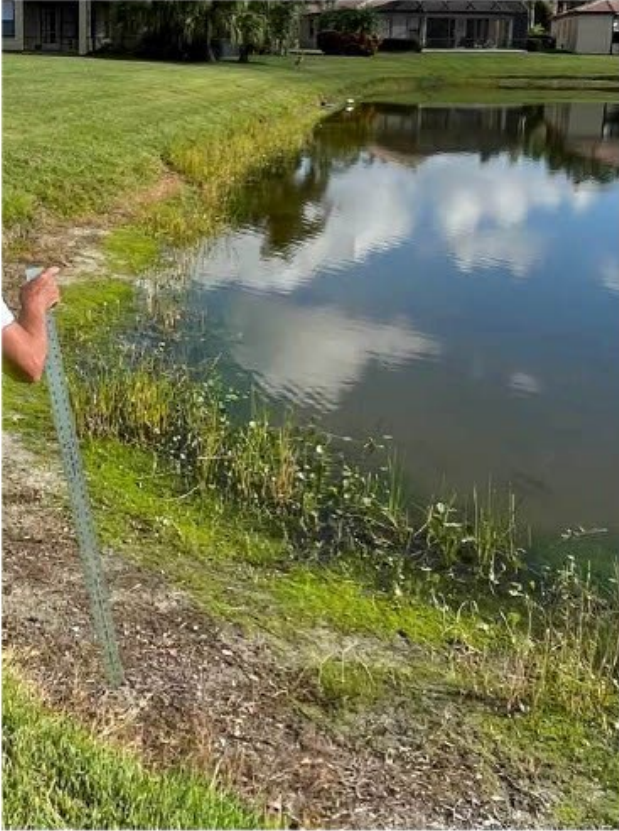
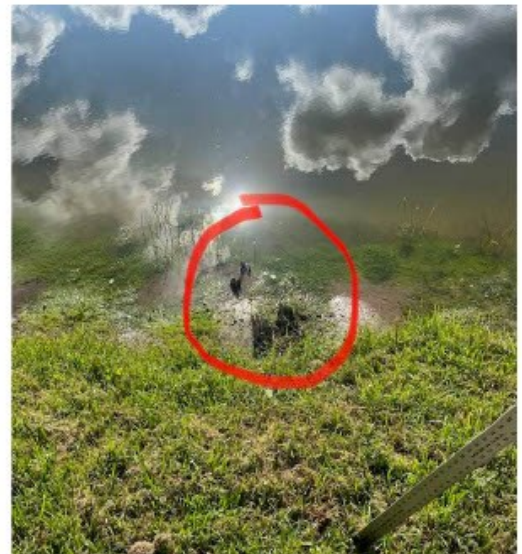
No holes or cavities found on the southwest or west side but there was a fair stretch of plants along the bank. Also, a tree stump in the water.

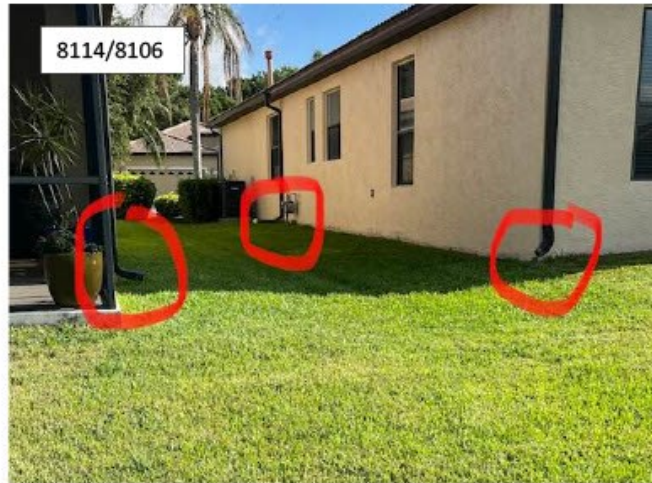
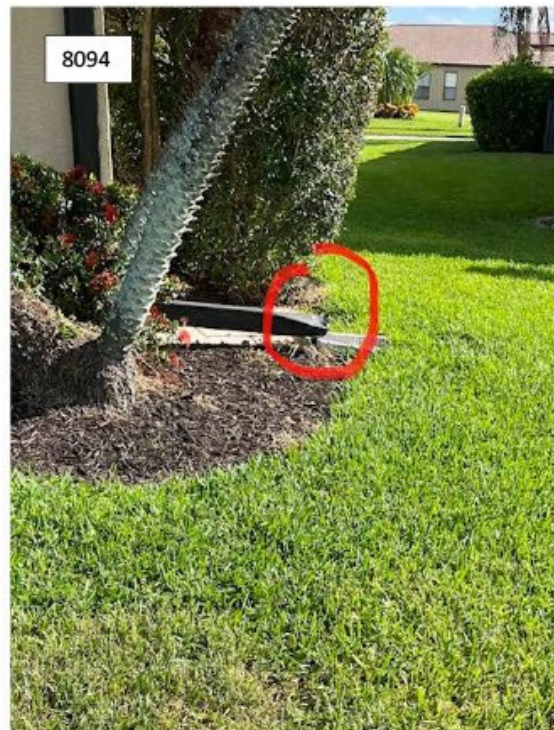
8014/8006 unburied drainpipes. Minor or developing (?) issues as shown on the previous page. 8098 has a strange cut through the yard with no apparent cause e.g. does not appear to be associated with unburied drainpipes.

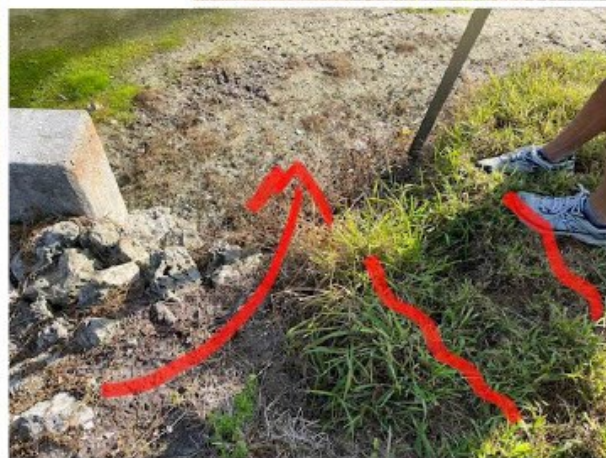
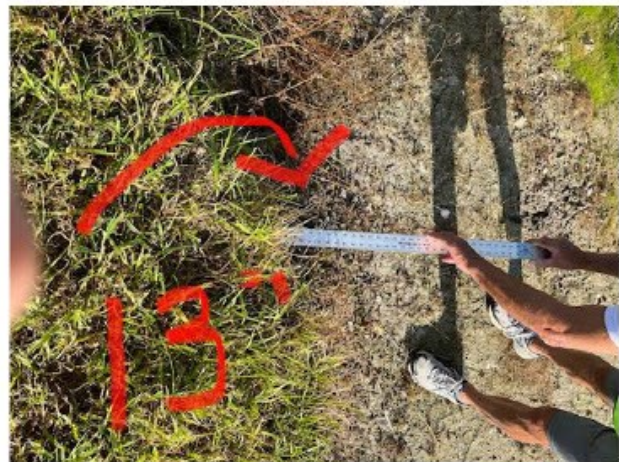
Randomly placed riprap behind overflow gate – or it shifted after installation? Either way, rocks have moved, dirt on the eastside has eroded and channels have developed in the bank which will allow water to bypass the wall and gate. If this is important, it needs to be repaired. Also, there is a 13" cavity under the bank on the east side of the wall.

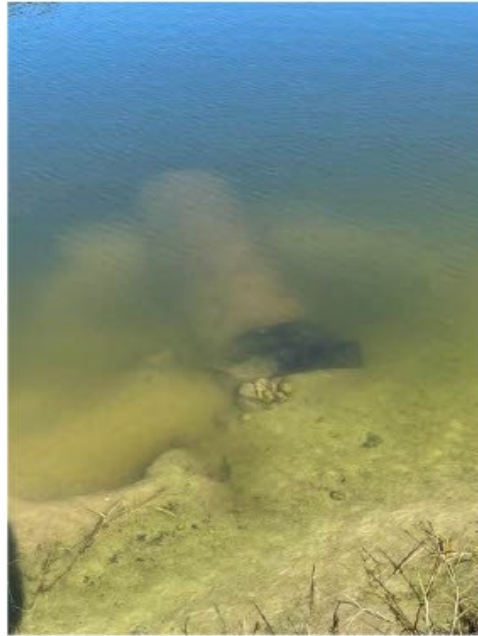
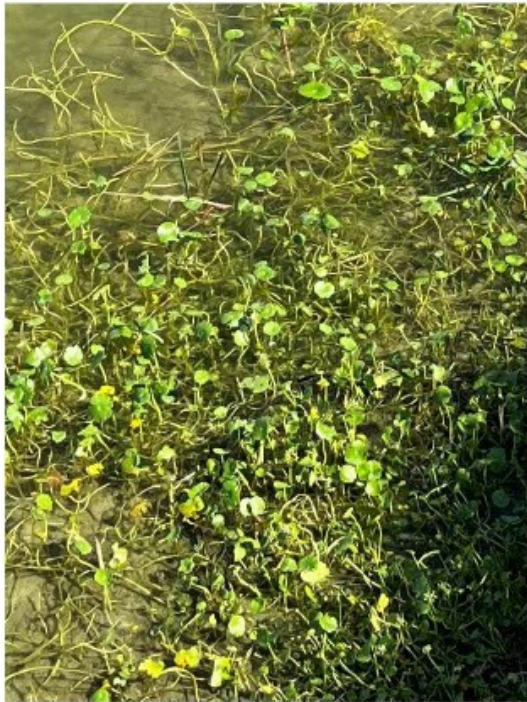
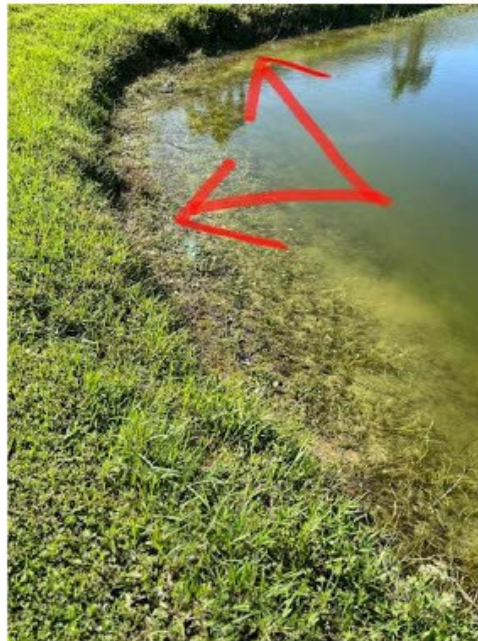
Top: Two unknown objects in the pond. Bottom left: Possibly Floating Pennywort = invasive. Bottom right: Another example of a thick grass waterfall over the bank edge to the pond. Found in several areas around the edge.

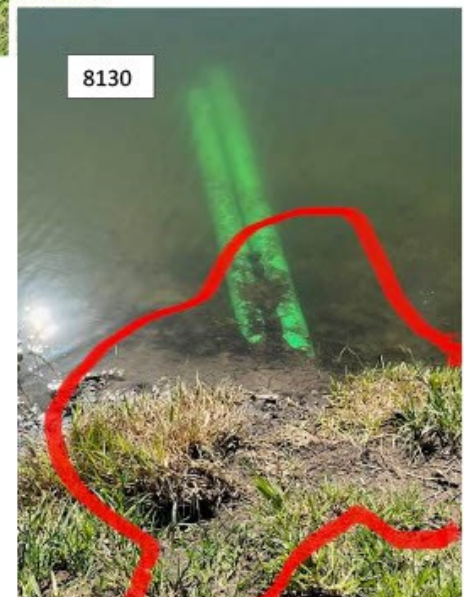
Top: Very unusual topography along the pond edge. Littoral shelf very shallow and very wide. Lots of pockets/holes (bottom)? Found on both east and west sides, but most prominent on the east side (below). Middle: Bank destruction of unknown cause (?) between 8038/8042. Bottom: Newly buried double drainpipe behind 8130. Note the poorly reconstructed bank with holes and loose clumps of sod. The soil is sliding into the pond and beginning to cover the pipe.

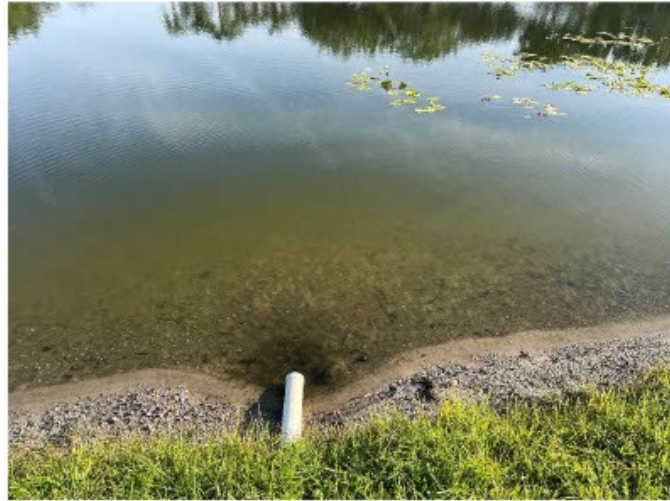
4263 Buried drainpipe (different contractor?) shows no continued erosion or recurrence of previous cut in the bank pre-burying. We should find out the contractor used and inquire about his methods.

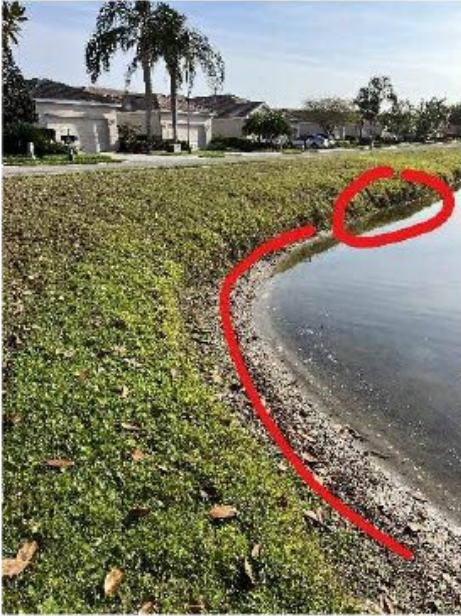
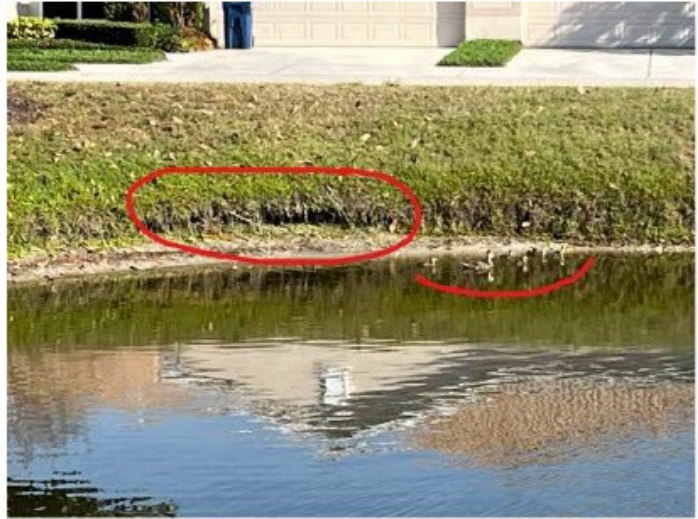
Corner Ashford & Cascade: Across from 4251 – 4255 Cascade, soil erosion has caused 8 – 13in deep cavities under the edge, extending as far as we were able to reach. The cavity is large enough for a family of 6 ducks to swim underneath the ledge (at circle)

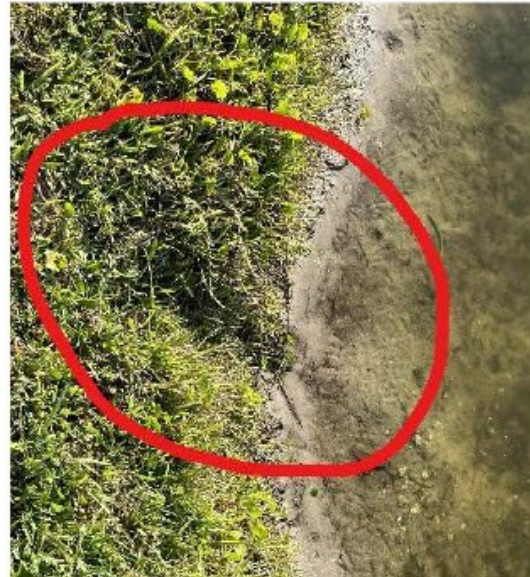
Across from 4159 – 4165 Cascade, there are multiple 4 – 6 in depressions 2 - 4ft from edge likely caused from soil erosion underneath the grass. Unable to evaluate the ledge at water's edge due to water level in pond. Across from 4165 there is a large erosion cut at water's edge.

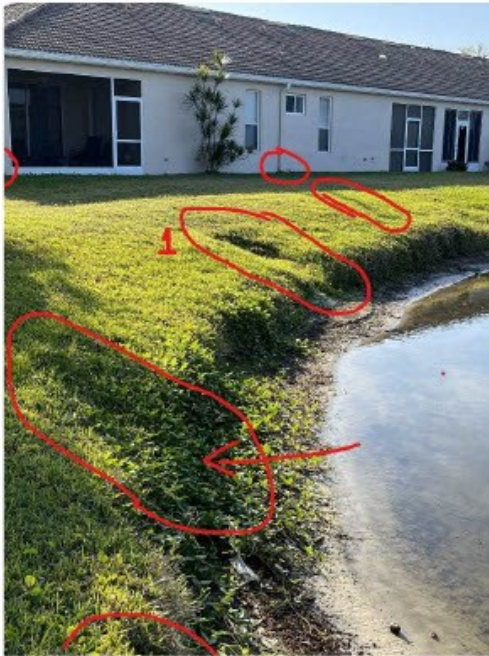
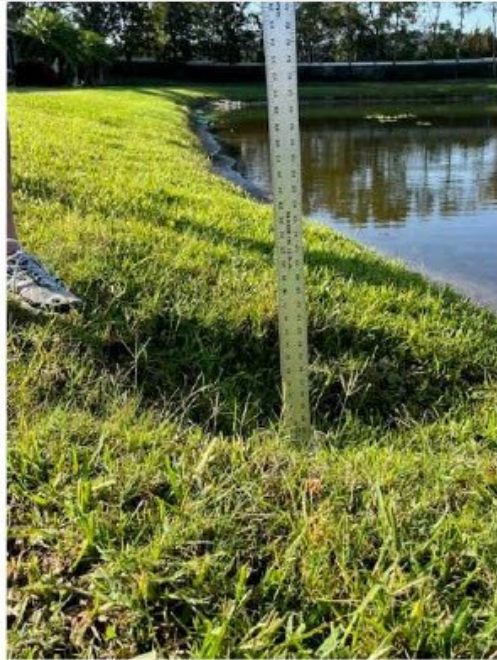
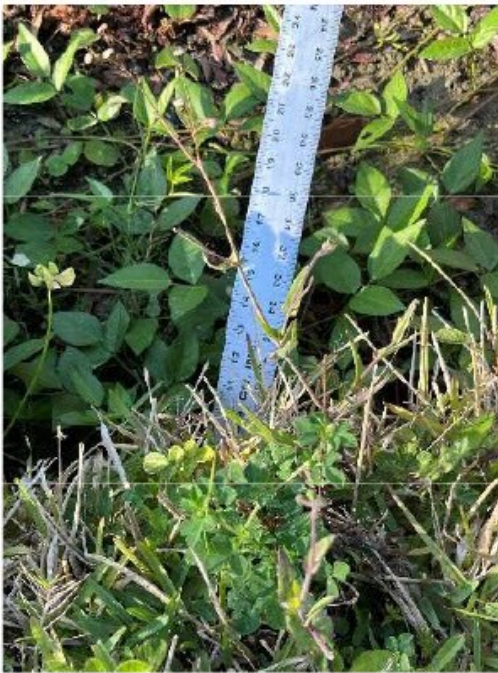
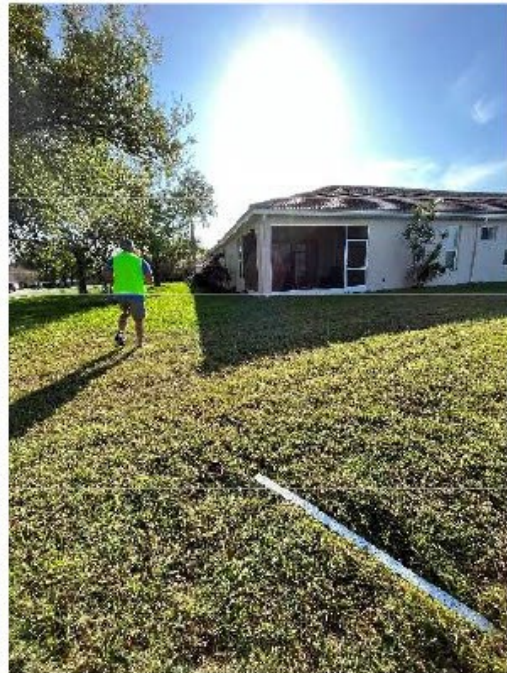
Corner Cascade & Simpson Falls: Multiple deep washout notches. The largest (1) is approx. 13" d x 18" w & 3' to water. Unsupported 11in deep cavity under ledge at arrow. Unburied downspouts behind 8208 & 8212 Simpson. Water from the road could be contributing to the washout areas due to significant slope & trough.

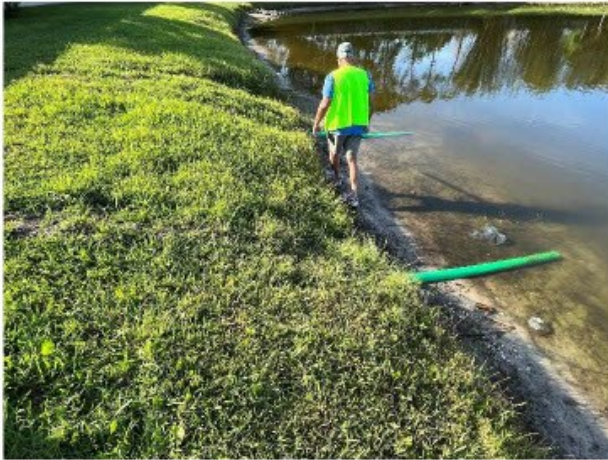
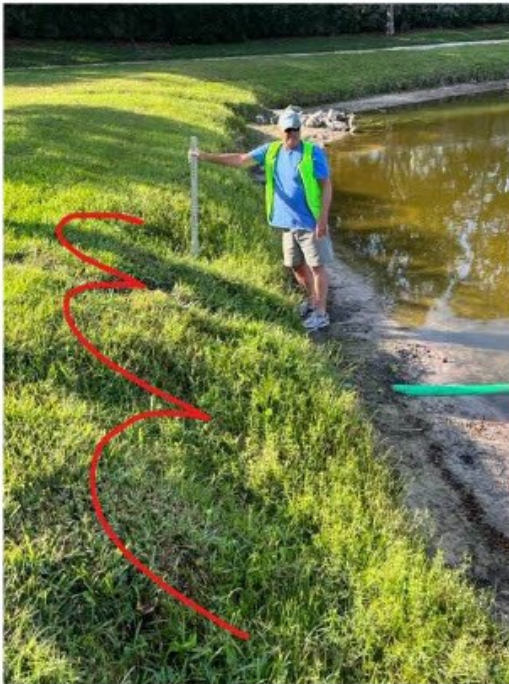
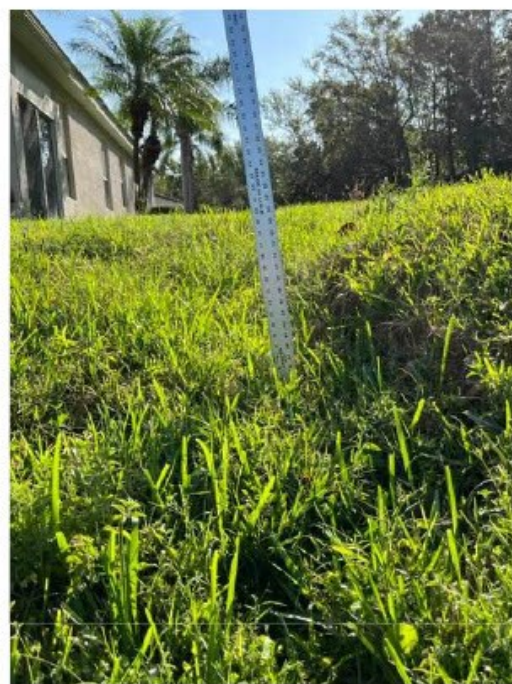
8216, 8220 & 8024 recently buried their downspouts. Don't know if the ground was filled flush after the spouts were buried or if the loosened soil caused by burying the spouts allowed continued erosion, but additional backfill is needed to fill holes and washout cuts still present where the spouts were buried. There is evidence of collapsed ledges (arrows), perhaps caused by erosion carving out cavities under the edges as shown in previous photos. The whole length of this side of the pond is riddled with 4 – 6" holes.

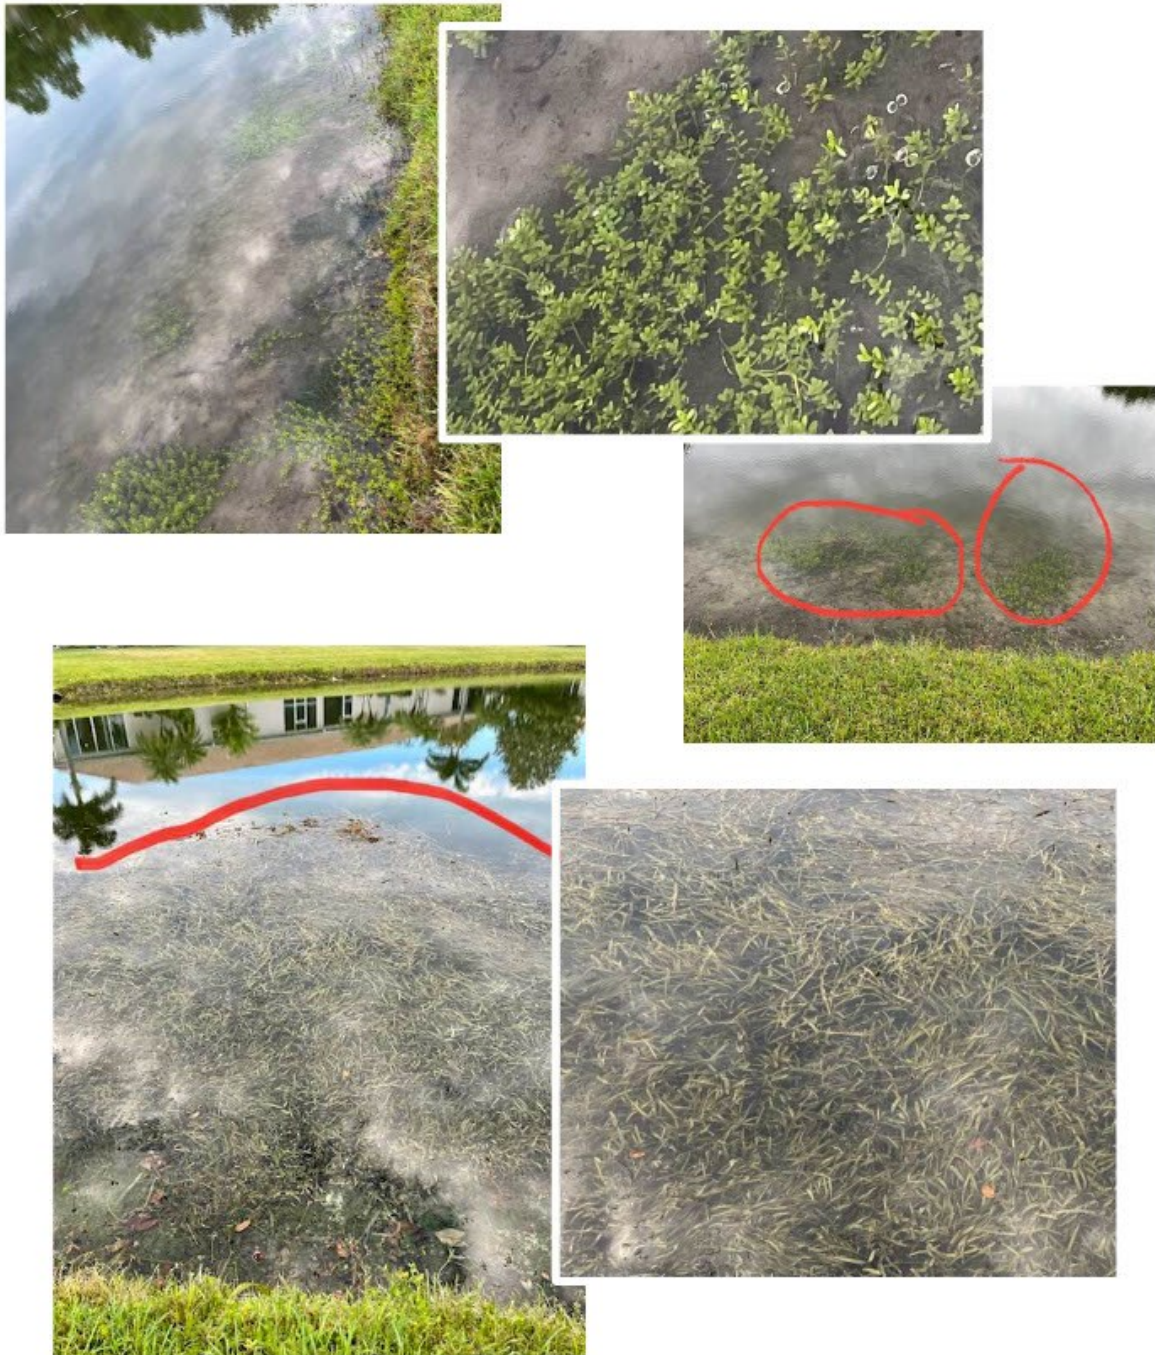
Too much water in the pond to walk the littoral shelf and determine the condition of the side of the bank. Top: Large patches of underwater plants - possibly Vallisneria - primarily on the north side of the pond. Vallisneria is highly invasive and should be removed or controlled. Bottom: Submerged grasses extending almost halfway across the pond on northeast side

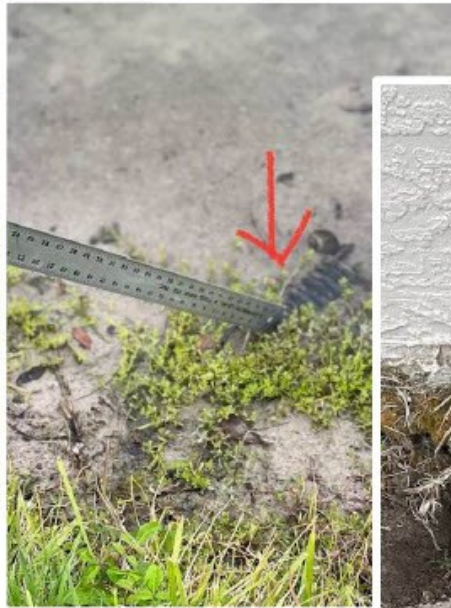
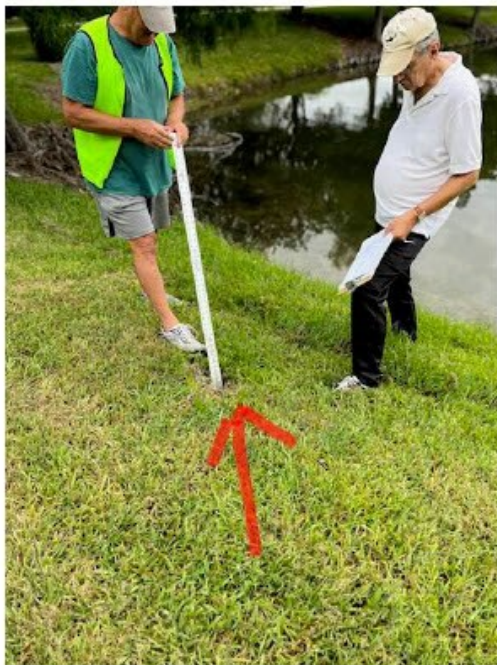
Top: The pond exit of the buried drainpipe at 4209 is completely blocked by continued erosion causing the rain water to back up and overflow the connection. This has resulted in a large hole around the pipe that extends under the foundation.
Bottom: Buried drainpipe at 4205 exits in the lawn 6ft from the pond edge. Exit is filled with grass and soil.

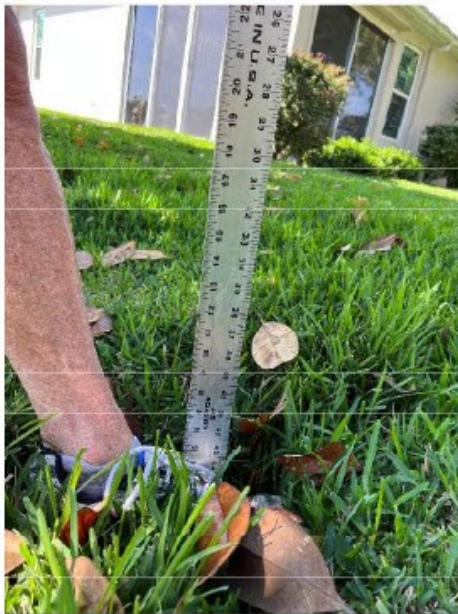
Northwest corner, Cascade & Cascade, a large swale between the buildings has been repaired several times. Apparently unsuccessfully as significant erosion persists. While drainpipes may contribute to the swale, it's clear that over-irrigation/rain must play a part. Perhaps a catch basin or terracing might reduce the impact of flow from drainpipes and road.

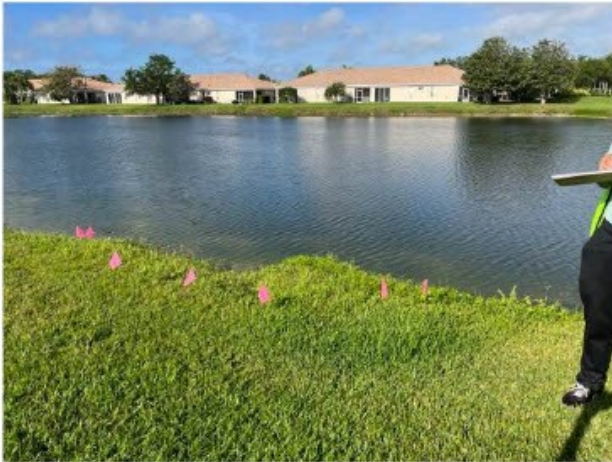
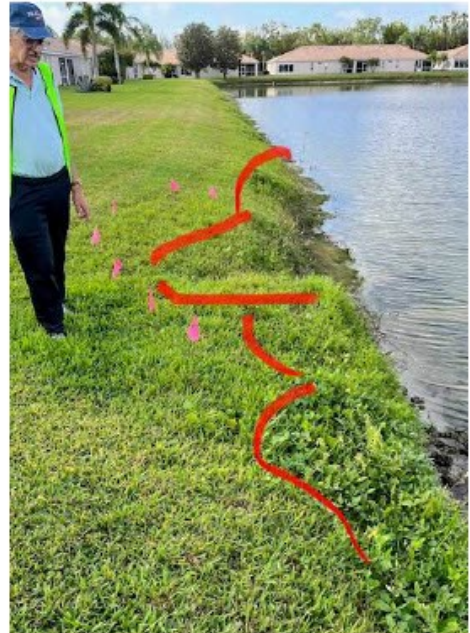
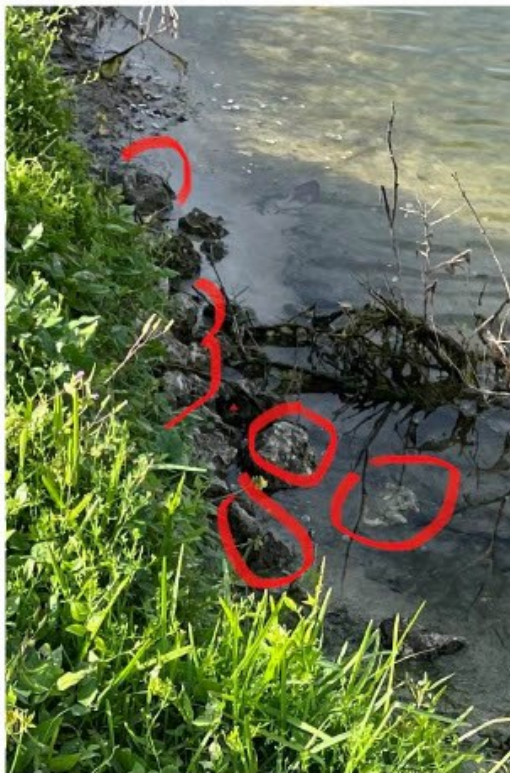
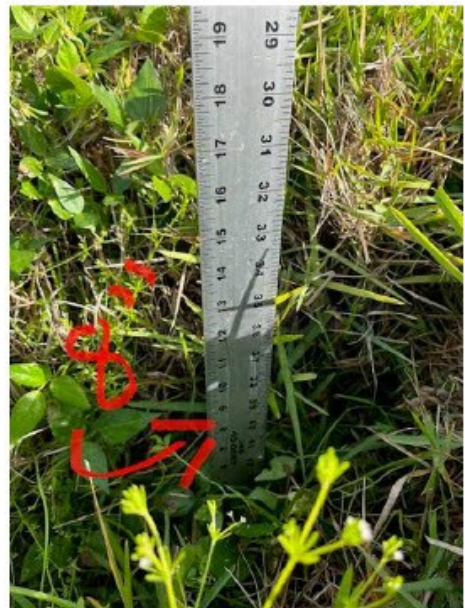
4171 Cascade: Owner has marked area of bank that has eroded leaving cuts and missing chunks. Old riprap put in several years ago is almost completely overgrown with dirt, grass, and weeds. The bank slope is very steep exceeding the 2:1 ratio for untethered riprap therefore some rocks have slipped or rolled down into the pond. There are also 8" holes in the lawn.

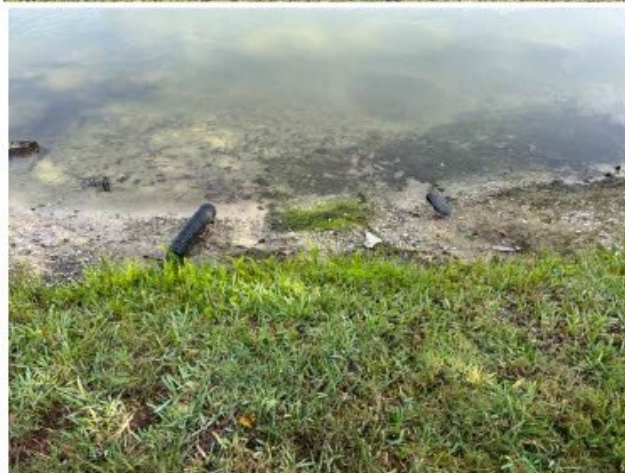
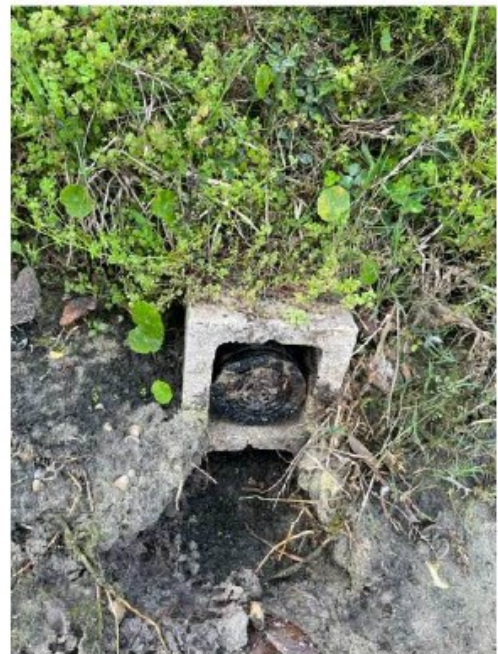
4127/4123 Both have 2 drainpipes buried. There is an 8" swale to the right of the concrete drain pipe coming between the units. The ground next to the swale (upper right) and above the exit pipes(bottom left) is chopped up and collapsing. Improperly packing of buried drainpipes often result in loosened soil in the trough and continued erosion. 4123's pipe is capped with a grate supported by a concrete block.

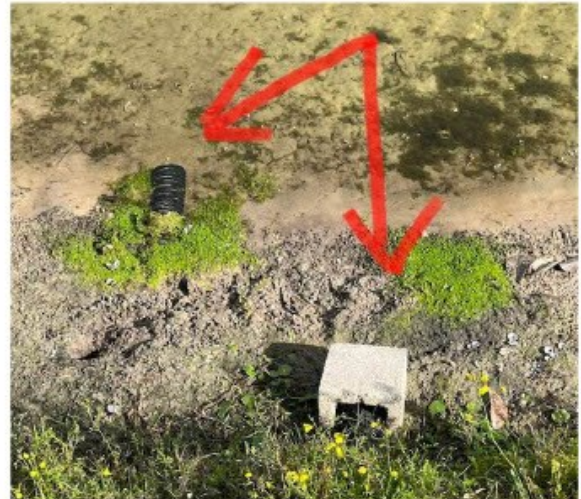
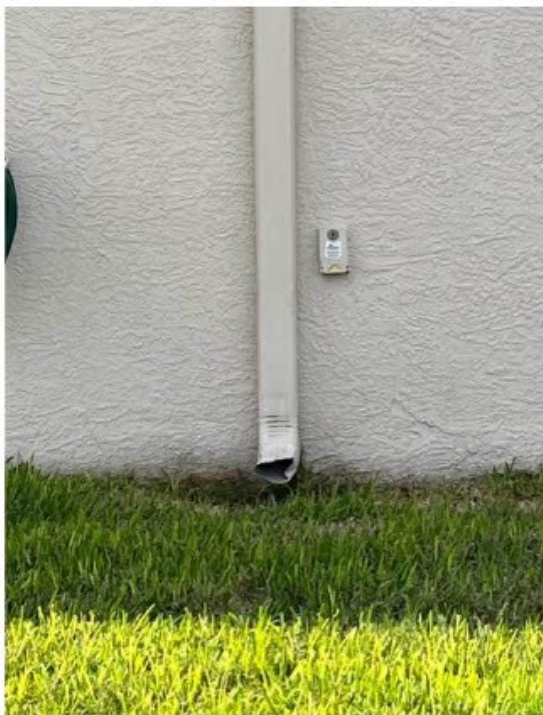
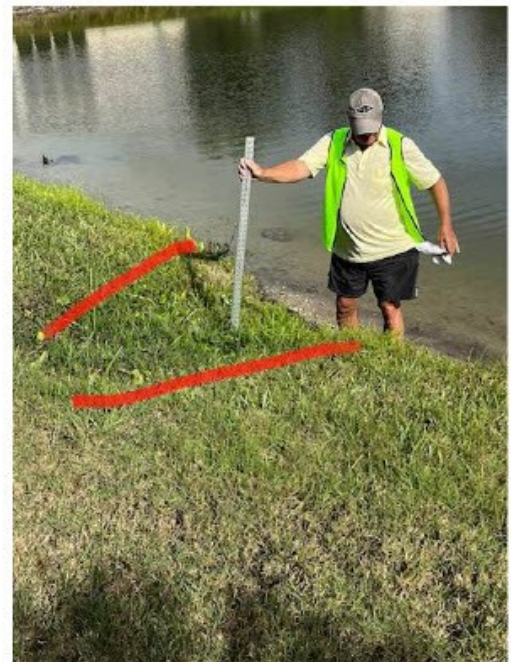
4121 (above) drainpipes are buried but the exit is partially blocked by silt from bank. 4119 (below) has an unburied drainpipe and a 10" deep by 5' wide swale. If not done well, buried pipes can cause almost as much damage as unburied.

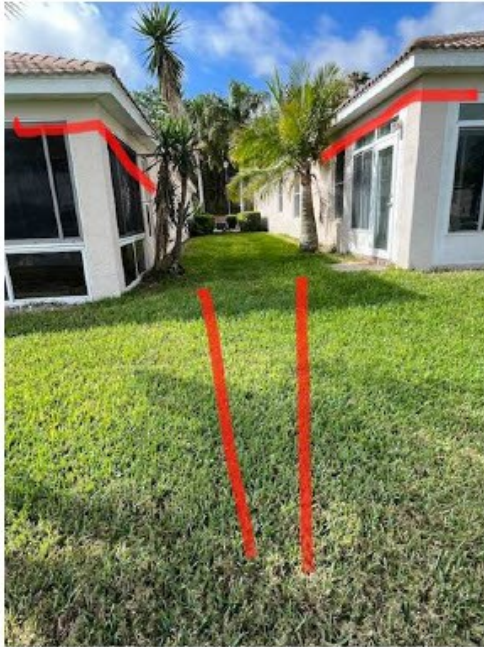
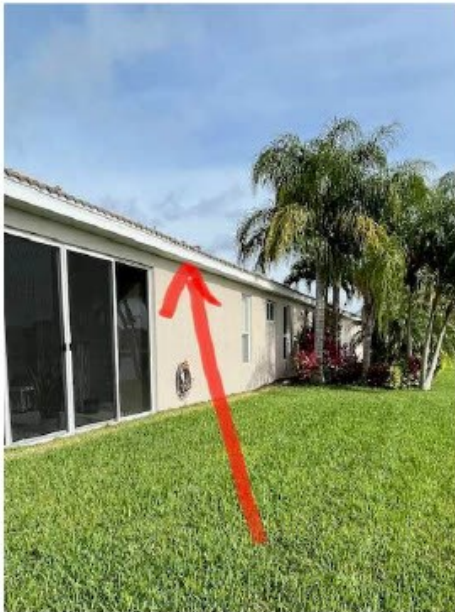
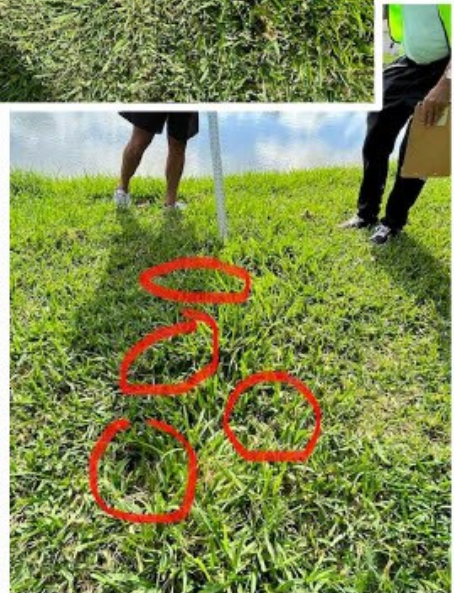
4115/4111 (above) No gutters but again double the water from the two roofs plus irrigation is likely what caused the swale between units and cut in pond bank. 4053 (below) No gutters/no cuts. Again, flat yard may allow water to percolate before it gets to the bank. However, there are numerous holes in the yard between unit and bank.

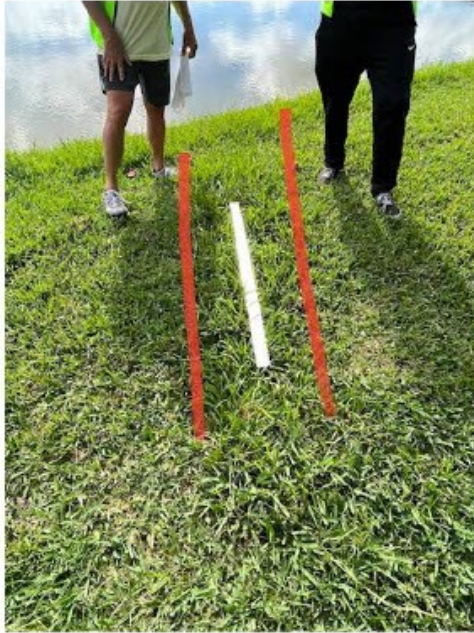
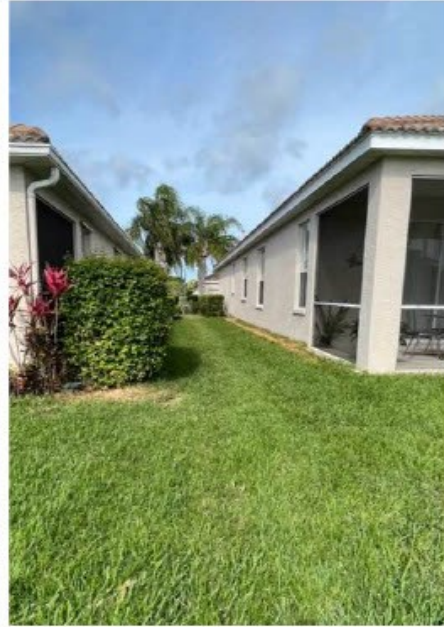
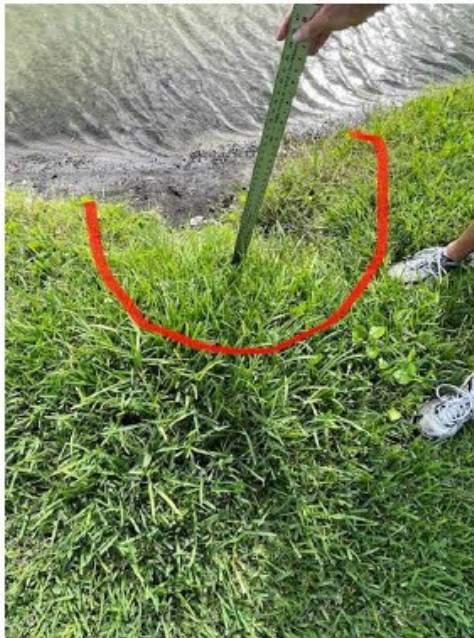
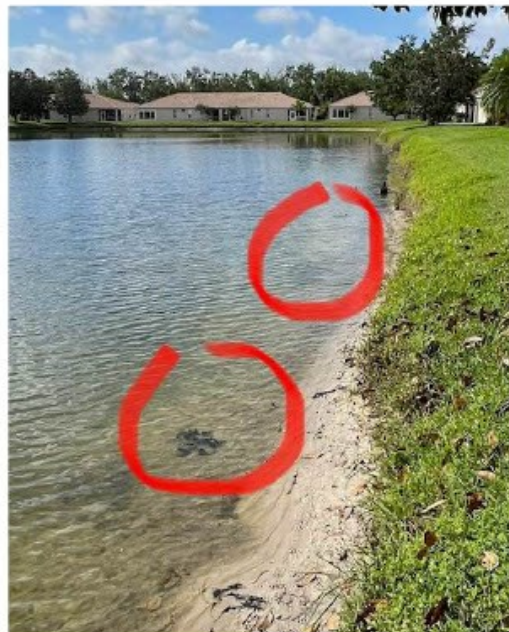
Trough between 4049 & 4045 and 4025 & 4019. Large chunk missing in the bank at 4019. Row of trees (lower right) under the water on the west side of the pond.

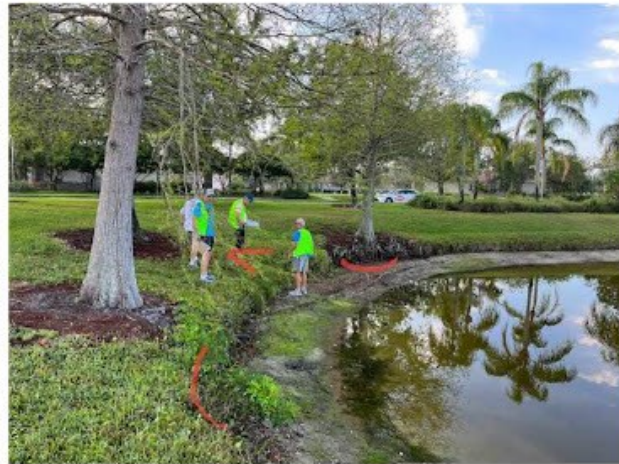
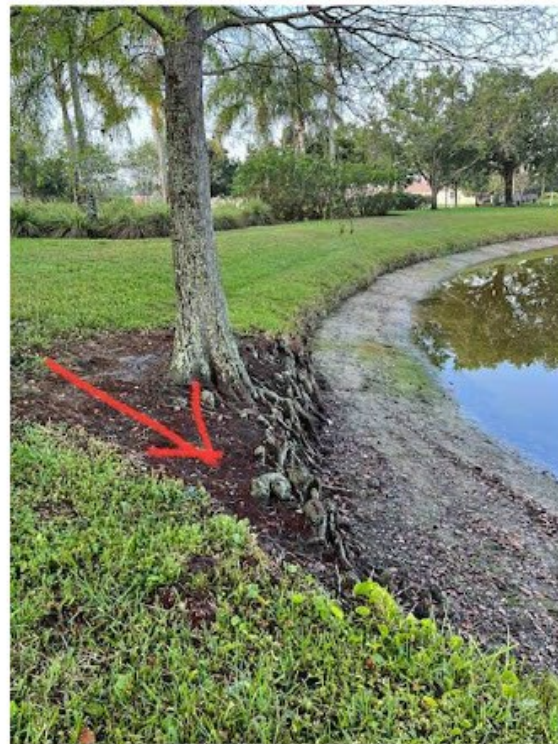
Top left: East side where rebar was placed 24" from bank edge several years ago. Currently at 20" apparently due to bank collapse. Top right: Erosion areas SE corner both from the top (irrigation) as well as from pond action. Bottom: close-up photos of above areas. The swale in the lower left corner due exclusively to top erosion by rain or irrigation as the pond level does not reach this high.

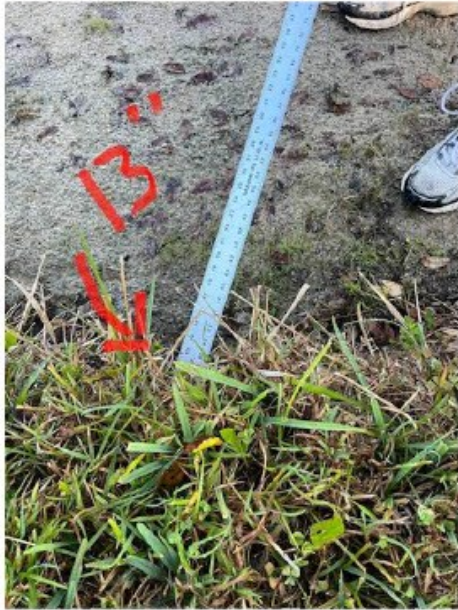
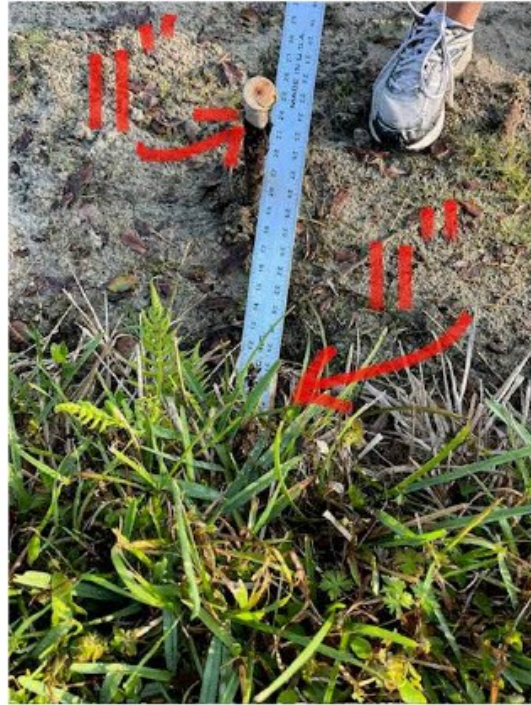
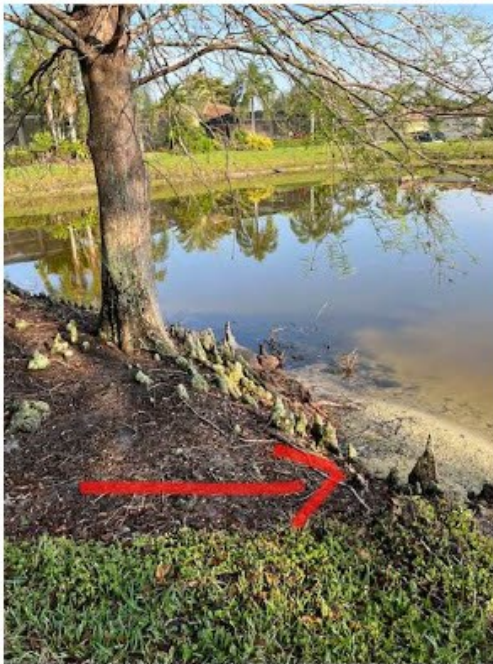
Approximately a 13" cavity under bank extends along most of the south side of the pond. Top right photo: 11" cavity under the bank and a corroded sprinkler head sitting 11" into the pond. Bottom photos: Washed out soil around Cypress roots from run off from sprinklers. White PVC pipe embedded in cypress tree.
