Pond Survey Summary

The LakeRidge Falls (LRF) Roads & Grounds (R&G) Committee Pond's Crew conducted a physical inspection and prepared an individual survey of 13 stormwater ponds in the community, during the early part of 2023. We did not survey Pond # 7 (by the back gate) as it is not connected to the other 15 ponds, is not maintained as a pond, and has been planted as a wetland. In addition, we did not have sufficient time to complete surveys of Ponds 2 and 16 before late spring rains limited our full access to these two ponds. The Ponds' Crew recommends conducting inspections and preparing surveys of these two ponds during the next dry season in 2024. The 13 individual surveys, for the most part, reflect our observations and are, therefore, the "facts" we found. These individual surveys stand on their own as direct observations, supported by photos and measurements. The recommendations we make, therein, are those that are obvious, such as burying, or redirecting pipes, and adding catch basins.

Pond Crew 2023

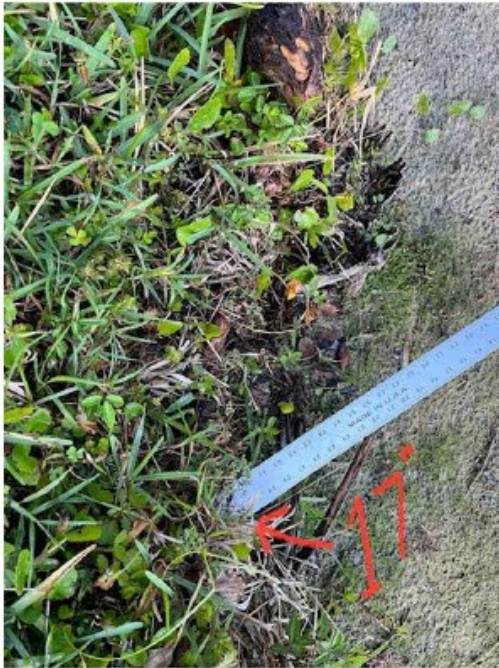
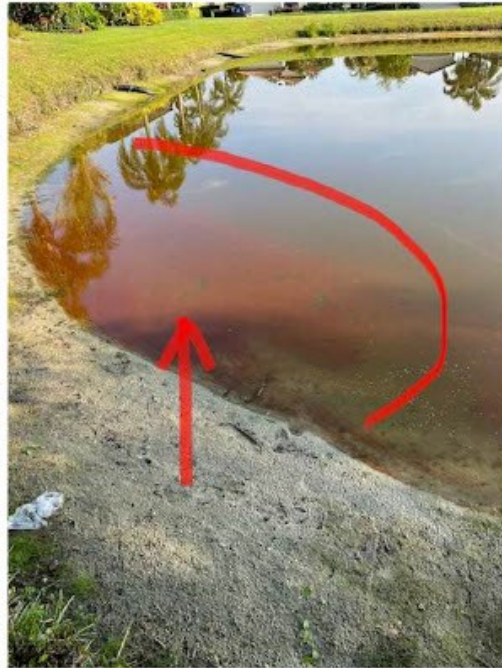
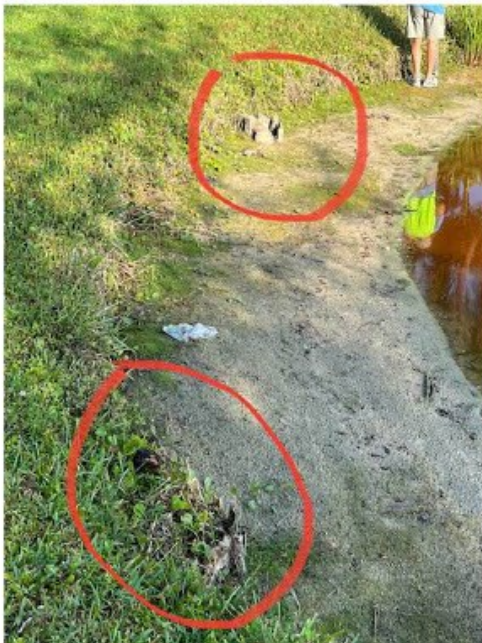
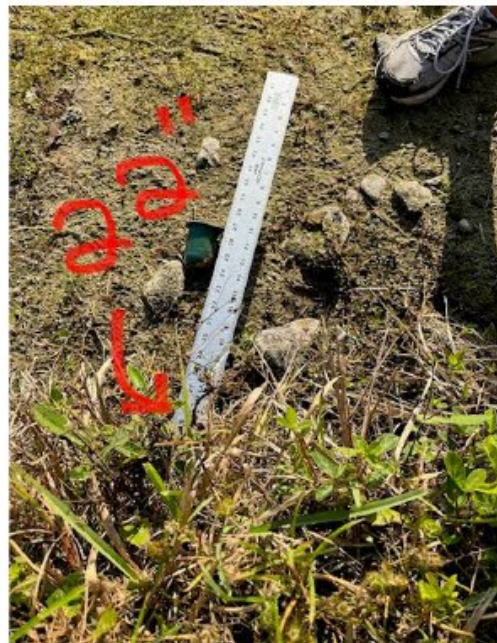
Top: 17" cavity at the SW corner; patch of rust colored water. Bottom: Tree stumps that would be submerged if water was at its normal level. 22" cavity under the bank on the west side between 8232 & 8228 Sterling Falls.

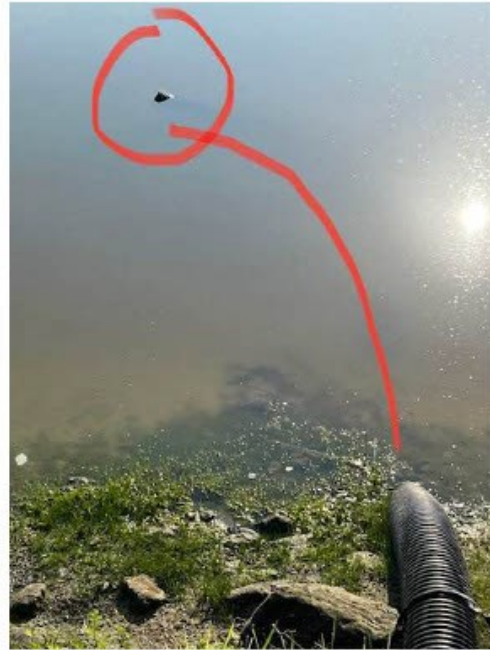
One of a few aquatic plants (Arrowhead/Duck Potato) left over from a planting several years ago that was subsequently removed. 8232/8228 Sterling combined to bury a single drainpipe. Note the exposed terminal end exposed above the water (?) Also note the scum and bubbles along the bank. The bubbles are usually caused by stagnant water, hot weather, and an excess of dissolved or decaying organic matter (fish waste, grass, leaves, etc).

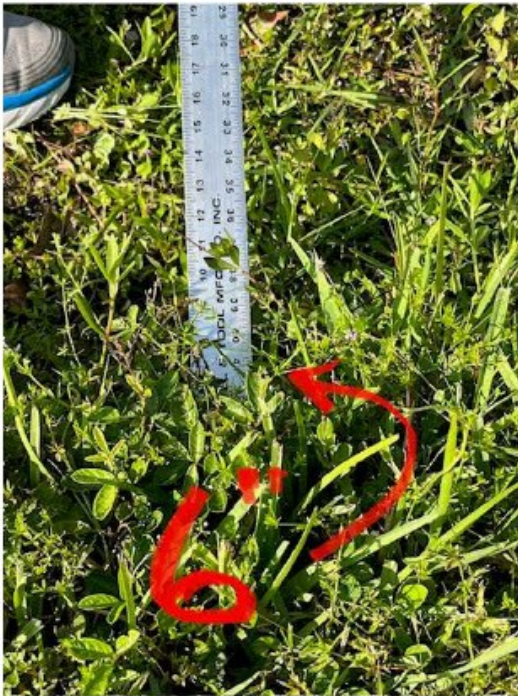
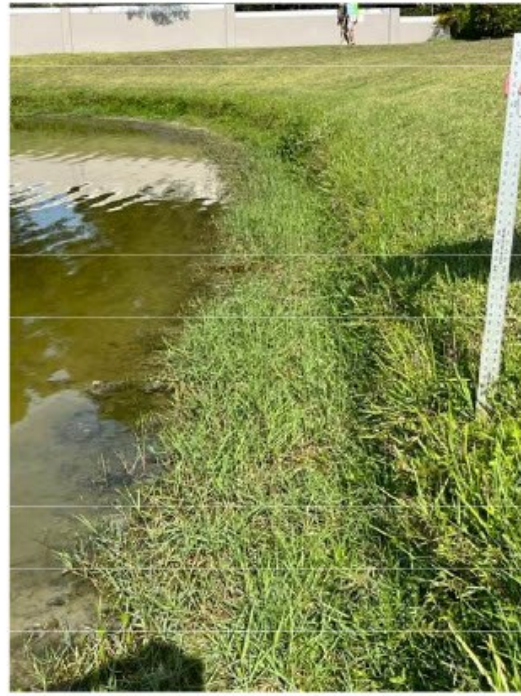
Upper photos: 8131 Stirling. Drainpipe not buried. 10" undercut at bank. 8" bank collapse at 8127.
Lower photos: 6" undercut at north east corner (L). Approximately a foot of thick grass/weeds on the littoral shelf along northern edge of pond (R). No bank undercutting noted but the water was too high to confirm.

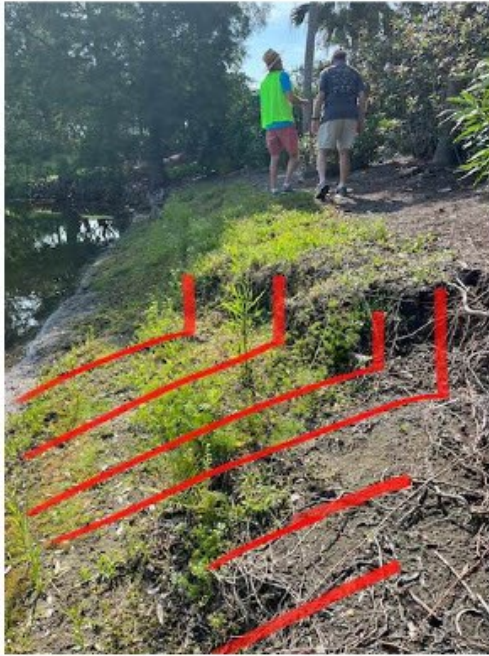
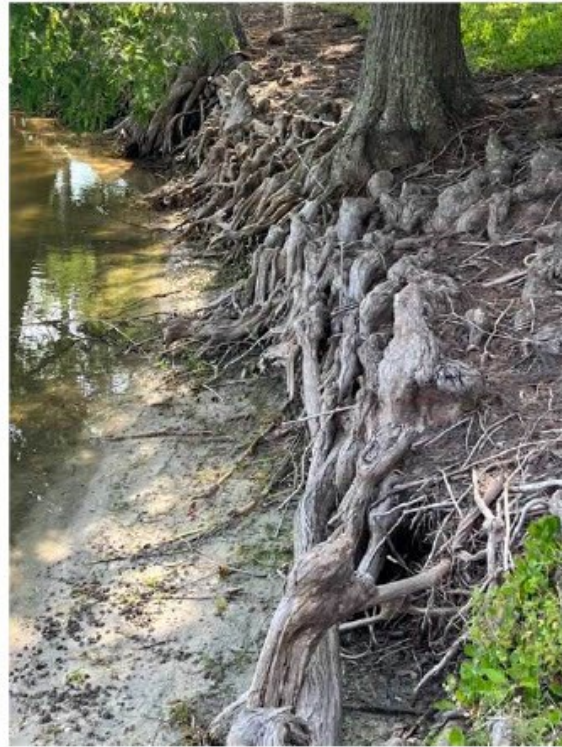
On the south side, bank collapse is caused from top side erosion by rain or irrigation since water level of the pond does not reach high enough to have caused erosion and exposure of the Cyprus knees and bank collapse. Lower left picture shows the position of the rebar which was placed at 12" and is now approximately 30" from the bank. The southwest side (top left) could be graded for plants, but the southeast side (top right) requires something more aggressive.

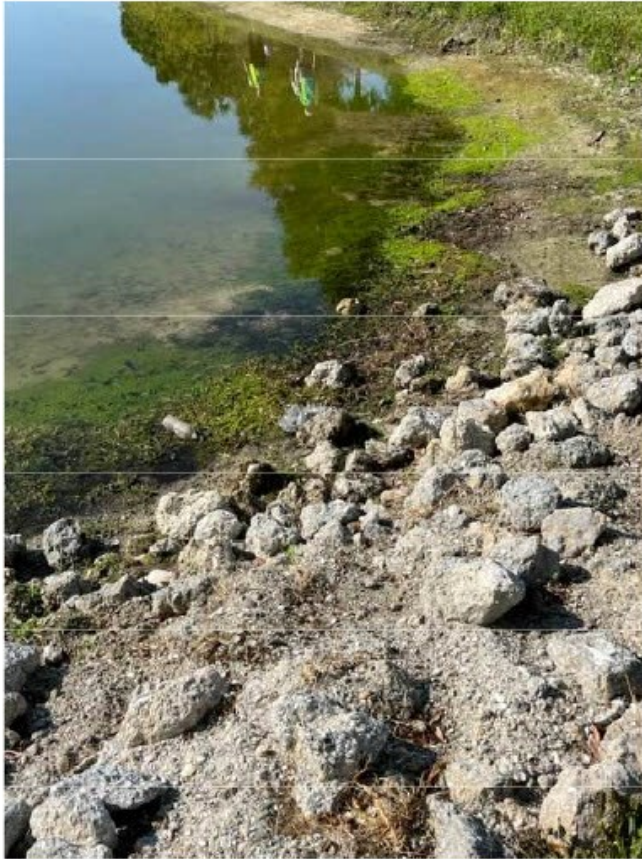
North side. Recently installed riprap appears to have not held up well. The rocks are loosely spaced and crumbling with lots of dirt/sand visible between rocks. Riprap should not have visible sand. Also note green scum/water and trash.
