May 2026

Annual Report

*Ponds Working Group (PWG) of
LakeRidge Falls*

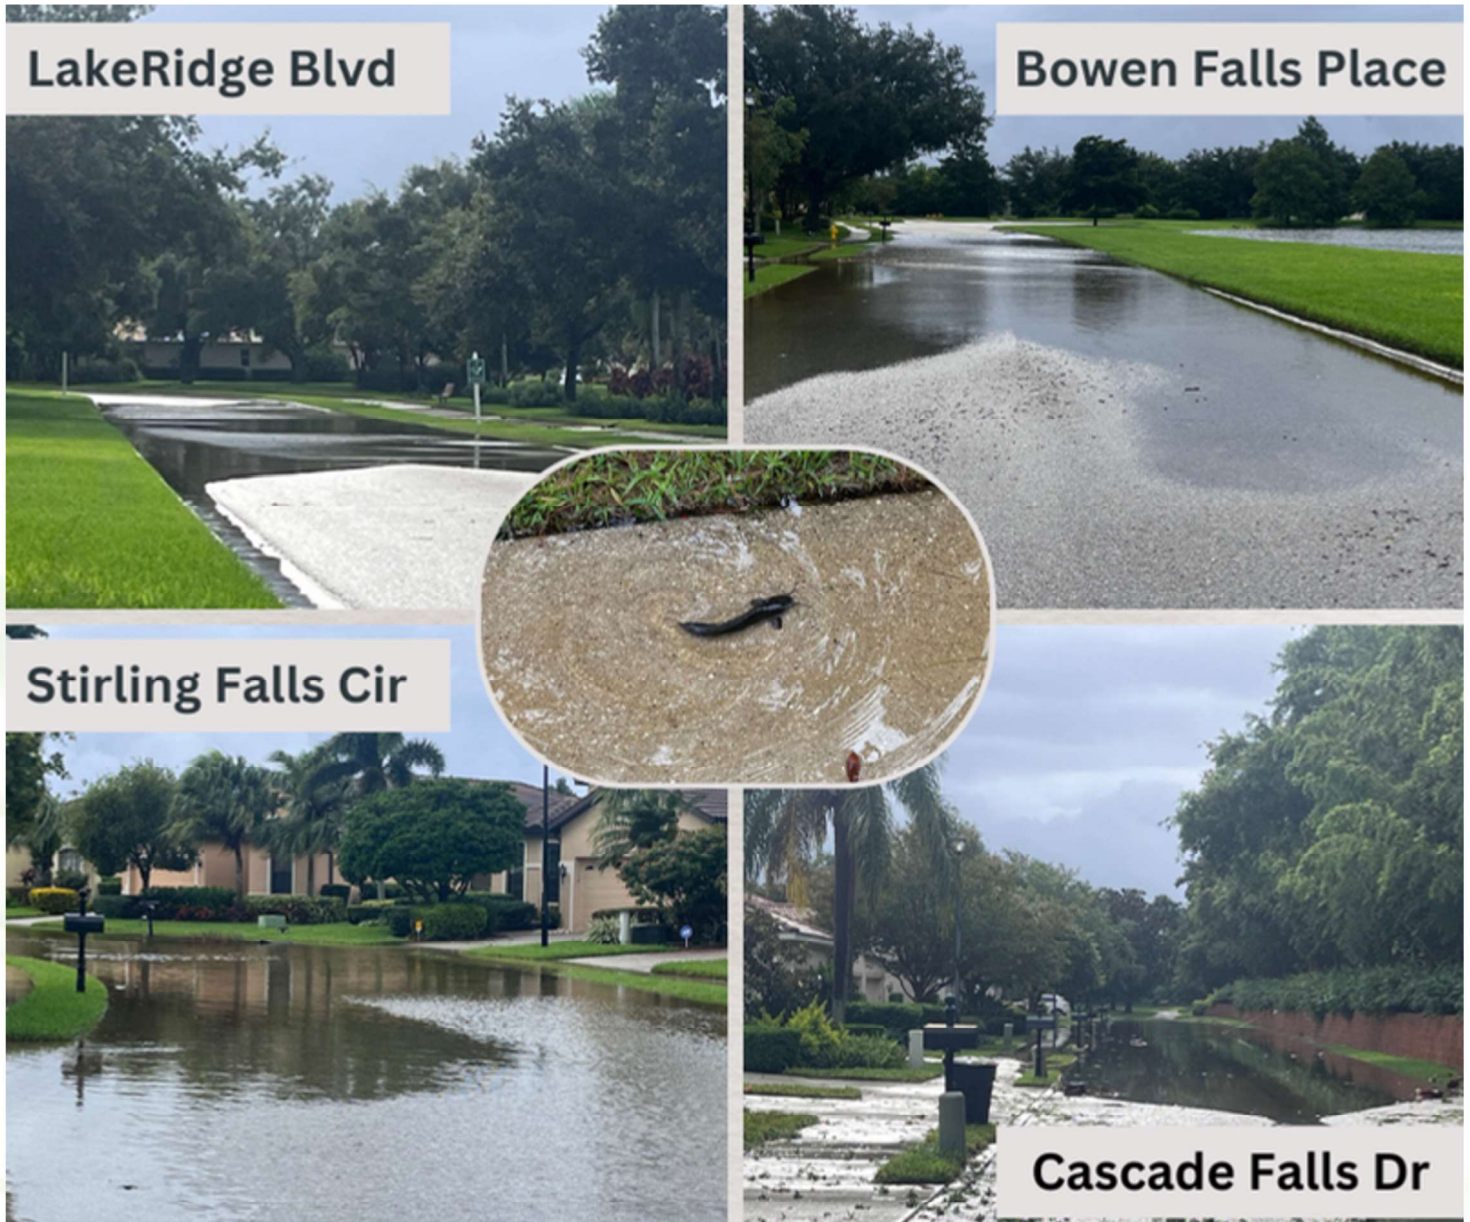
August 2024

Overwhelmed Stormwater System in LakeRidge Falls = Floods

Such failures occur when rainfall surpasses the engineered capacity of ponds or catch basins, ponds storage capacity is decreased due to shoreline erosion, and/or obstructions such as debris impede the system's function.

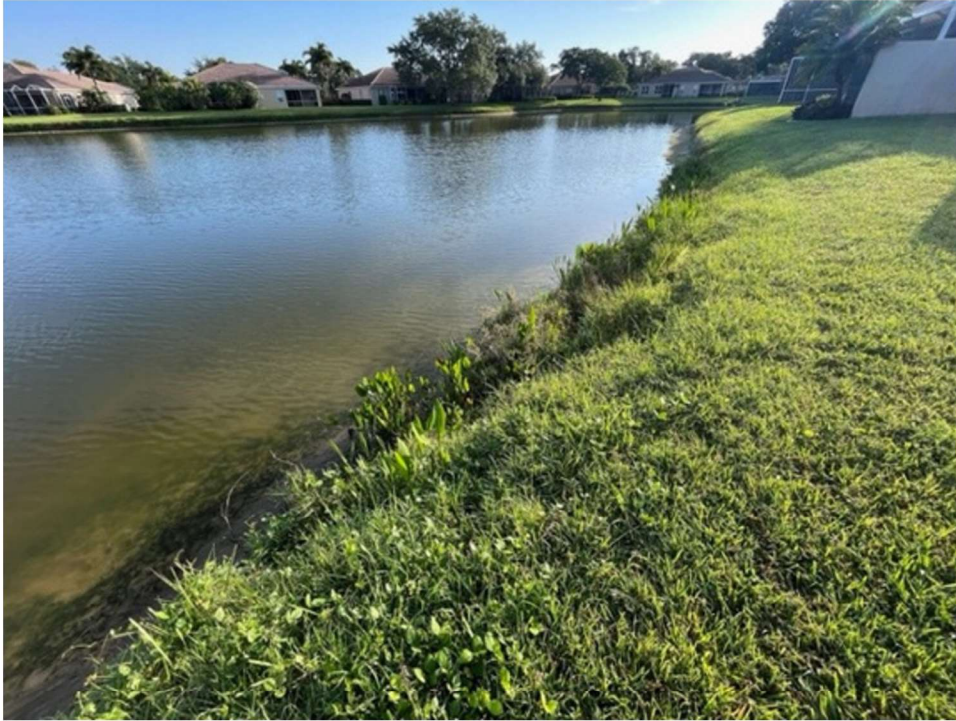
April 5, 2023 - Aquatic Plants behind 8107 Victoria

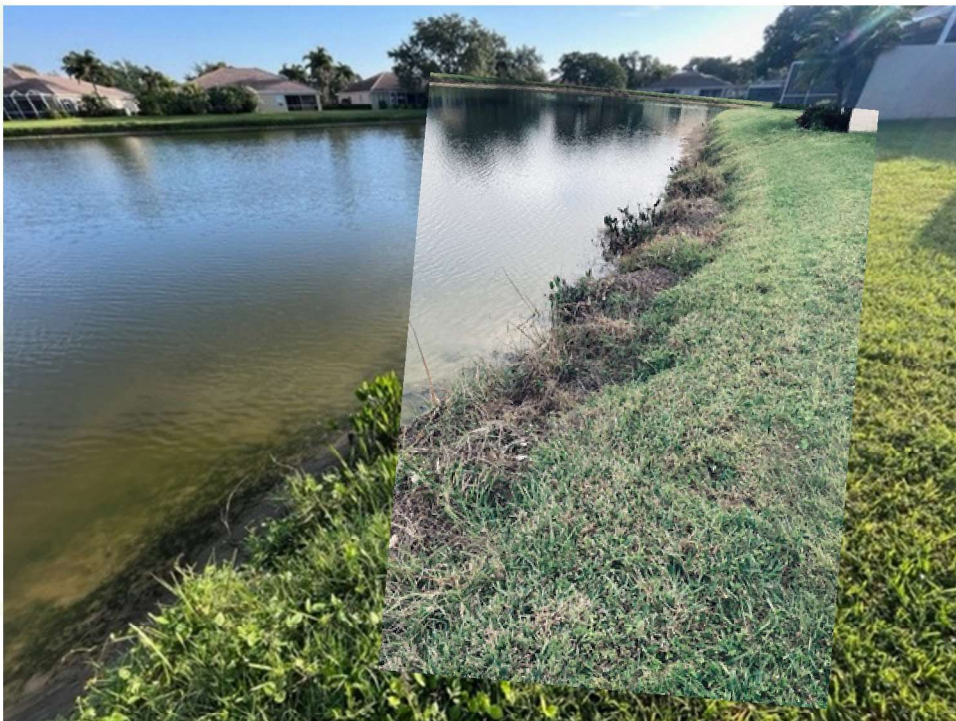
Feb 18, 2026 - Imposed picture on top of the 2023 picture

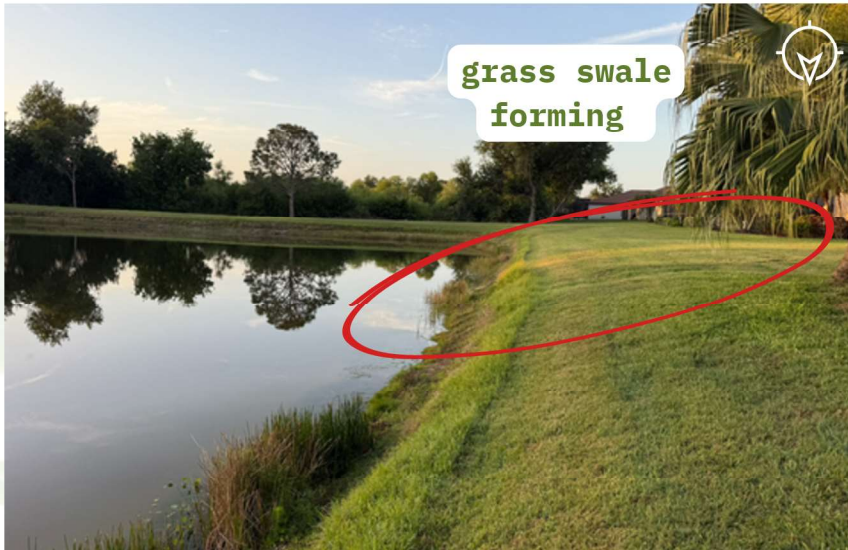
grass swale forming

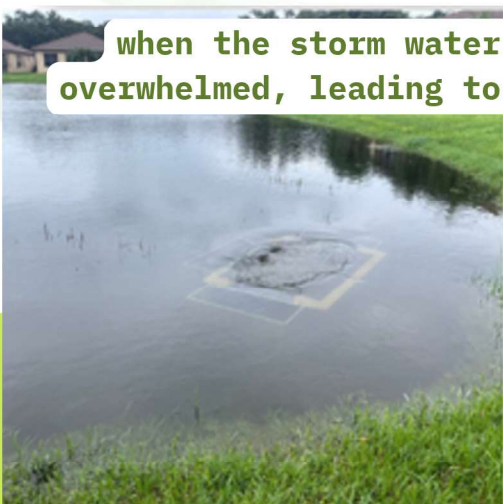
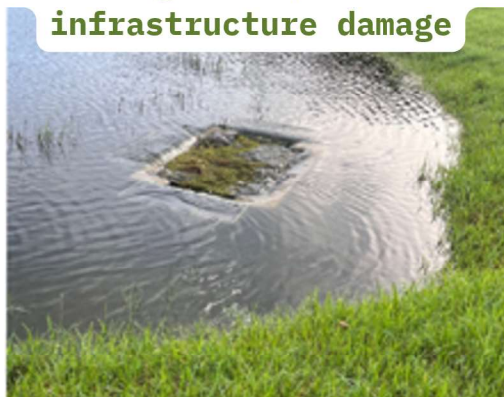
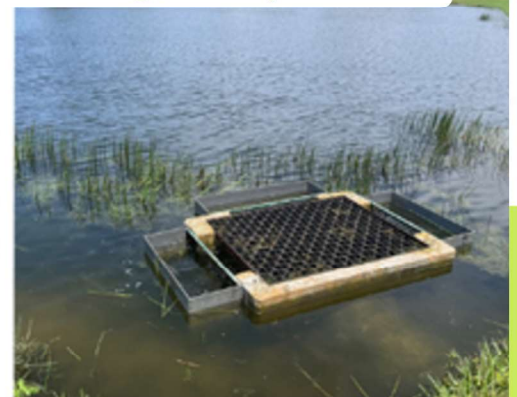
when the storm water system can't empty water fast enough it becomes overwhelmed, leading to surfacing water, localized flooding, and potential infrastructure damage

August , 2024 - Hurricane Debby - drain at Pond 4

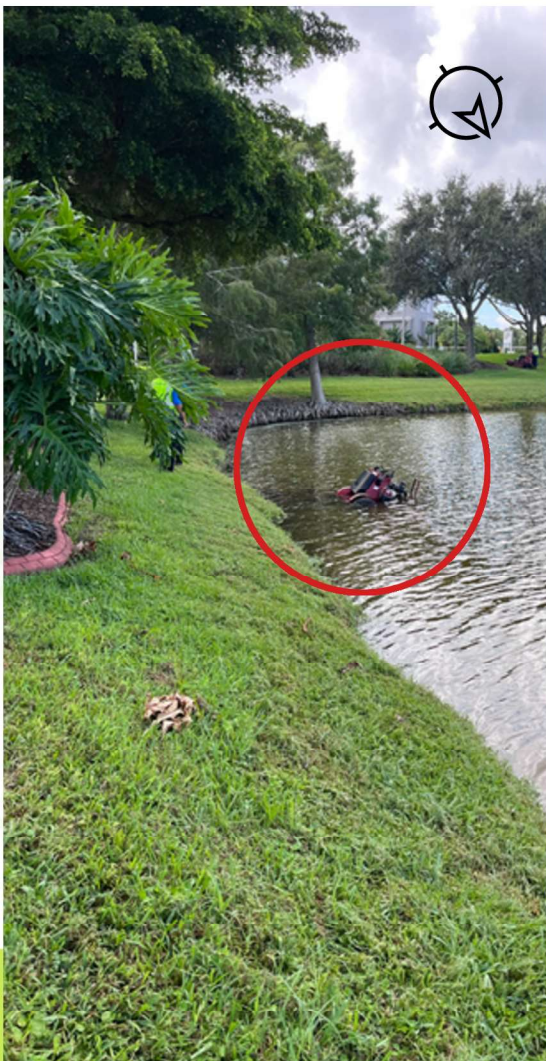
Sept 18, 2023
Mower in the pond

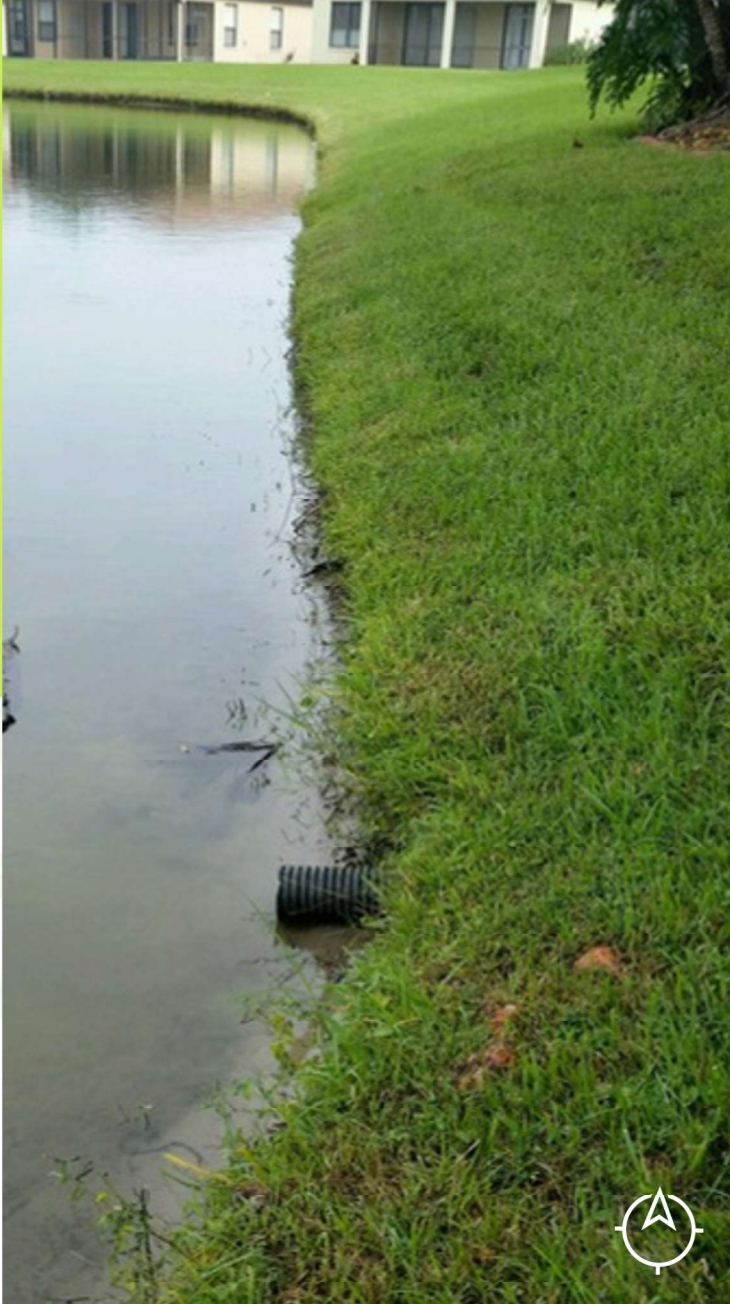
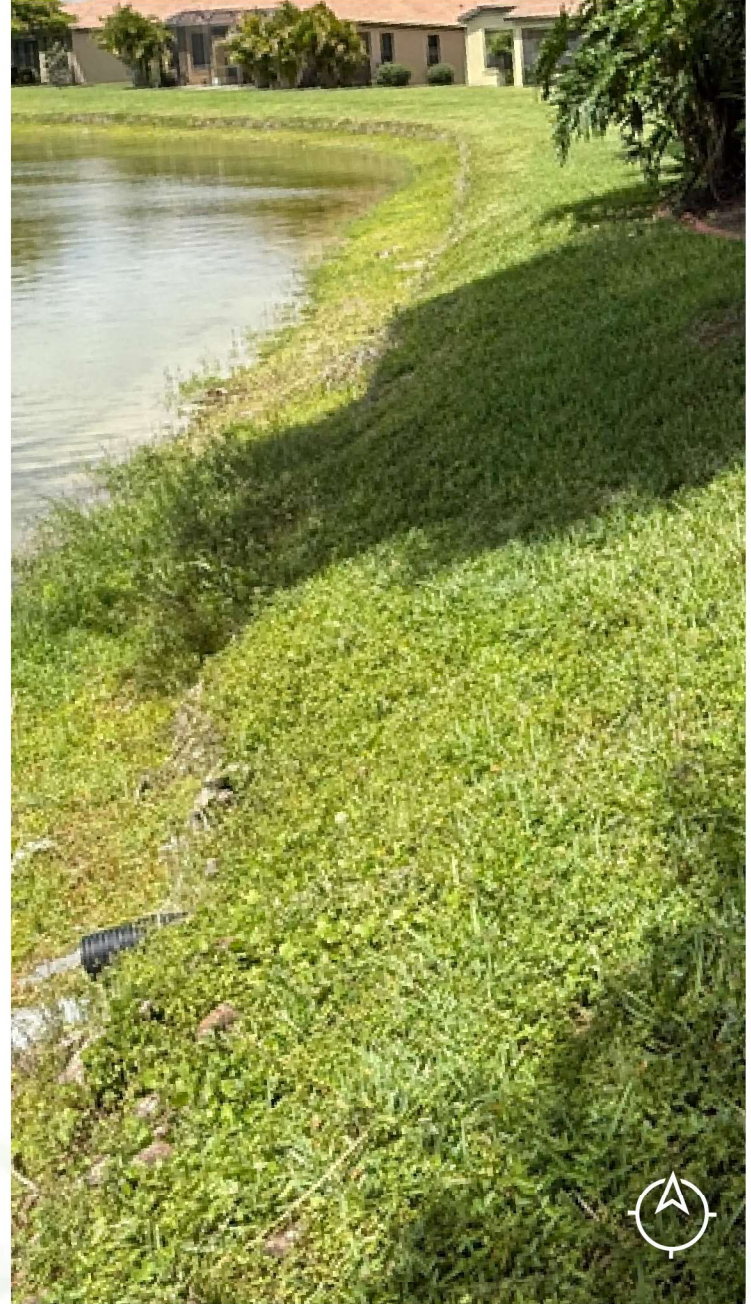
2017 Vs 2026 - Behind 8227 Stirling - Significant erosion

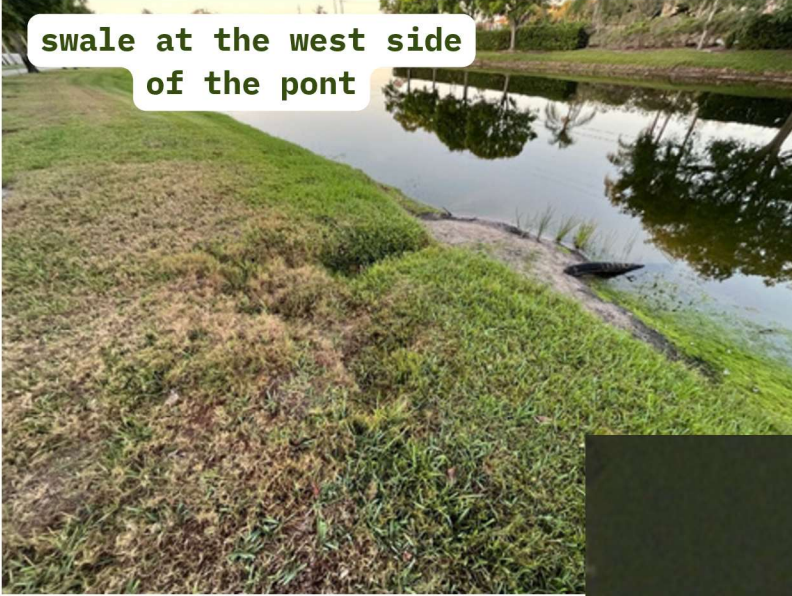
swale at the west side of the pond
