Pond Survey Summary

The LakeRidge Falls (LRF) Roads & Grounds (R&G) Committee Pond's Crew conducted a physical inspection and prepared an individual survey of 13 stormwater ponds in the community, during the early part of 2023. We did not survey Pond # 7 (by the back gate) as it is not connected to the other 15 ponds, is not maintained as a pond, and has been planted as a wetland. In addition, we did not have sufficient time to complete surveys of Ponds 2 and 16 before late spring rains limited our full access to these two ponds. The Ponds' Crew recommends conducting inspections and preparing surveys of these two ponds during the next dry season in 2024. The 13 individual surveys, for the most part, reflect our observations and are, therefore, the "facts" we found. These individual surveys stand on their own as direct observations, supported by photos and measurements. The recommendations we make, therein, are those that are obvious, such as burying, or redirecting pipes, and adding catch basins.

Pond Crew 2023

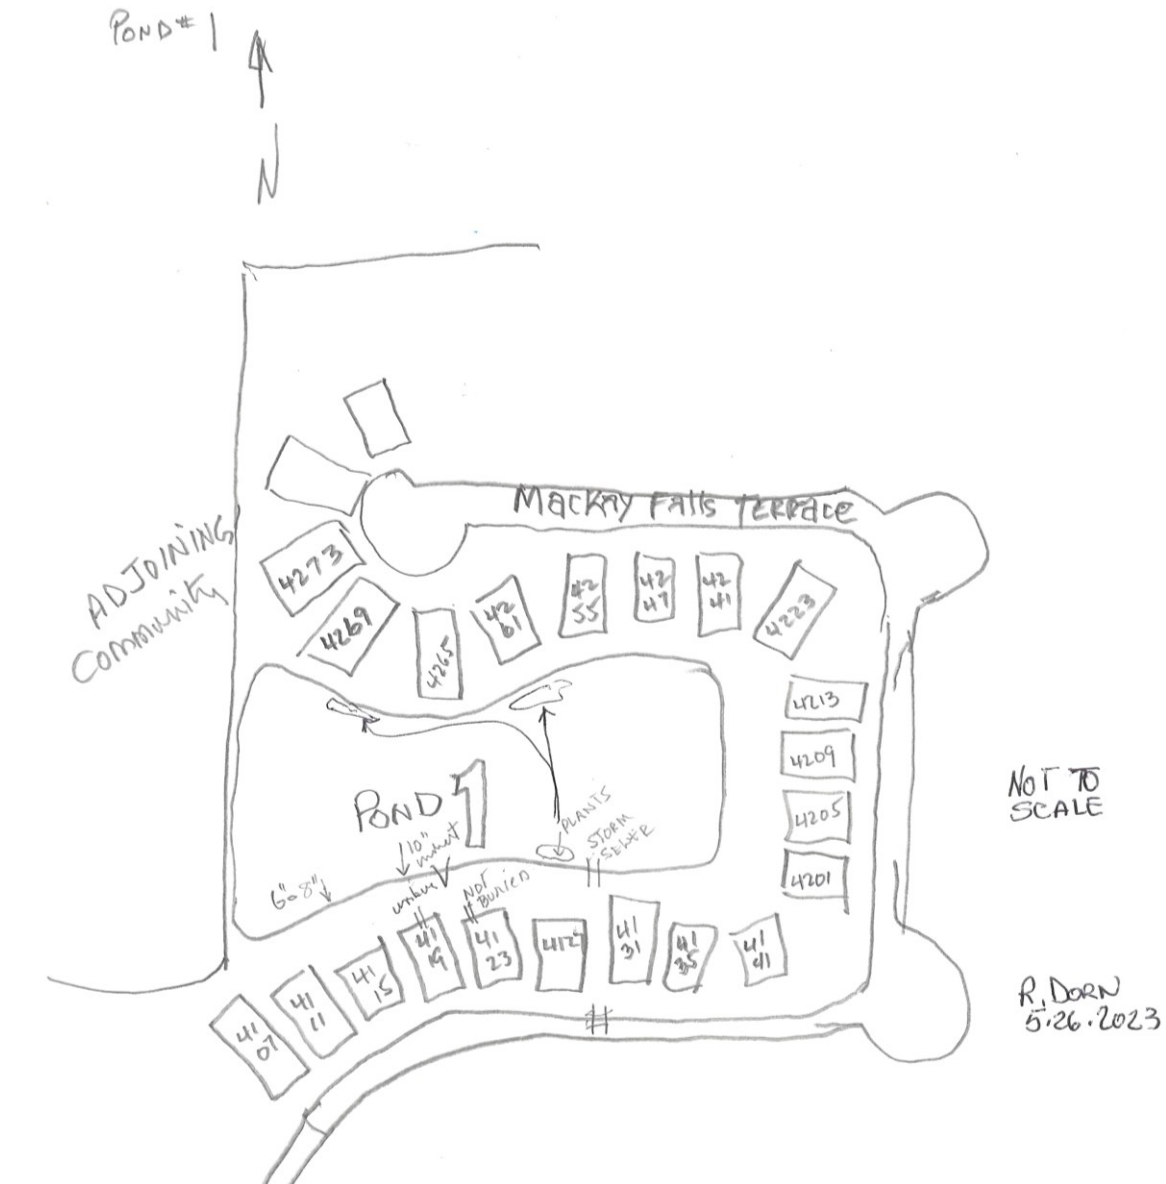
POND #1

Top: Several piles of rocks (coral?) located around the pond. Culvert from the street, Note the silt buildup covering the lower portion of the pipe. One of several tree stumps found in the water. Bottom: 6" thick grass "waterfall" over the bank to the water around most of the pond. This, as well as the aquatic plants, would greatly buffer the effects of bank erosion.

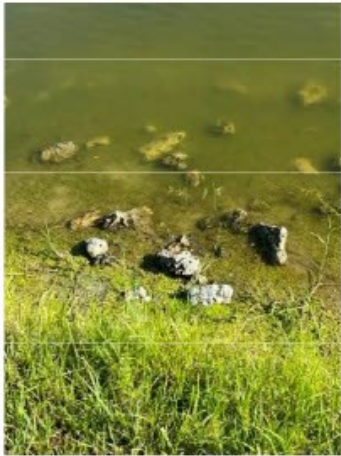
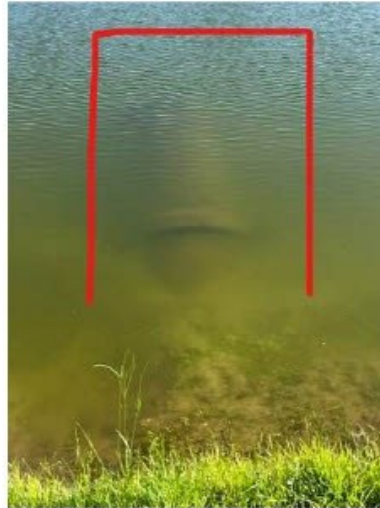
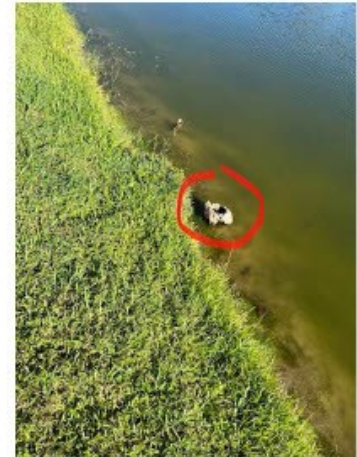
POND #1

The south side of the pond, from the west corner evidence of an average bank undercut of 6 to 8 inches. Behind units 4119 and 4123, both of which have gutters and unburied downspouts, the undercut measures ten inches. Due to the present water level not much more of this pond lent itself to the usual access to measure the undercut. Behind units 4119 and 4123, as well, there is a bank cut noticeable, and in our view, caused by roof runoff from these two units.

This pond is in good shape as compared to the other ponds. 8" cavity under bank behind 4115 Mackay Falls Terrace. Top right: Tree stumps in the water. Note this pond had far fewer stumps compared to other ponds. Behind 4119/4123 6 – 8" deep cavity under the bank running for approximately 10ft. Also a swale between the houses.

TO DO: The owners of units 4119 and 4123 should be encouraged to bury their downspouts, possibly joining them and running one pipe into the pond instead of two.

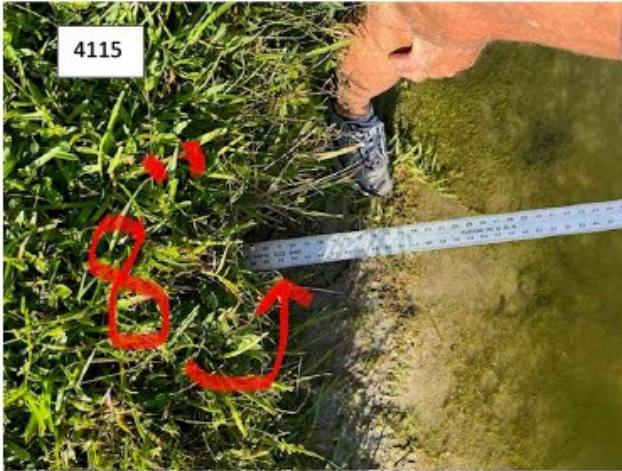
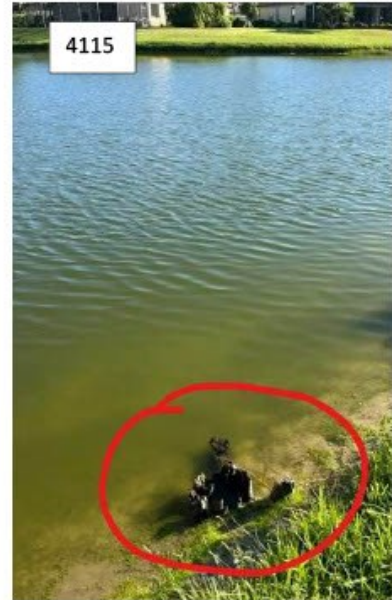
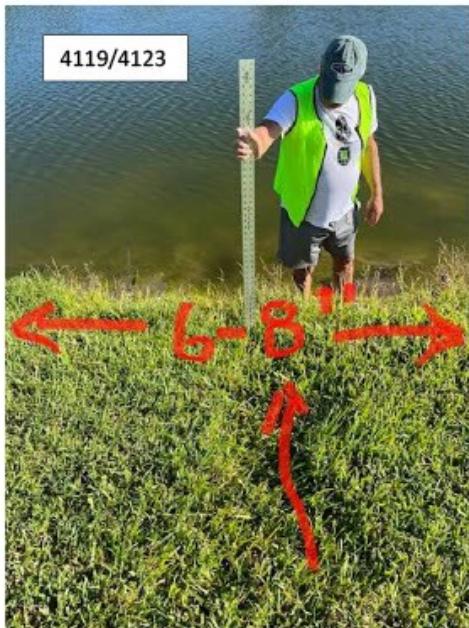
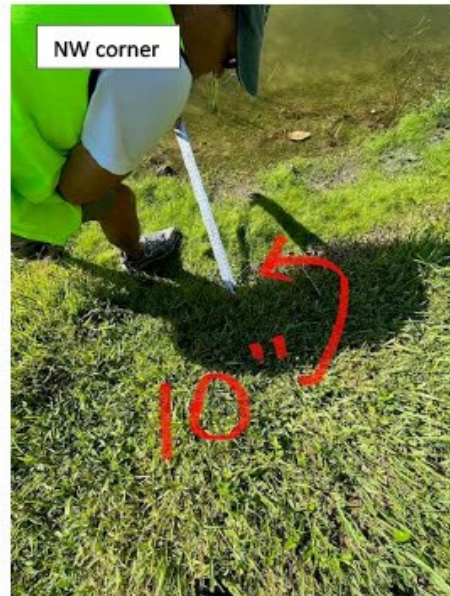
POND #1

Grasses and other aquatic plants found all around the pond. Numerous turtles, ducks, and other birds...also, a stump in the water.

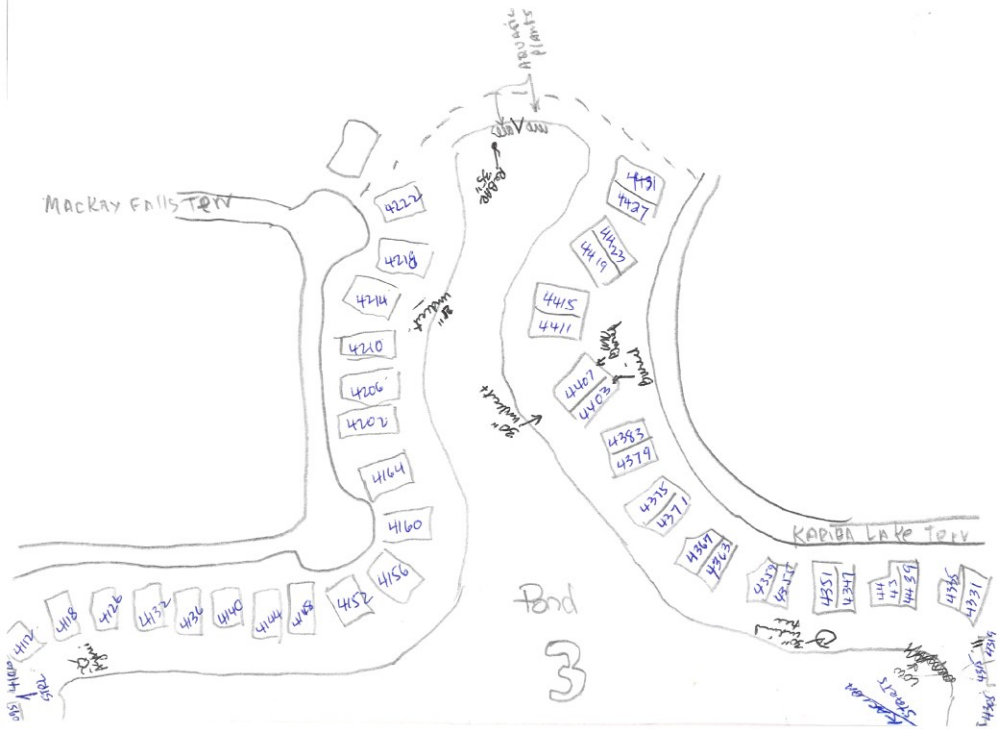
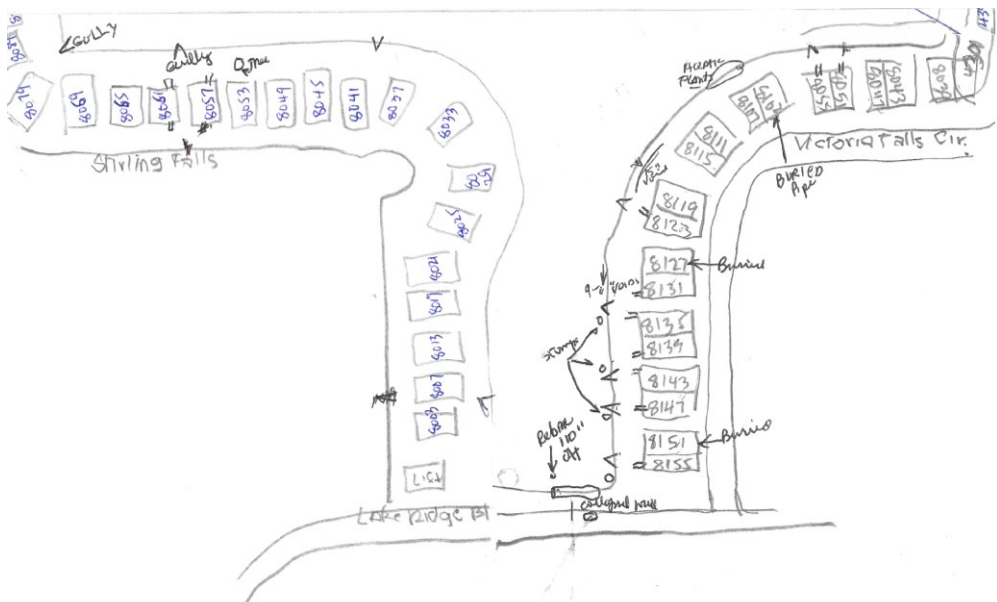
no evidence of an imminent collapse was observed at that time.) There are several trees along this south side facing imminent collapse into the pond. We wondered if over-irrigation could be adding to the problem. This is the worst eroding area of this pond found during the survey. It would seem a mechanical solution would be at least part of the solution for this location going forward.

Broken water pipes
fill recently added?

Southern side of Pond #3 along LRF Blvd. Bank collapsed. Could have been undercut by wave action, but also a victim of irrigation runoff. Looks like it's been used for dumping landscaping materials as its soggy, full of grass, weeds, and clumps of dirt. Rebar originally placed 24" from bank now measures 9ft from "new" bank due to collapse of original bank. Also visible is one of the numerous tree stumps that can be seen at the water line, or under water, around several ponds. The gentle slope of this Pond would lend itself to using plants to slow erosion.

Also, the live oak trees need to be supported beneath the grass line or removed.

SEVERITY RATING: Average with the exception of the southern rim. This needs to be stabilized sooner than later.

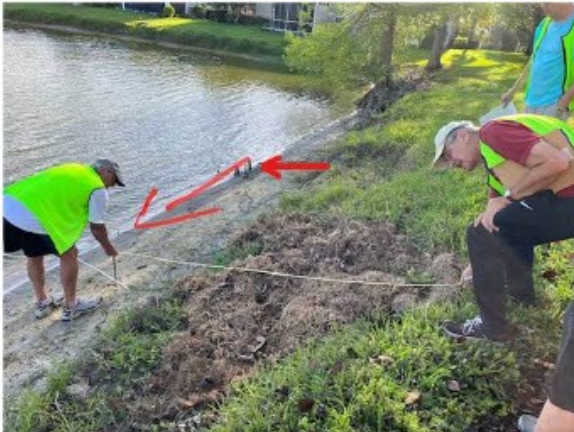
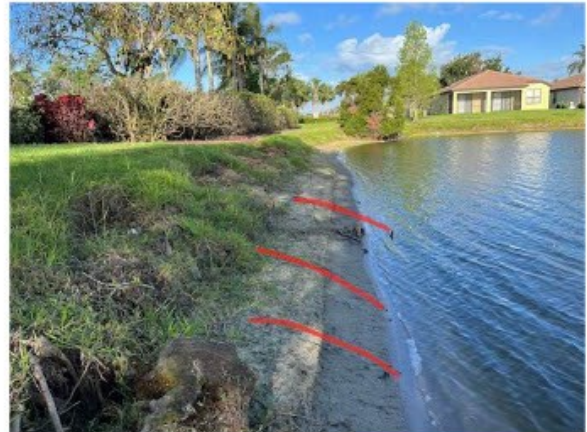
Southern side of Pond #3 along LRF Blvd. More submerged tree stumps in a line along the southwestern side. Cypress tree sitting halfway beyond the bank has exposed roots on the side from wave erosion and on the top from rain/irrigation. Lower photo shows an exposed sprinkler line.

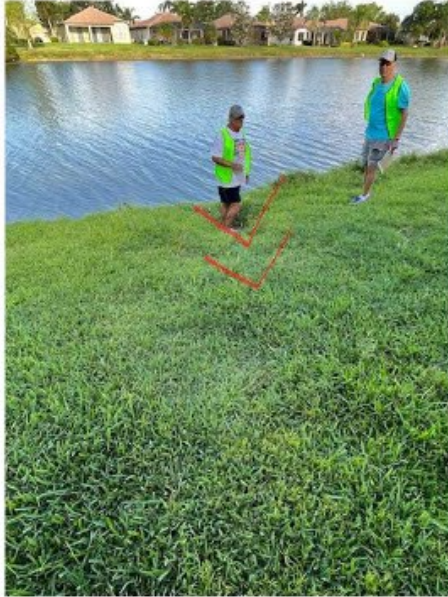
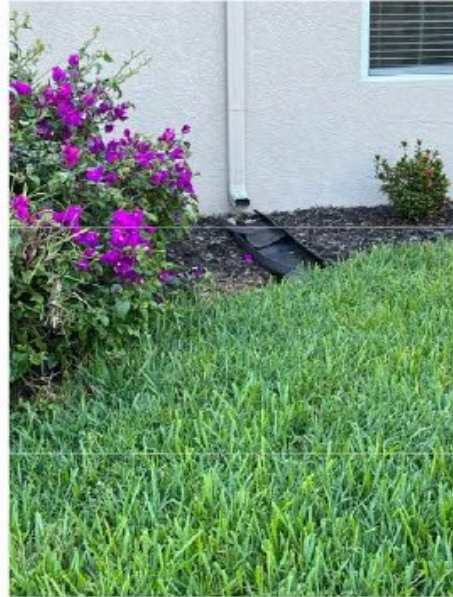
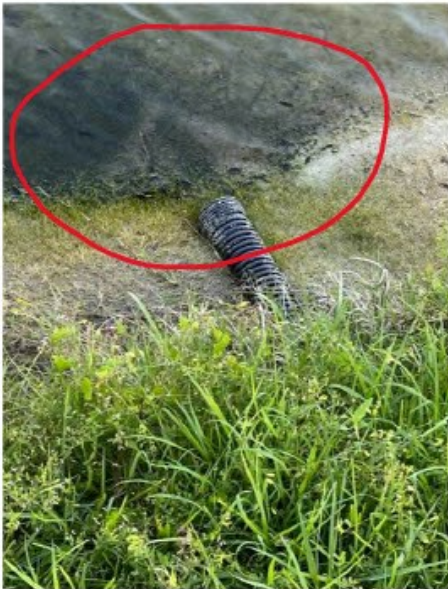
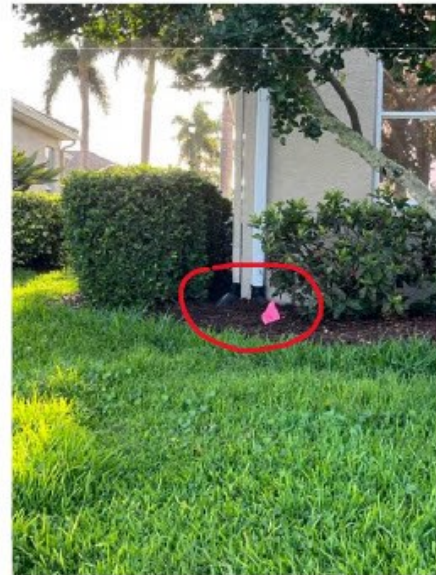
POND #3

East side of lower N/S arm Pond #3. Upper: 2 unburi ed downspouts at 8147 Victoria. Approx 8" deep hole and deep cut in bank (danger area flagged by owner).

Lower: Unburi ed downspout at 8143 Victoria above an 8-15" gulley in bank.

TO DO: It is obvious that downspouts need to be buried or redirected. Noted during this inspection were units that the unburied downspouts were doing serious damage were Victoria #s 8155, 8147, 8143, 8133, 8135, 8131. 8123, 8055, 8051. Stirling #s 8079, 8051, 8057, 8087. The southern end of this pond along LRF Blvd presents a collapsed pond wall in troubling condition. We need a Mechanical solution proposal.

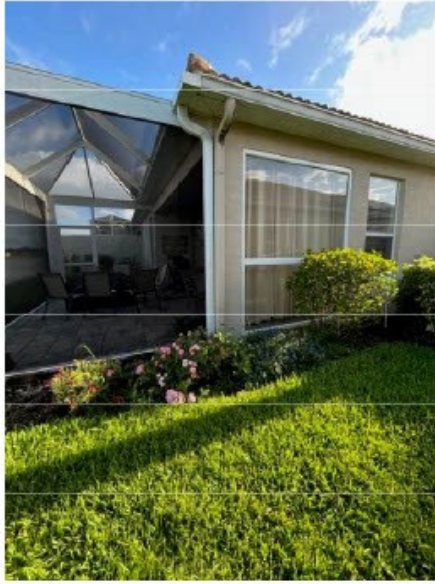
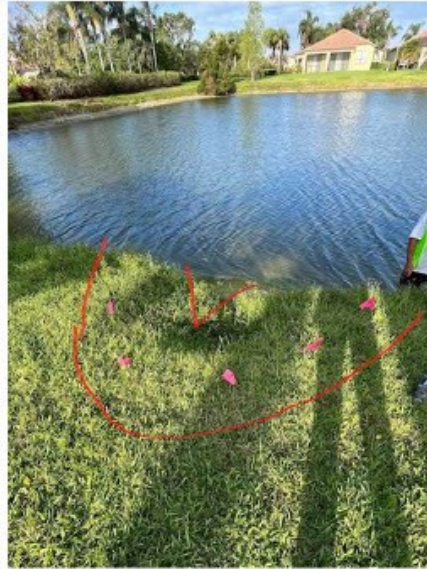
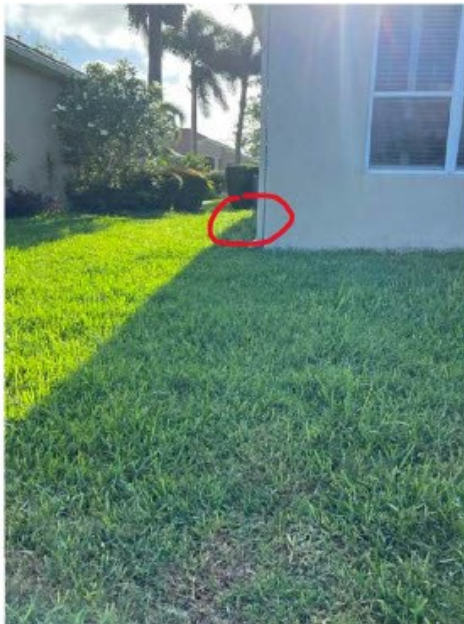
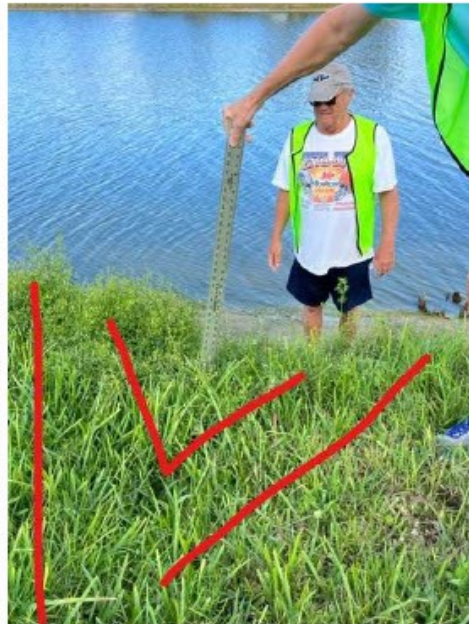
POND #3

6 stumps at or under waterline.

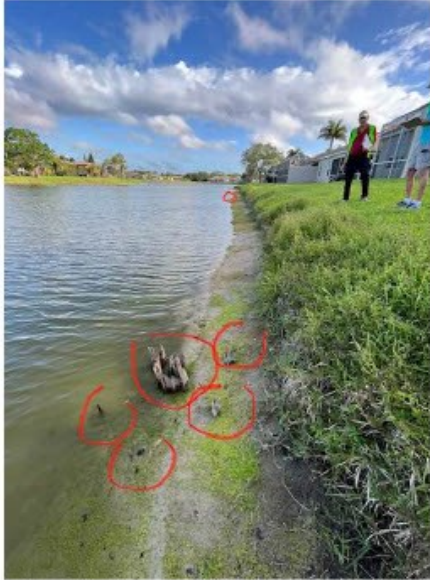
9 – 13" undercut cavity from 8139 through to E/W arm to 8055 Victoria

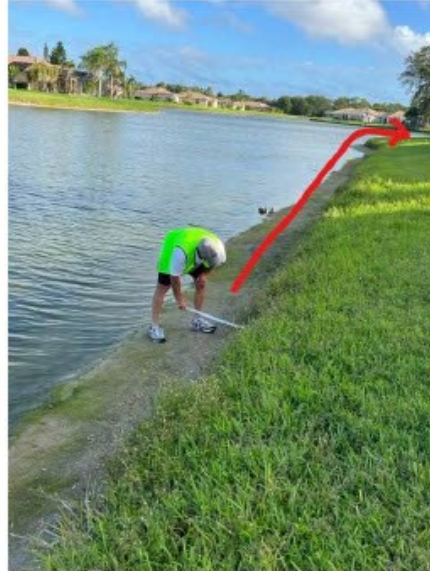
8136 – 8131 Victoria. Unburied downspouts above washout trench & silt build up in pond

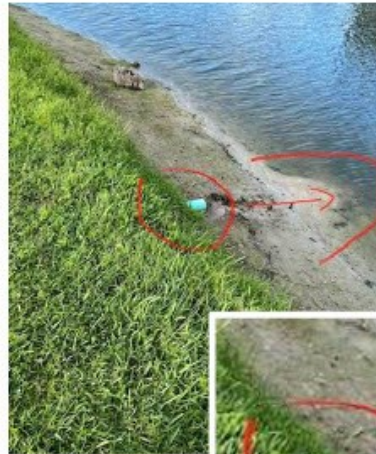
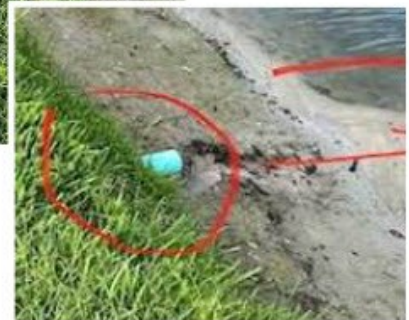
East side of lower N/S arm Pond #3. Dbl buried downspouts. Force of water from buried pipe eroding a trough in littoral shelf. This is an improper way to bury the downspout as it is increasing erosion on pond floor.

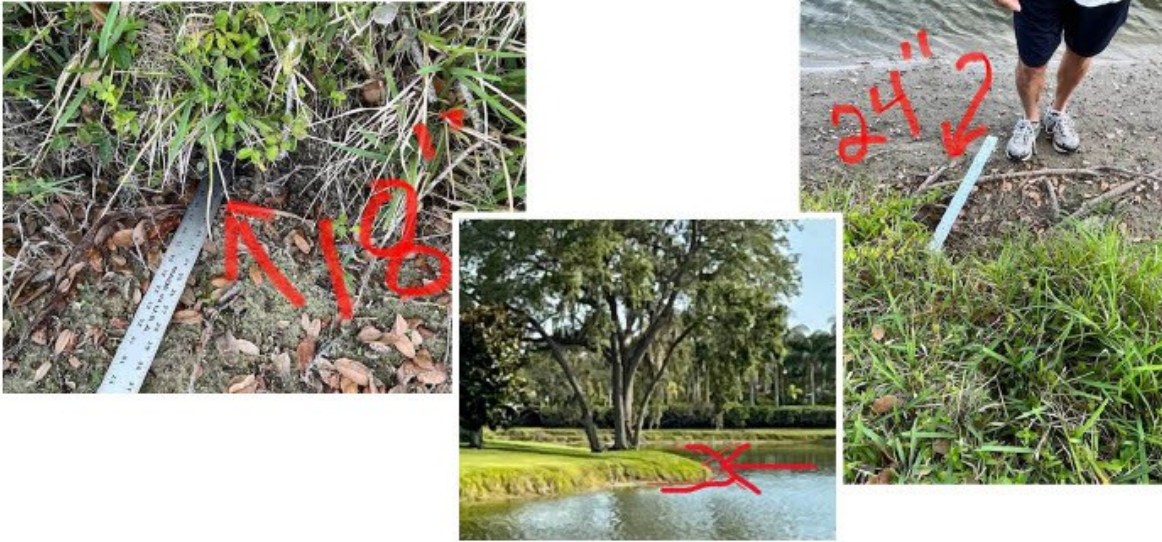
Corner of East side of lower N/S arm and south side of eastern E/W arm of Pond #3. 18" cavity at 8123. 24" deep by 20ft long cavity running from 8123 to 8119 (150 – 200 ft?) under a large oak tree.

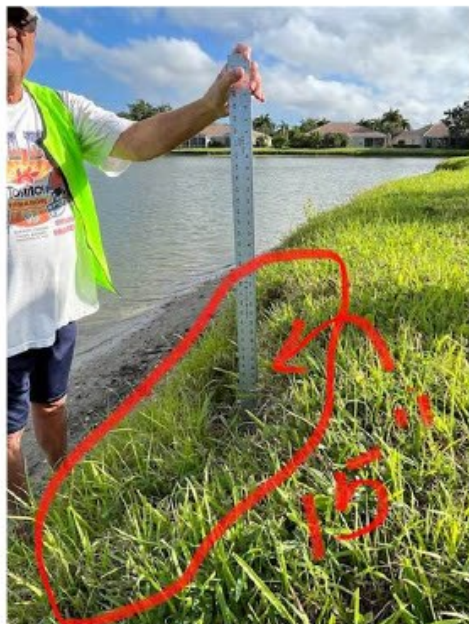
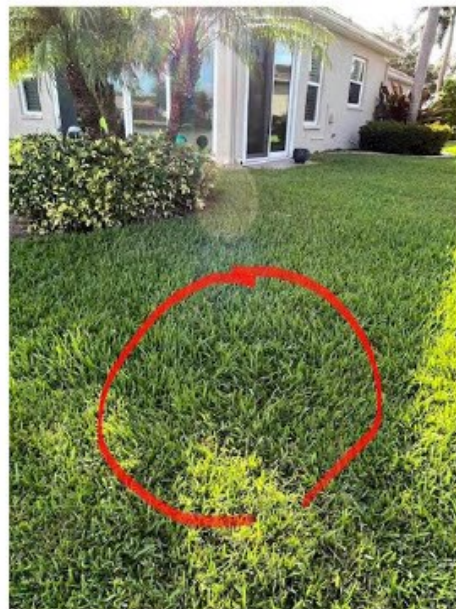
Corner of East side of lower N/S arm and south side of eastern E/W arm of Pond #3 at 8119/8115 Victoria. 15" x 30" oval shaped hole (possibly a chunk of the bank has separated?) 8" deep hole in the middle of the yard – no cuts or dips around it.

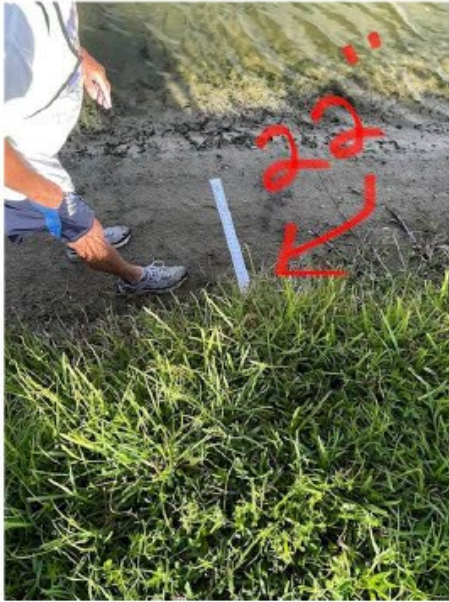
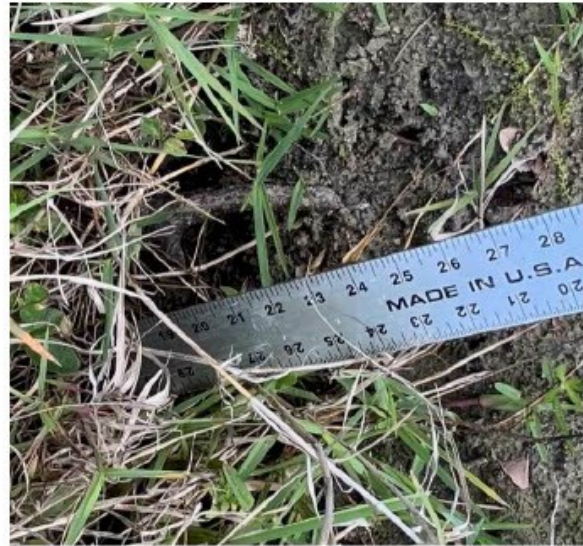
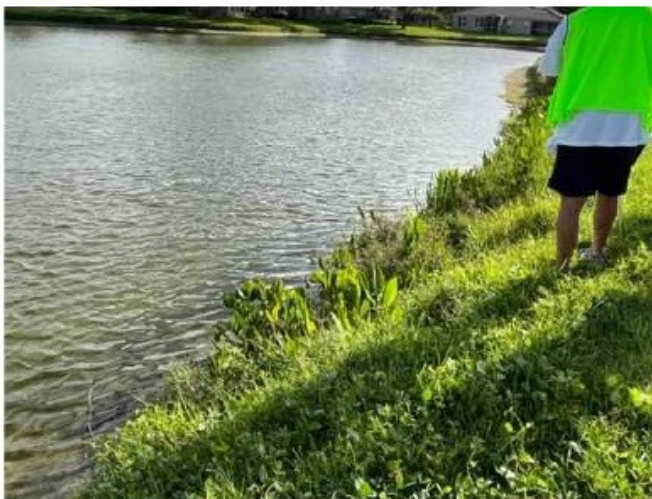
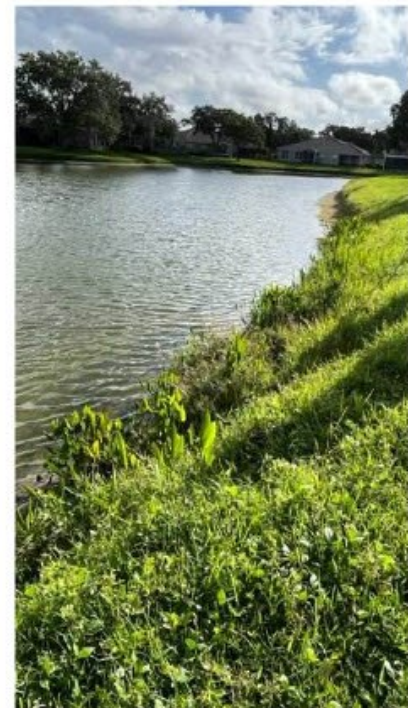
Corner of East side of lower N/S arm and south side of eastern E/W arm of Pond #3 at 8111/8107 Victoria.
Upper: 22" cavity (L) Close-up looking into the cavity (R) Lower: Aquatic plants on Littoral shelf & no mow zone at 8107

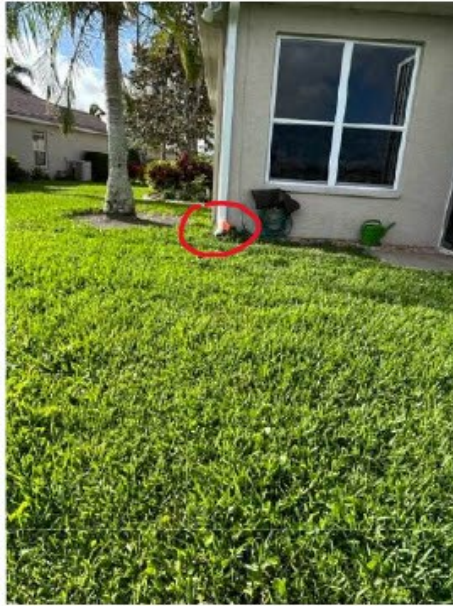
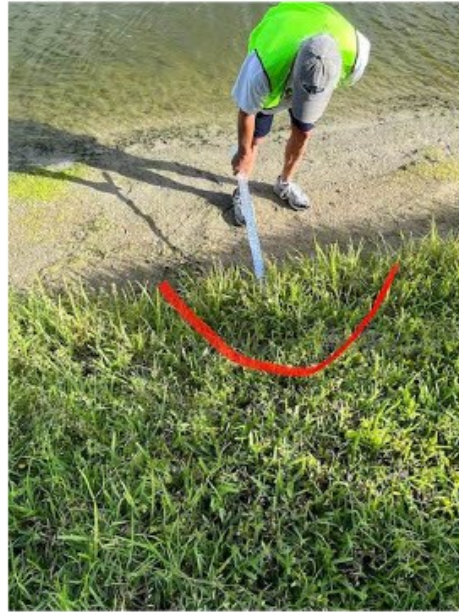
South side of eastern E/W arm of Pond #3 at 8103 Victoria. Buried downspout but the bank is collapsing over the pond exit

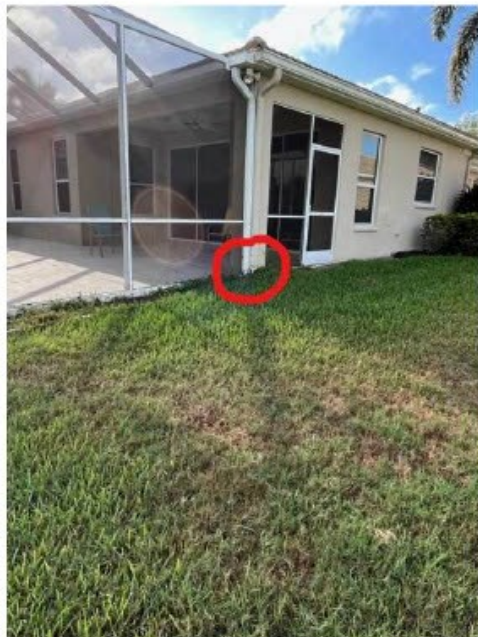
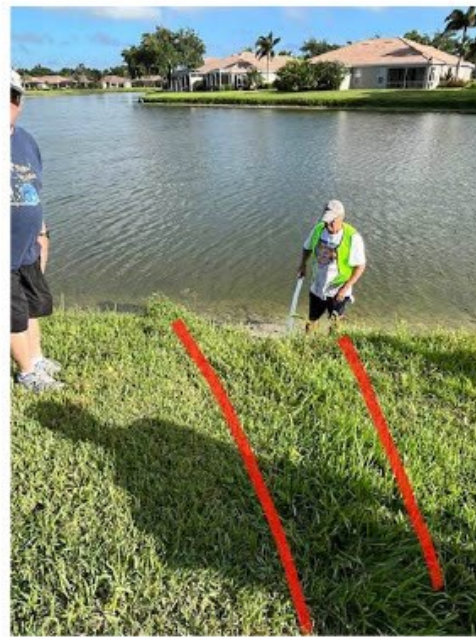
South side of eastern E/W arm of Pond #3 at 8103 Victoria. Downspout not buried. Swale leading to a cut in the bank.

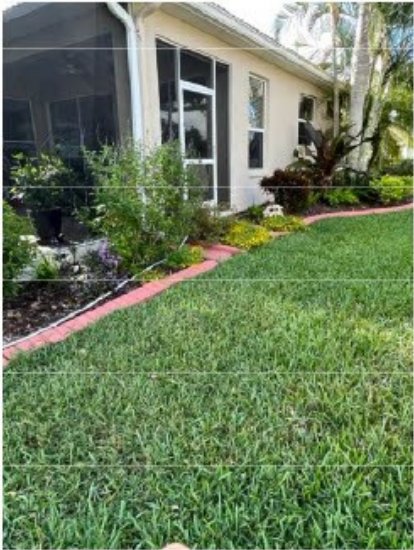
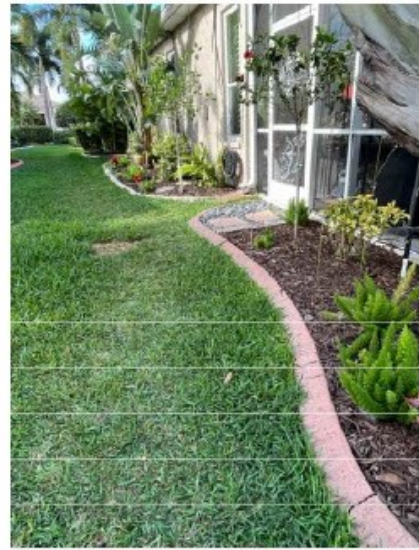
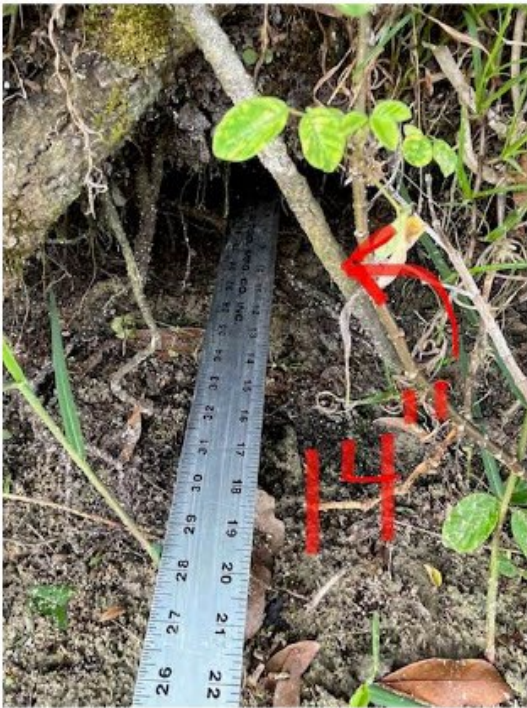
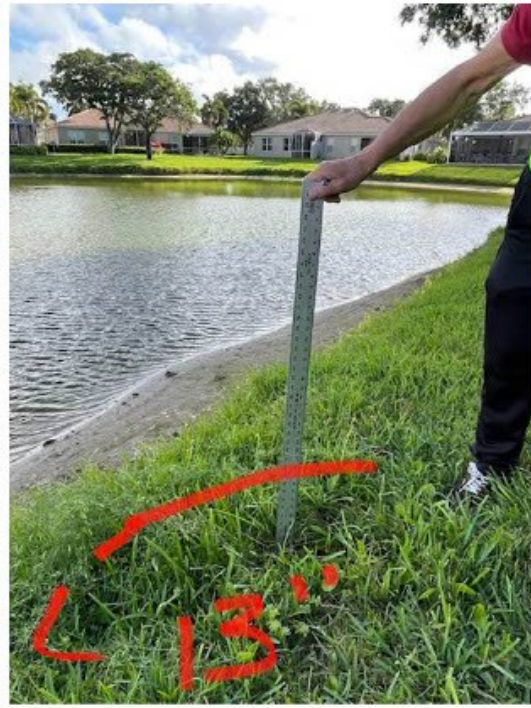
South side of eastern E/W arm of Pond #3 at 8051 & 8047 Victoria. Downspouts not buried. 13" deep hole close to 8151 bank edge. 14" deep x 5" high cavity under 8047 bank.

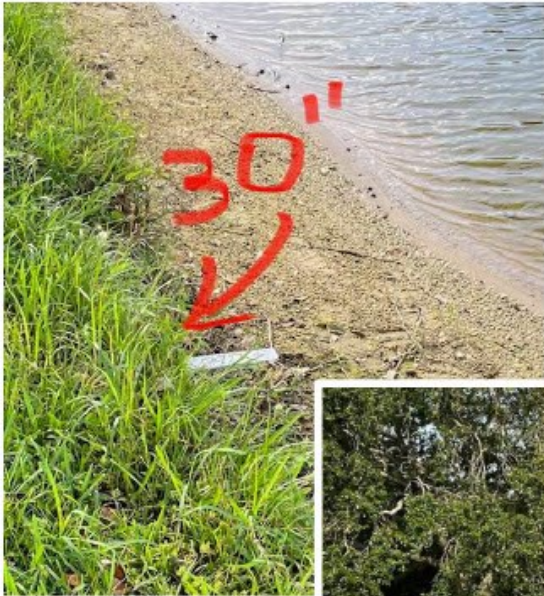
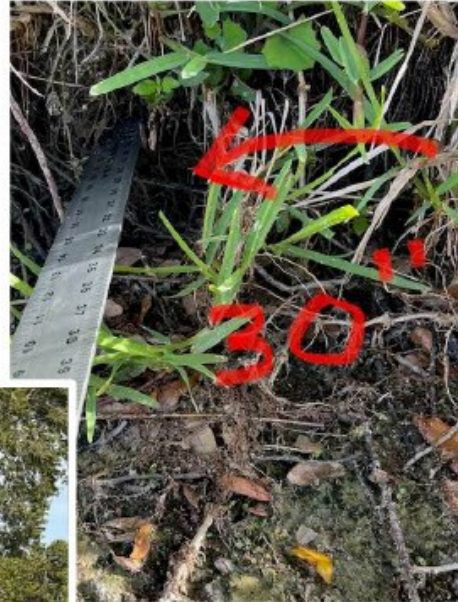
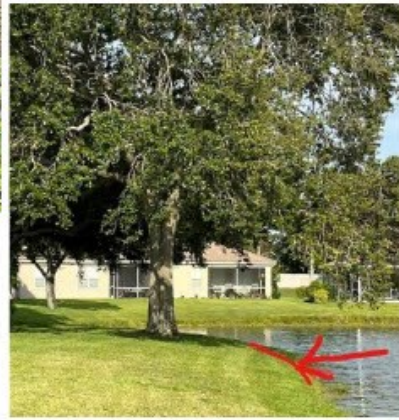
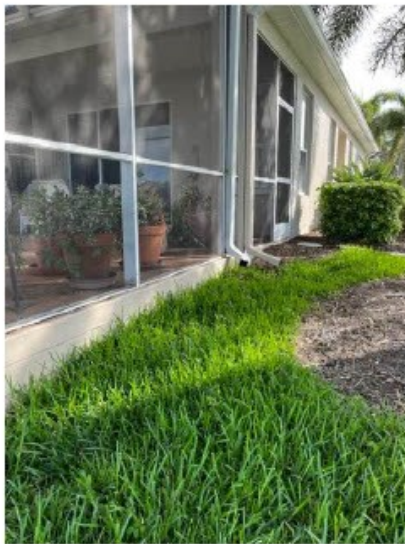
North side of eastern E/W arm of Pond #3 at 4347 & 4351 Kariba. 30" deep x +/- 6" high cavity under large oak tree. Cavity runs approximately 6 ft wide along bank under tree.

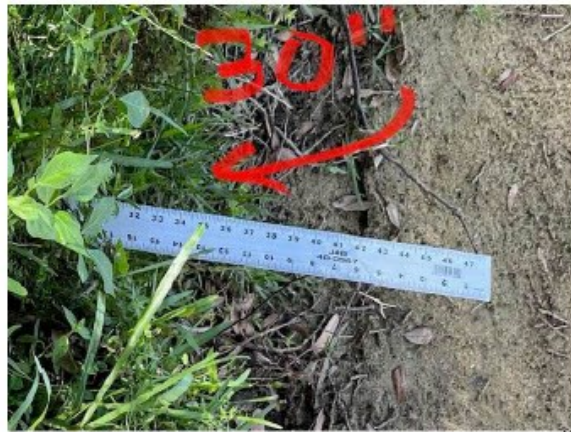
East side of upper N/S arm of Pond #3 at 4371 Kariba. Downspout not buried. 30" deep x cavity.

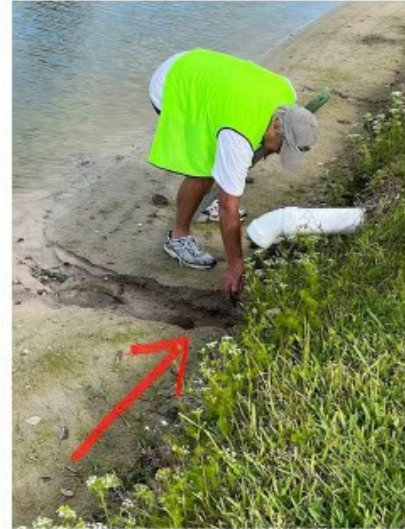
East side of upper N/S arm of Pond #3 at 4371 Kariba. . Waterline stumps at 4371 & 4403 Kariba (L). Angle of buried downspout at 4407 causing a deep washout rut in pond bottom (R).

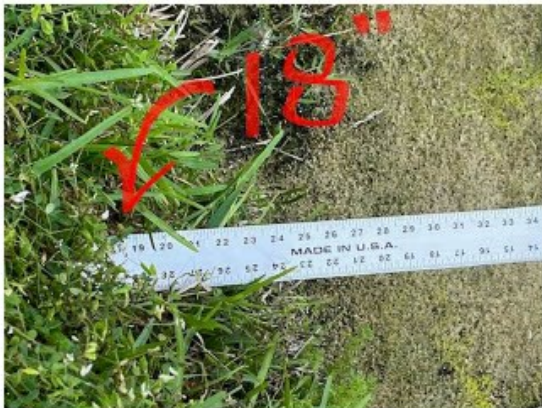
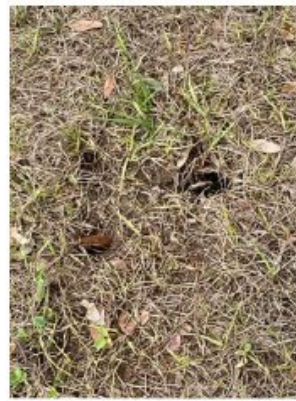
East side of upper N/S arm of Pond #3 at 4419 Kariba. Buried downspout / 18" deep cavity

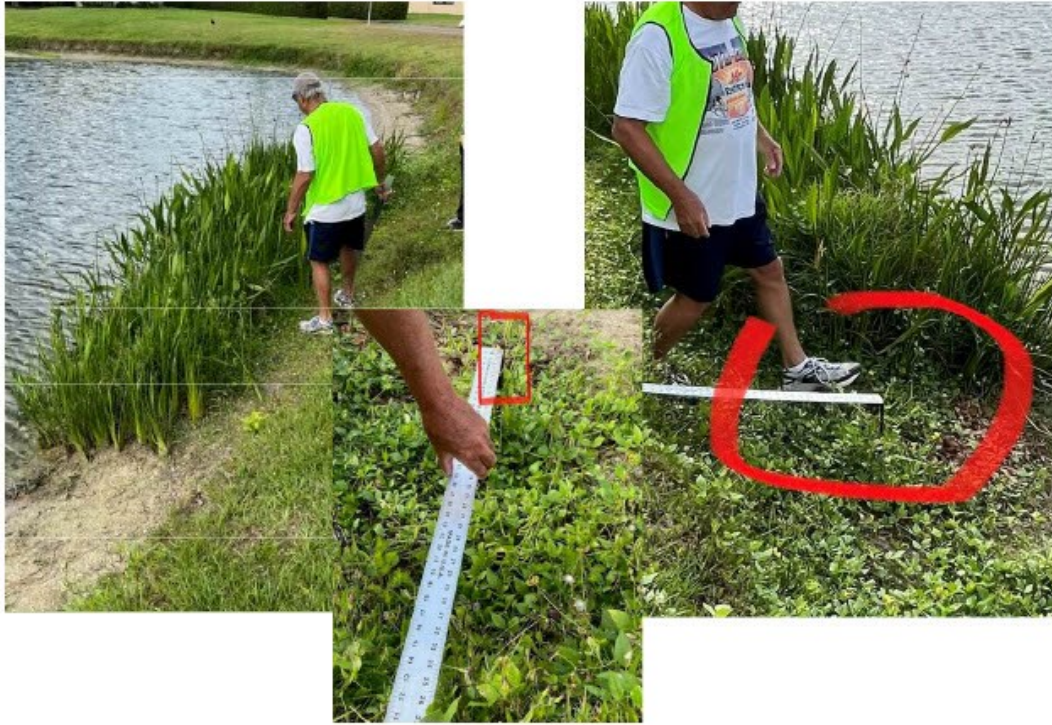
North side of N/S arm of Pond #3 at crossover. Aquatic plants (L). Rebar stake approximate 35". Original placement was 24". Measurement difficult since there has been some bank collapse.

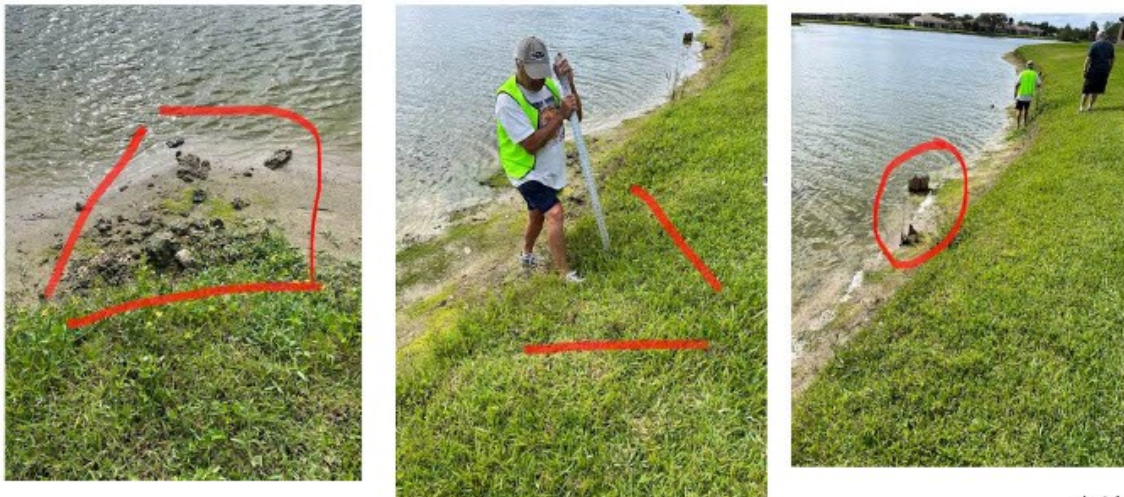
West side of upper N/S arm of Pond #3. Personal riprap? Or dumping(L)? Gully between 4210 & 4206 Macay; downspouts not buried (C). Waters edge tree stumps (R).

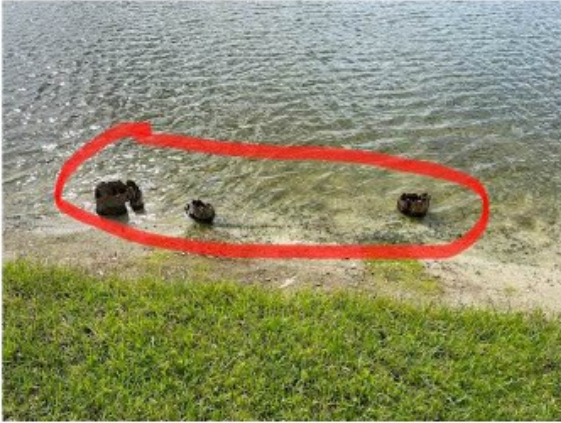
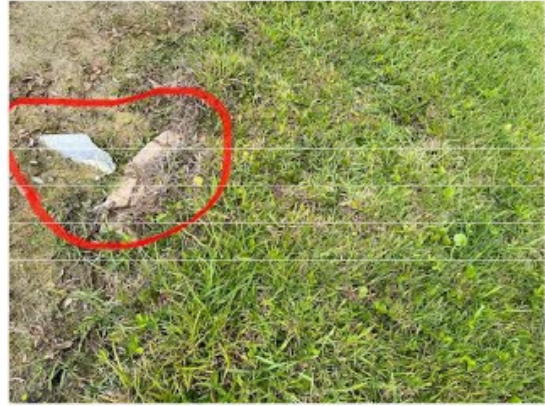
West side of upper N/S arm of Pond #3 at 4156 Macay. More underwater tree stumps and builder's tiles.

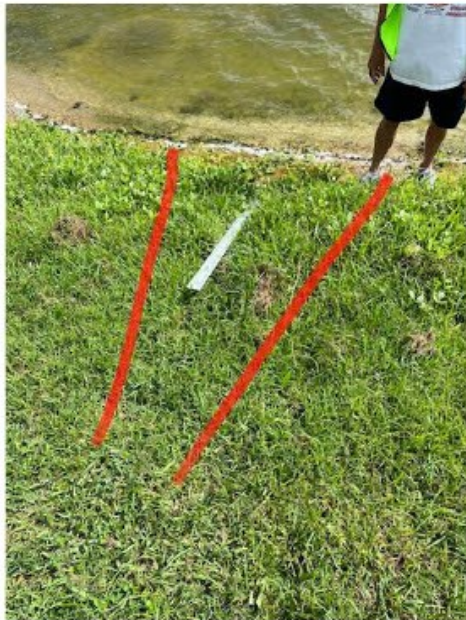
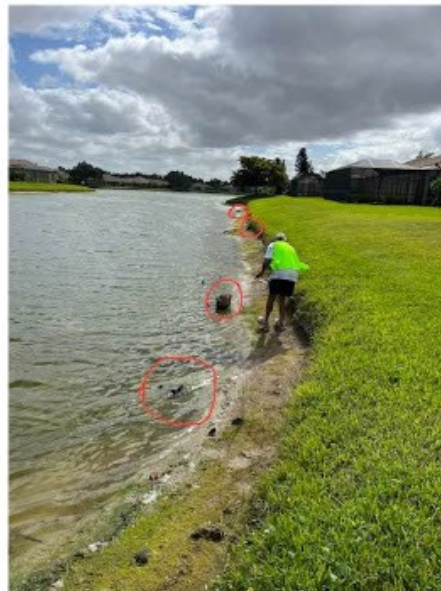
West side of western E/W arm of Pond #3 at 8089 Stirling Falls. Gully.

South side of western E/W arm of Pond #3 Stirling Falls. Row of tree stumps at or below waterline.

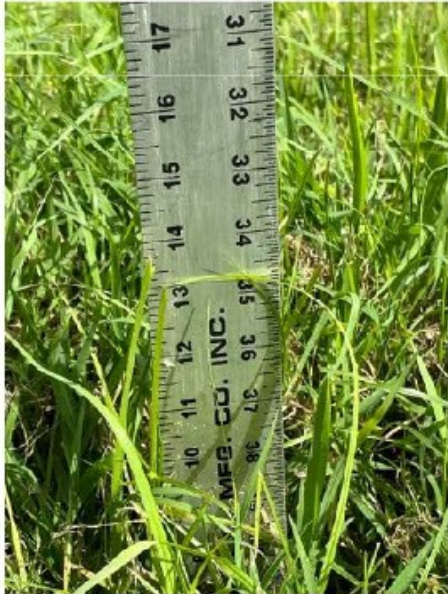
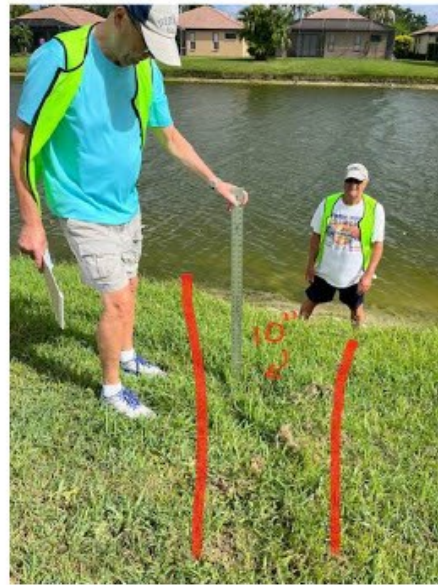
South side of western E/W arm of Pond #3 at 8061/8057 Stirling Falls. 10" hole and gully to cut in bank.

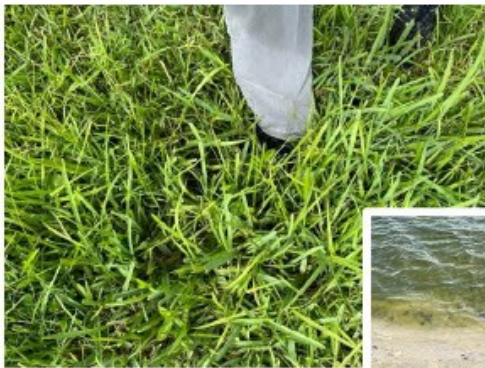
South side of western E/W arm of Pond #3 at 8049 Stirling Falls. Ankle deep holes in yard.

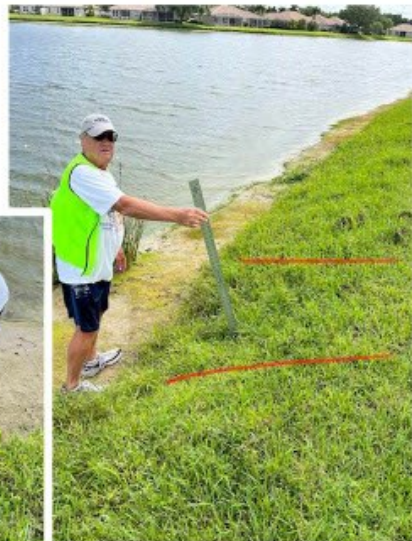
South side of western E/W arm of Pond #3 at 8045/8041. 10" deep gully.

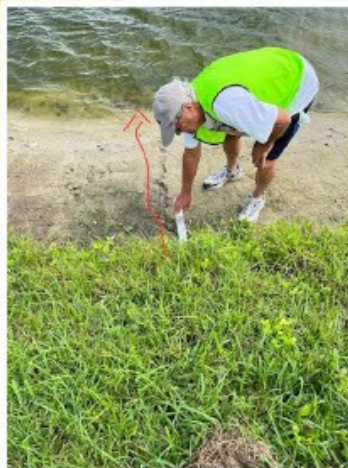
West side of lower N/S arm of Pond #3 at 8037/8033 Stirling. 25" rivulets from bottom of bank to pond. Origin??

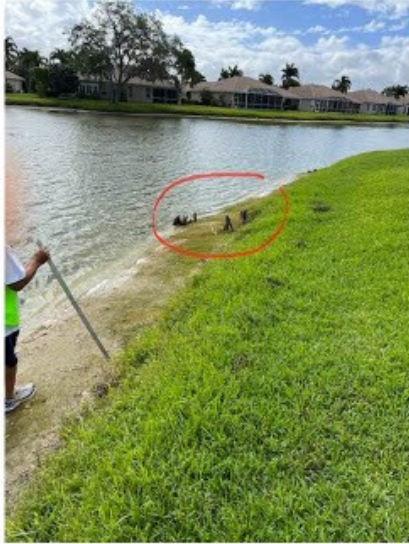
West side of lower N/S arm of Pond #3 at 8033 Stirling Falls. More submerged tree stumps.

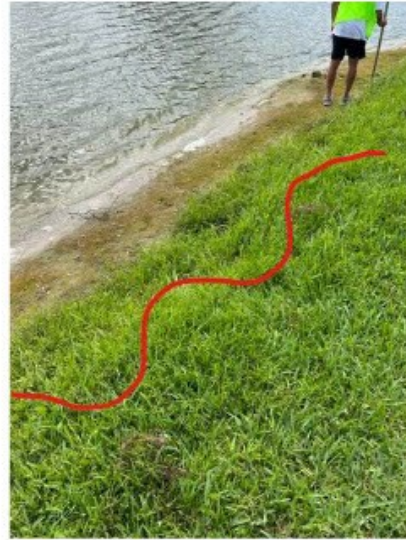
West side of lower N/S arm of Pond #3 at 8025/8022 Stirling Falls. Bank collapse

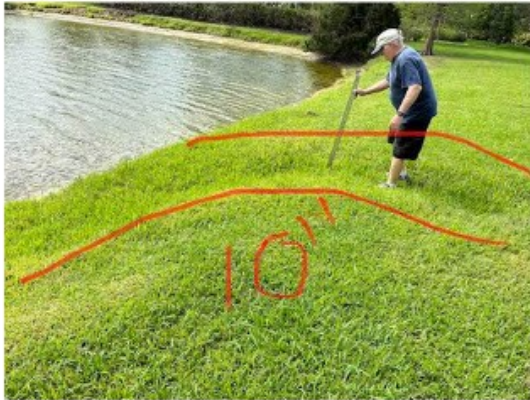
West side of lower N/S arm of Pond #3 at 8013 Stirling Falls. 10" deep and wide gully.

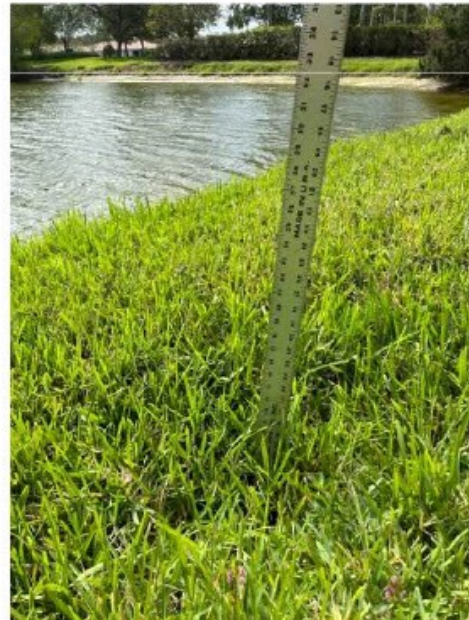
West side of lower N/S arm of Pond #3 at 8007 Stirling Falls. 10" deep holes.

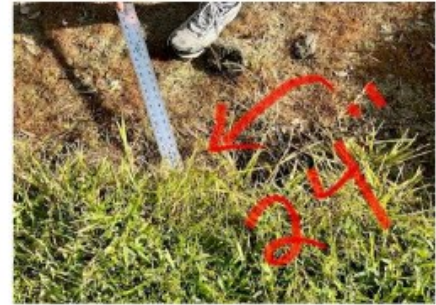
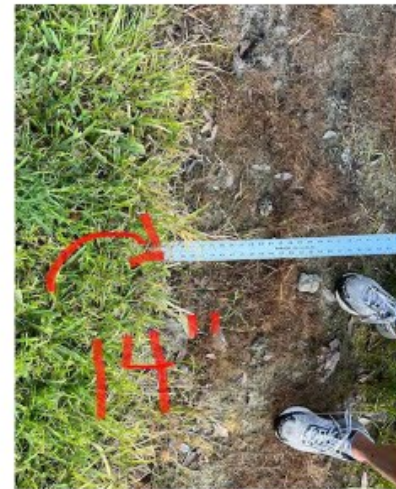
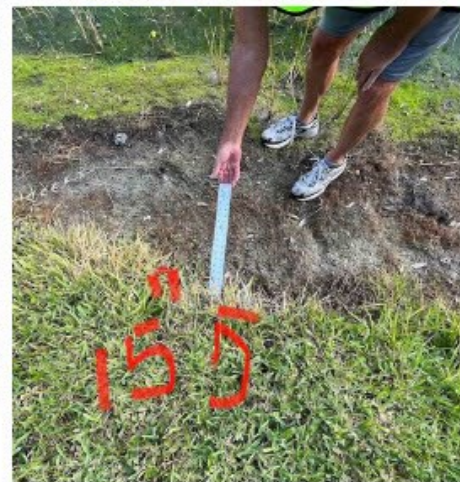
The gentle sloping of the pond bank would lend itself to the use of plants as an inexpensive preventative measure to forestall future damage. The area to the left of the overflow culvert has 14 – 24" cavities under the southside bank extending well beyond what is shown in the photo below. This area is of no threat to homes, roads, or sidewalks, therefore a collapse, should it occur would do no harm. Plants could keep it from getting worse.

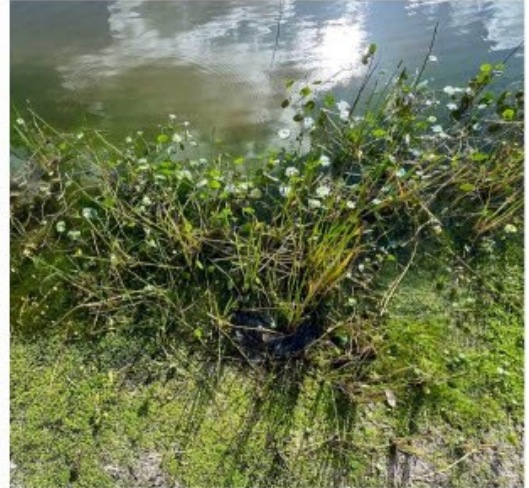
No holes or cavities found on the southwest or west side but there was a fair stretch of plants along the bank. Also, a tree stump in the water.
