Pond Survey Summary

The LakeRidge Falls (LRF) Roads & Grounds (R&G) Committee Pond's Crew conducted a physical inspection and prepared an individual survey of 13 stormwater ponds in the community, during the early part of 2023. We did not survey Pond # 7 (by the back gate) as it is not connected to the other 15 ponds, is not maintained as a pond, and has been planted as a wetland. In addition, we did not have sufficient time to complete surveys of Ponds 2 and 16 before late spring rains limited our full access to these two ponds. The Ponds' Crew recommends conducting inspections and preparing surveys of these two ponds during the next dry season in 2024. The 13 individual surveys, for the most part, reflect our observations and are, therefore, the "facts" we found. These individual surveys stand on their own as direct observations, supported by photos and measurements. The recommendations we make, therein, are those that are obvious, such as burying, or redirecting pipes, and adding catch basins.

Pond Crew 2023

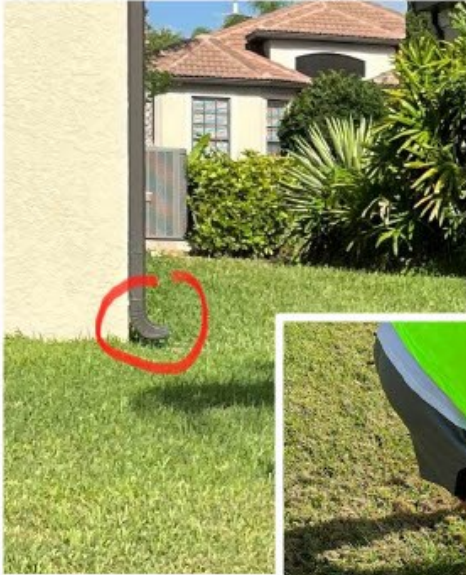
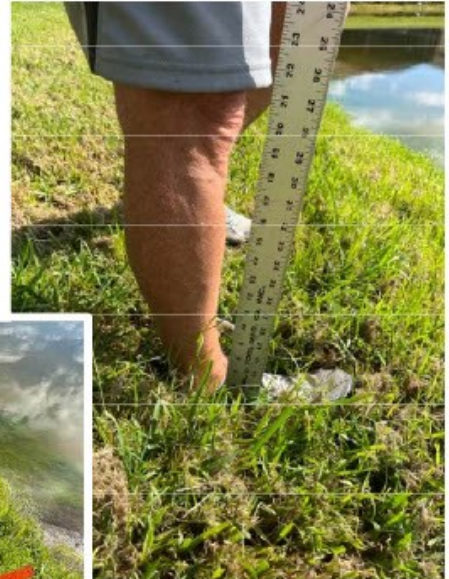
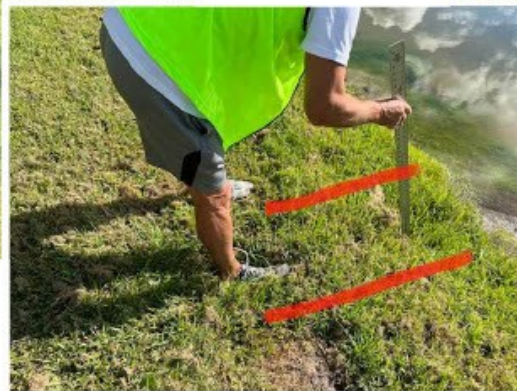
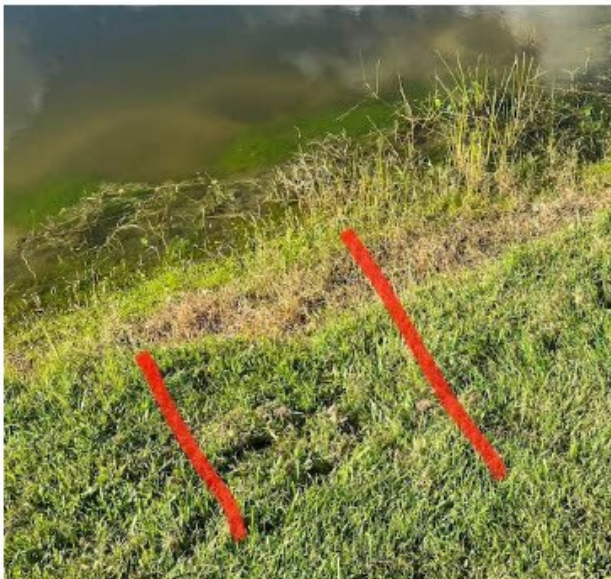
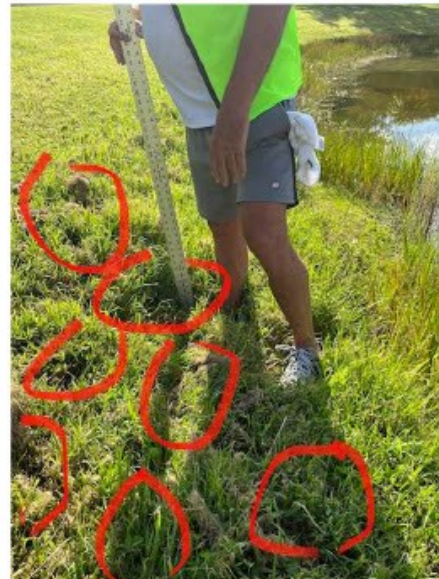
Top: 8046/8042 Unburied drainpipes. Small swale and cut in the bank about 6" deep. Also small divots in the yard.
Bottom: 8018/8014 minor swale hidden by the grass. Multiple small divots throughout the yard.

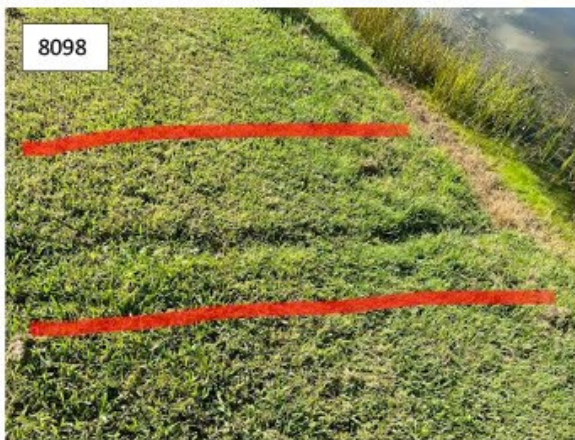
8014/8006 unburied drainpipes. Minor or developing (?) issues as shown on the previous page. 8098 has a strange cut through the yard with no apparent cause e.g. does not appear to be associated with unburied drainpipes.

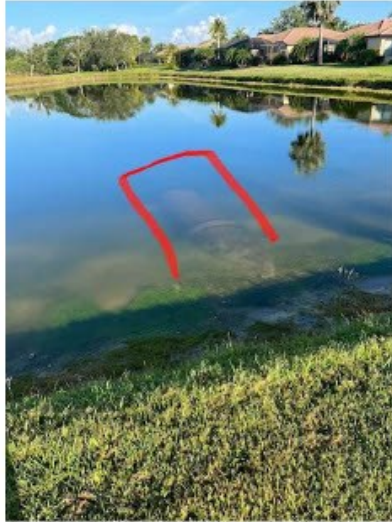
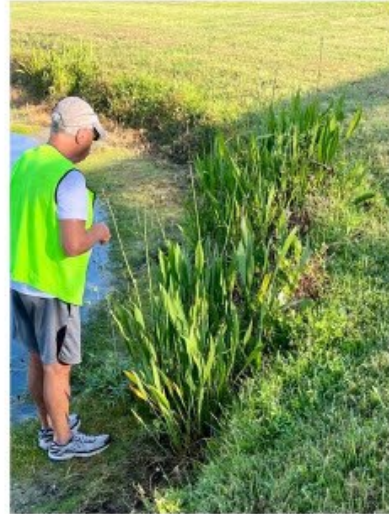
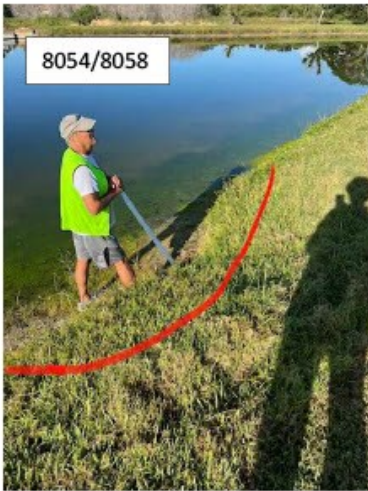
East side: Soil buildup in and around aquatic plants; conduit from street drain on Stirling Falls Cir. 8054 drainpipe is unburied and there's a dip and cut-out in and on top of the bank behind 8054/8058. White pipe behind 8062 possibly connects to pond 3.

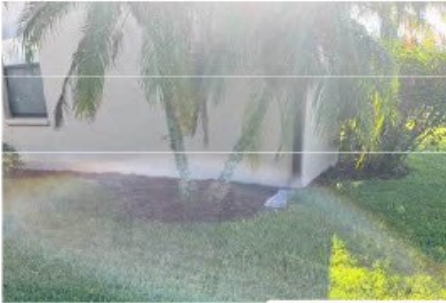
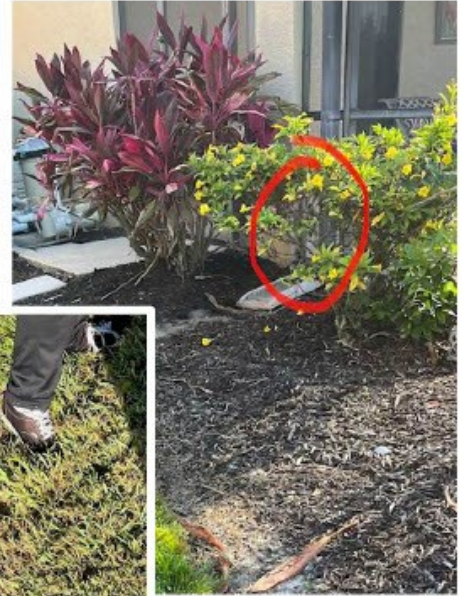
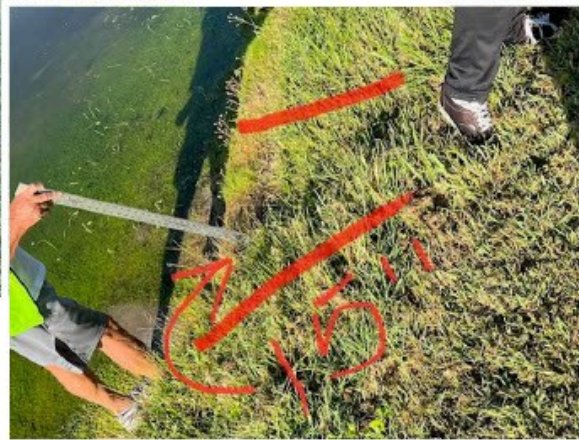
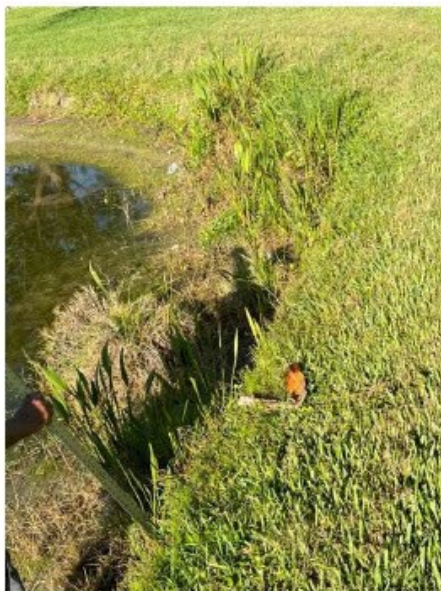
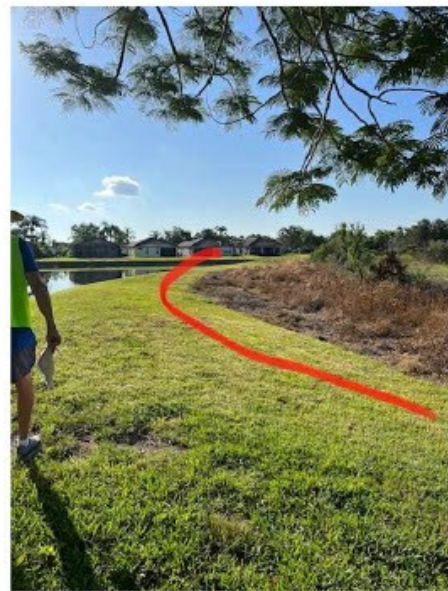
Top & middle: Unburied drainpipes at 8062 & 8064 and there's a wide swale and 15" deep cut in the bank. Bottom left: More aquatic plants at northwest corner – soil is captured but weeds are prevalent. Bottom right: border of Mitigation Area on left.

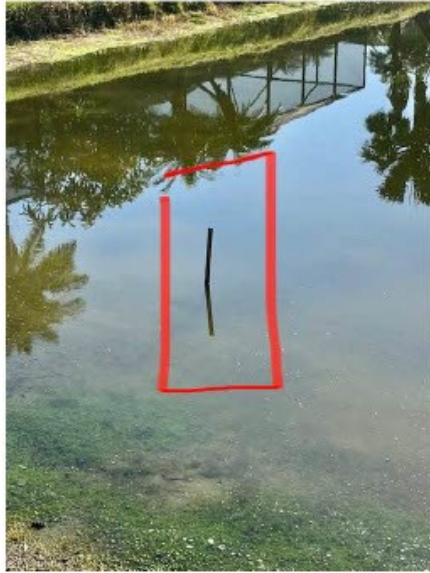
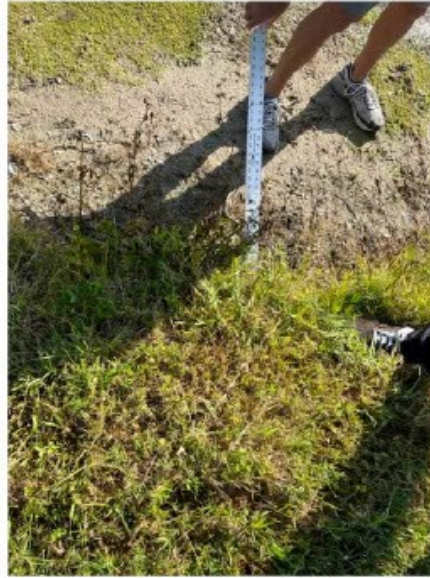
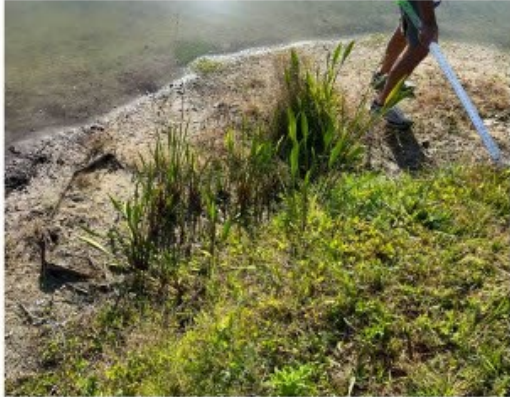
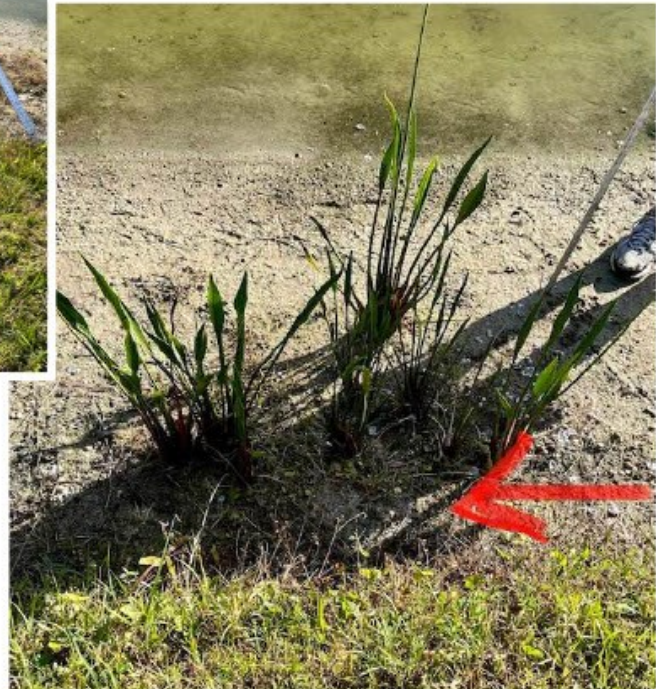
On the northwest side there's frothy scum and a mystery stick; 6 – 8" cavities; soil buildup in and around aquatic plants.

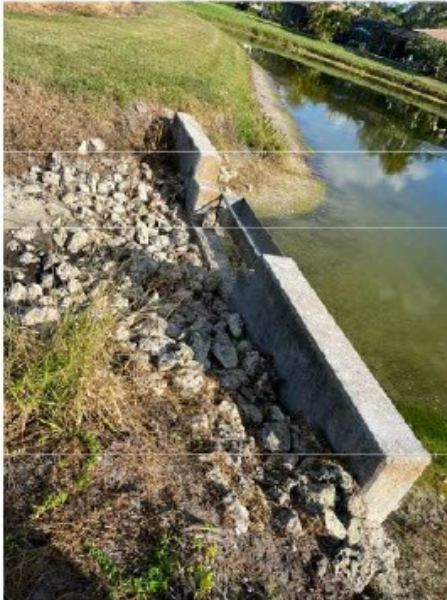
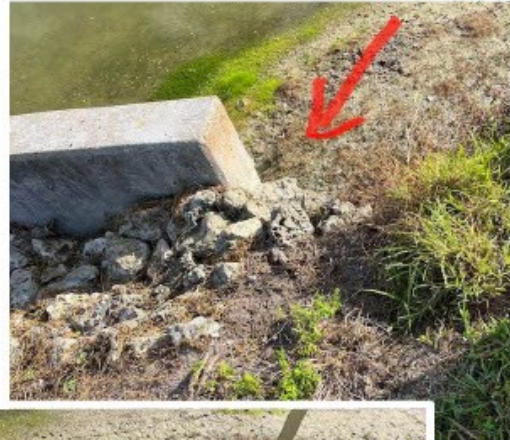
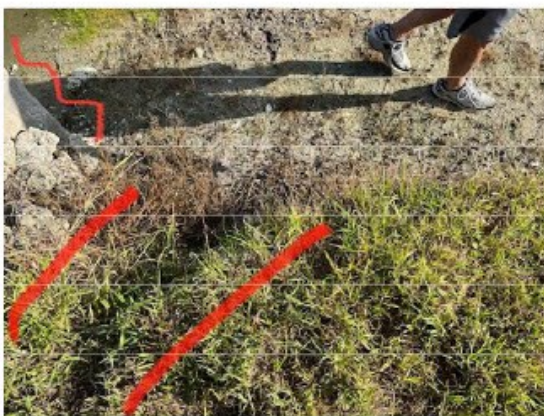
Randomly placed riprap behind overflow gate – or it shifted after installation? Either way, rocks have moved, dirt on the eastside has eroded and channels have developed in the bank which will allow water to bypass the wall and gate. If this is important, it needs to be repaired. Also, there is a 13" cavity under the bank on the east side of the wall.

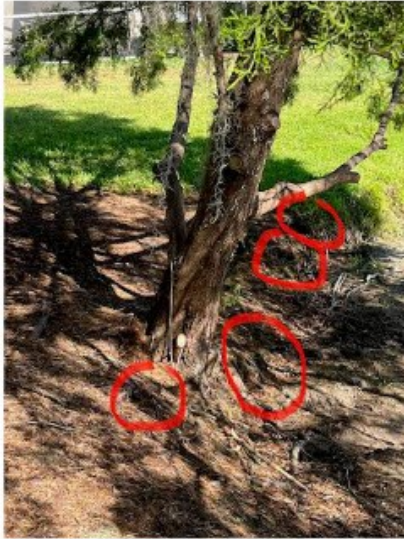
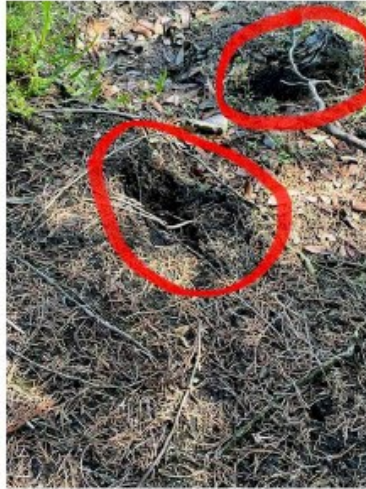
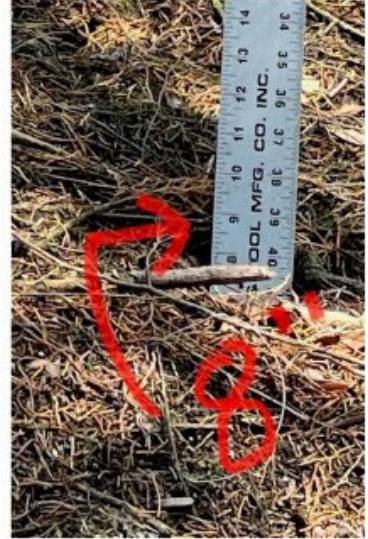
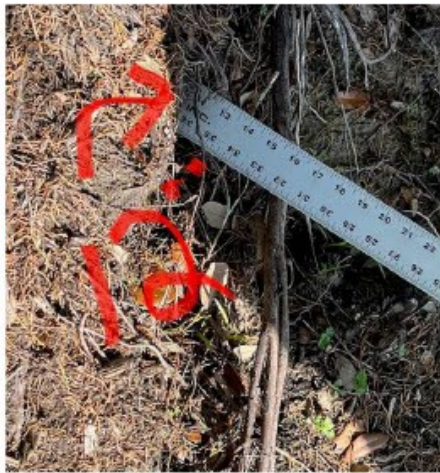
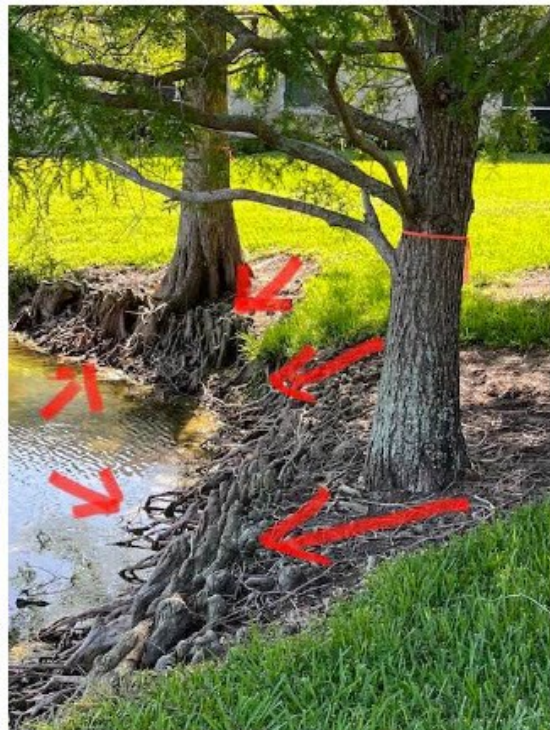
SEVERITY RATING: Average except for the south bank, which is serious.

8 – 12" deep cavities extending 4 or more feet wide undermining the Juniper/Cypress trees on the south side of Pond 6. Lower right picture demonstrates erosion exposing the roots. The erosion is the result of both pond wave action on the side as well as surface erosion due to rain or over-irrigation.

1. Encourage Units 8154 and 8010 to bury or redirect their pipes.
2. Get a proposal/plan for a mechanical solution to stop erosion/stabilization at the south bank. We need advice on how to deal with exposed roots on the pond edge without damaging the trees.
3. Evaluate irrigation quantity as well as frequency to determine impact.

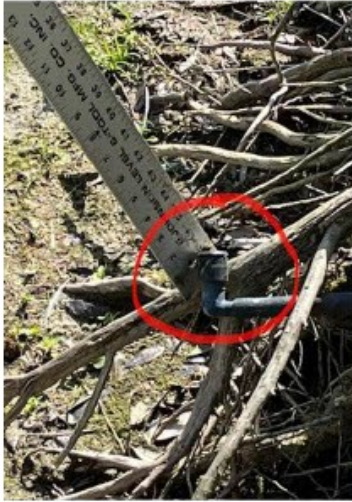
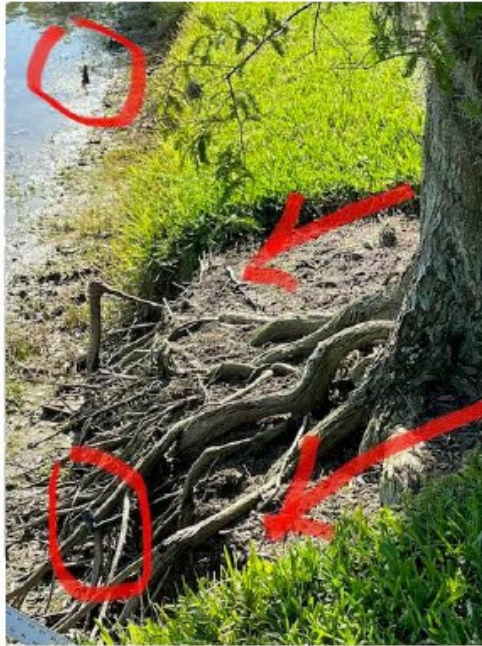
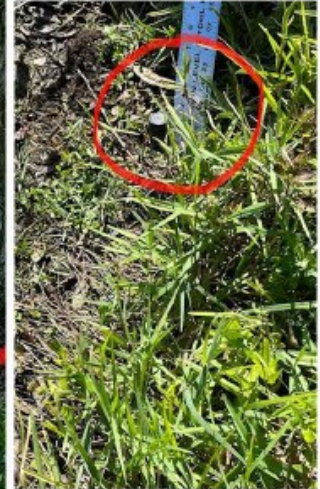
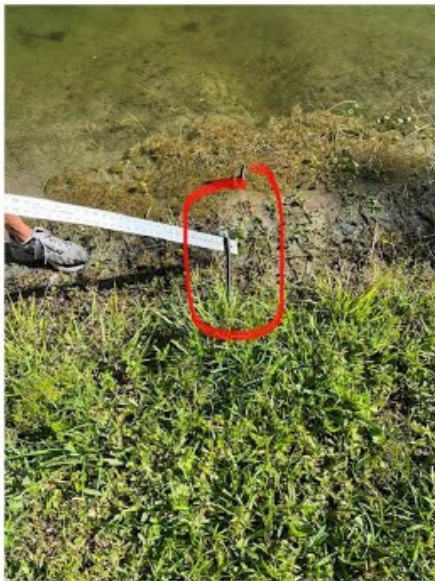
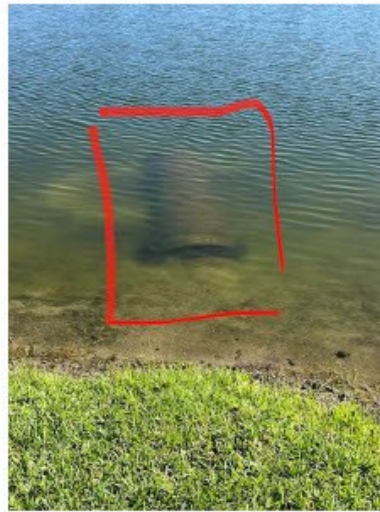
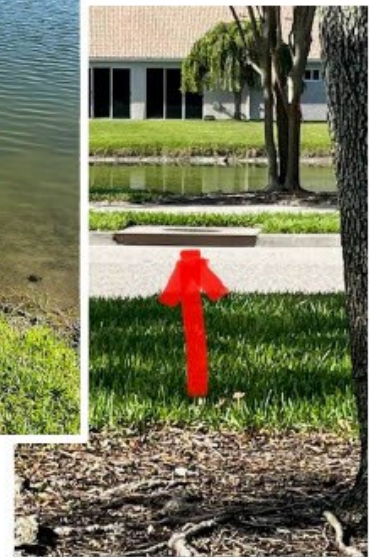
Top: Numerous sprinklers (capped?) in the water or at the water's edge and at the base of mature trees. Bottom left: sprinkler (capped) extending 12" past bank edge. Bottom right: Culvert from street drain on Lakeridge Blvd.

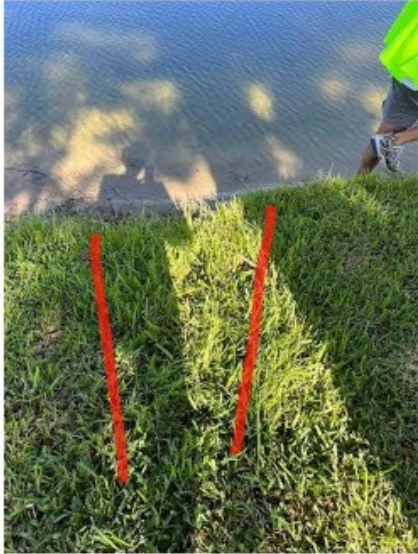
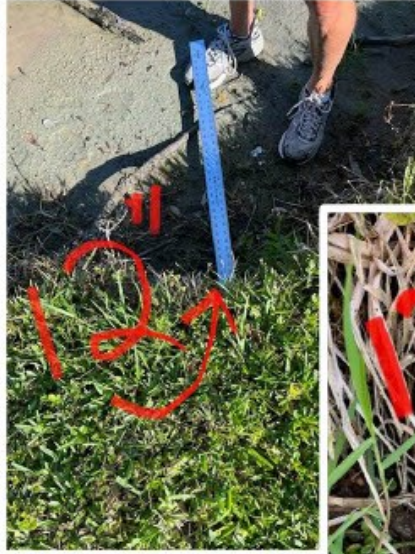
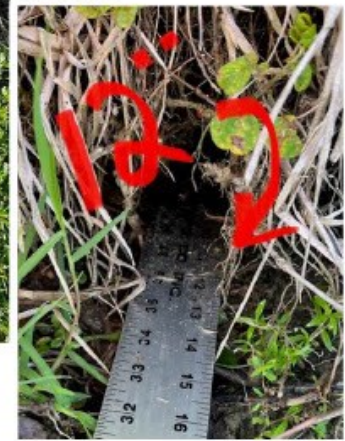
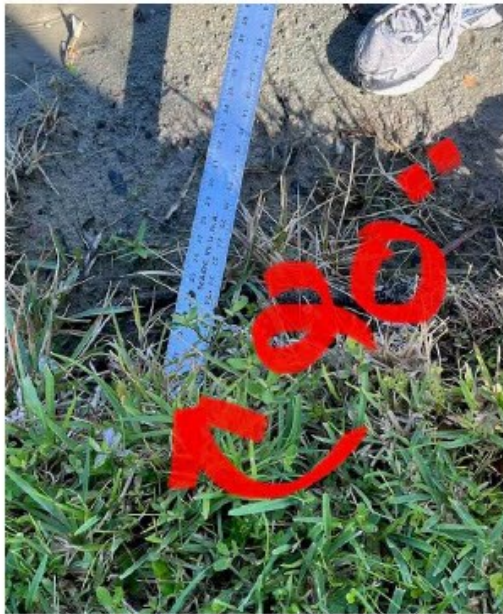
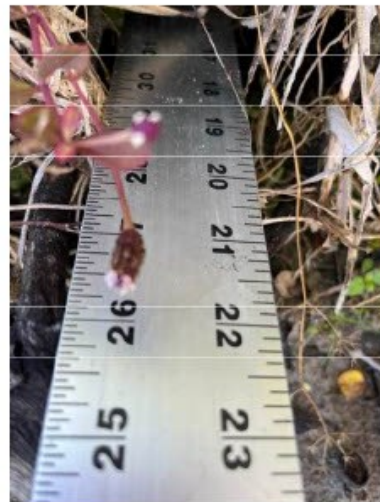
Proceeding up the eastern bank, there are two bank cuts at unit 8010. This unit, like others at this location, have two rear downspouts, one at the outside corner, and the second adjacent to the middle divider wall. No other unit around the pond has cuts directly attributable to the downspouts. Not all units have gutters, and we found that only 2 out of 22 had buried their pipes.

8010/8014 Victoria Falls Circle: Steep cut and 12" cavity behind 8010; 20" cavity behind 8014

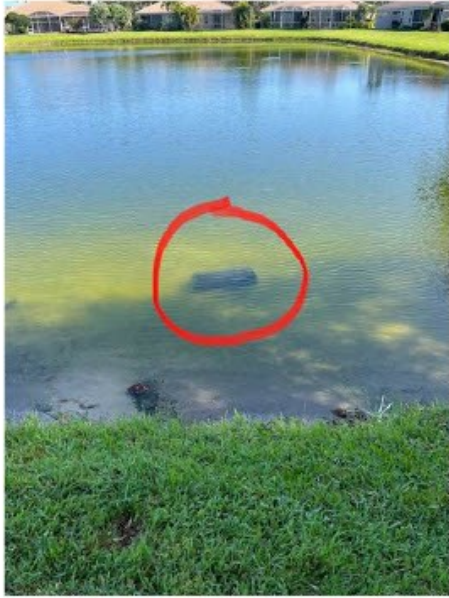
Top: Two unknown objects in the pond. Bottom left: Possibly Floating Pennywort = invasive. Bottom right: Another example of a thick grass waterfall over the bank edge to the pond. Found in several areas around the edge.

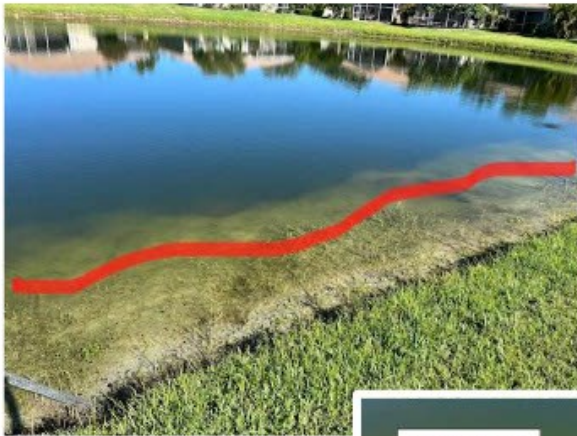
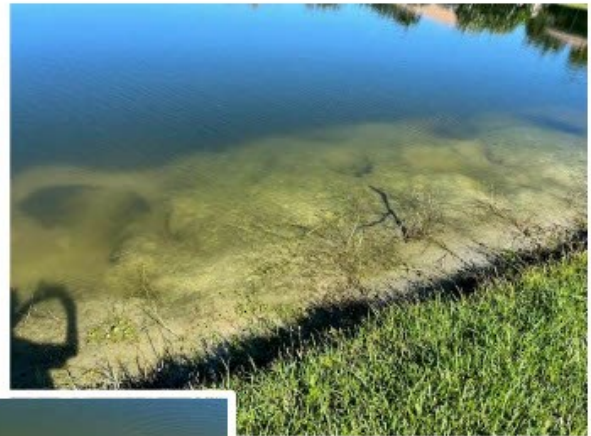
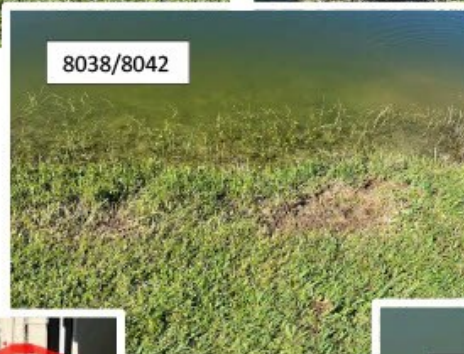
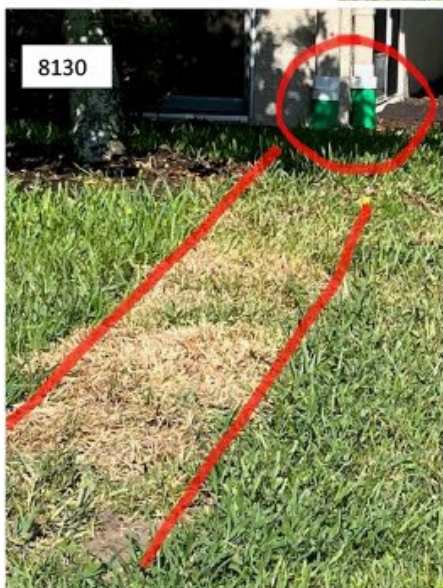
Top: Very unusual topography along the pond edge. Littoral shelf very shallow and very wide. Lots of pockets/holes (bottom)? Found on both east and west sides, but most prominent on the east side (below). Middle: Bank destruction of unknown cause (?) between 8038/8042. Bottom: Newly buried double drainpipe behind 8130. Note the poorly reconstructed bank with holes and loose clumps of sod. The soil is sliding into the pond and beginning to cover the pipe.

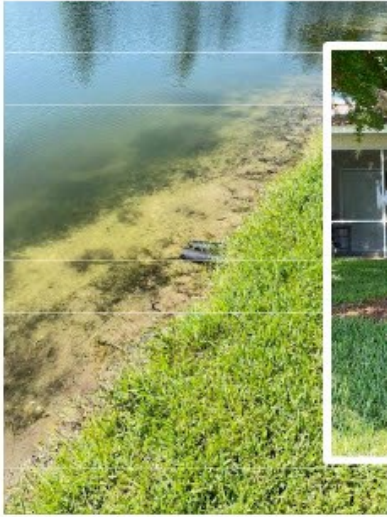
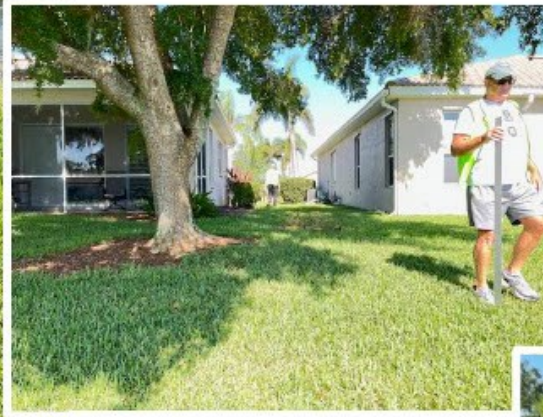
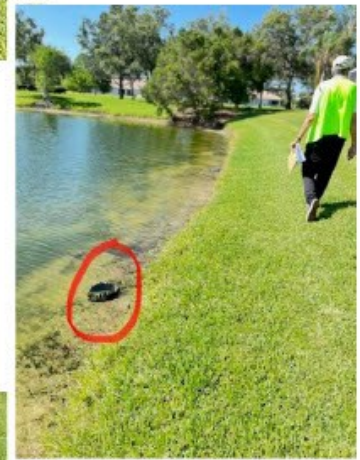
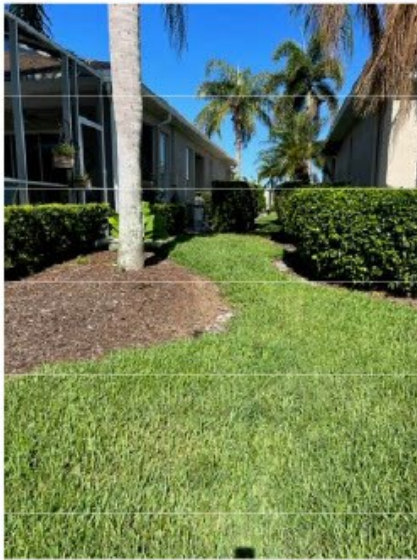
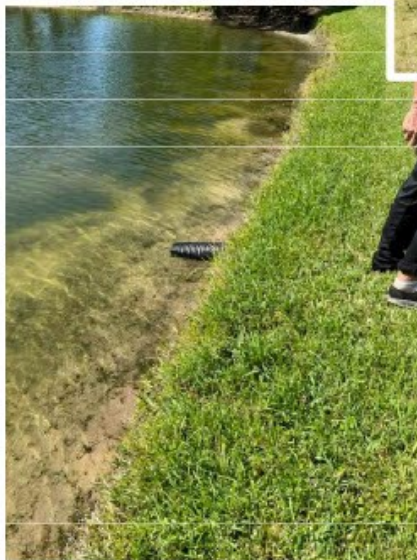
Top left: Buried pipes of undetermined origin behind 8038/8042 whose drainpipes are not buried. Also note the algae. Middle right: Tree stump in the water. Also, more algae. Bottom: Buried drainpipes at 8146/8150 but only one exit pipe could be found the pond. Possibly the homeowners combined drainage to one buried pipe.

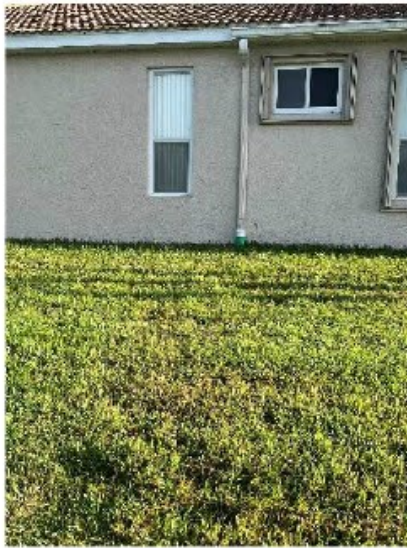
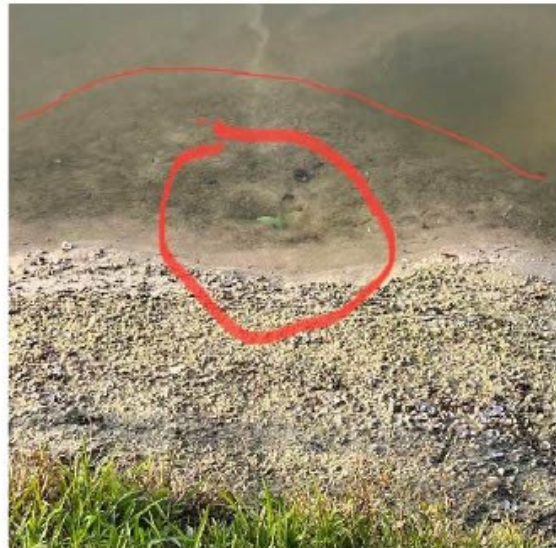
South bank behind Cascade multi-units with and without buried drainpipes. Riprap installed in several places several years ago to stave off the erosion. In most places where drainpipes have been buried, including where riprap was installed, continued erosion can be seen evidenced by silt build-up extending into the pond submerging the end of the pipe, and the troughs dug to bury the pipes have continued to erode and sink leaving dips and cuts in the grass. Use of a geotextile fabric under the riprap could reduce or eliminate continued erosion.

4251 Cascade: Buried drainpipe. Continued erosion has almost covered the drainpipe with silt after the pipe was buried.

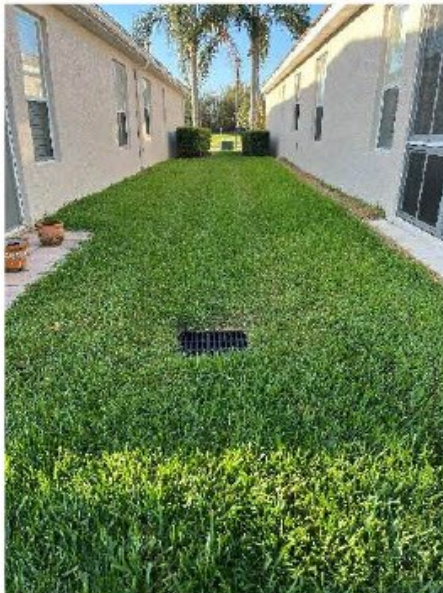
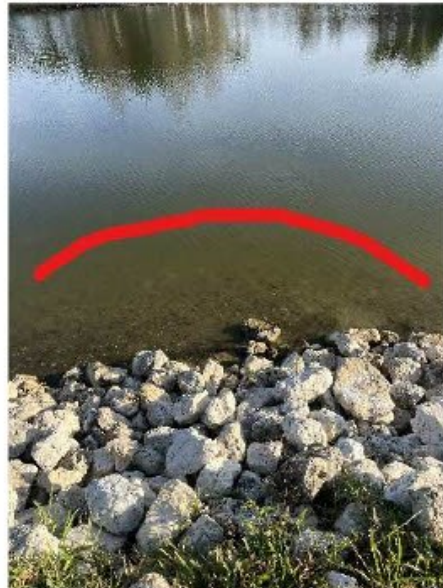
Catch basin & riprap added 4255/4259. No geotextile used under riprap. Continued erosion through rocks (silt build-up)

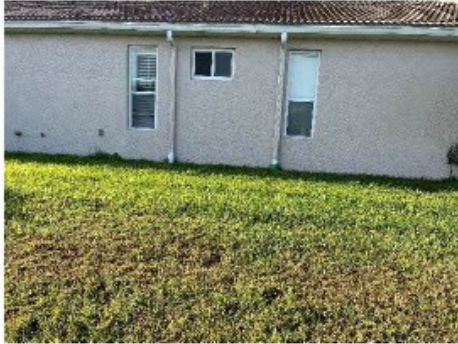
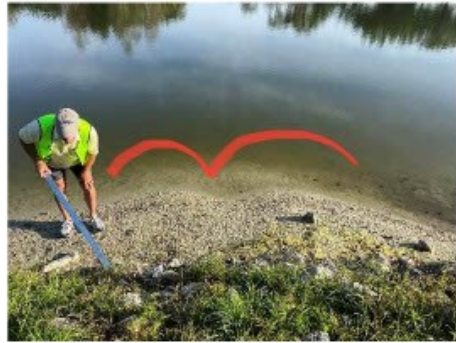
4259/4261. 2 buried drainpipes. Continued erosion after burying evidenced by silt buildup.

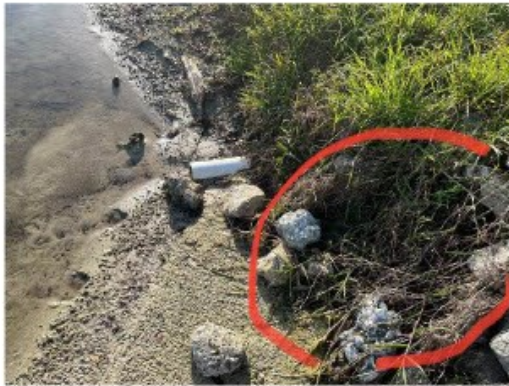
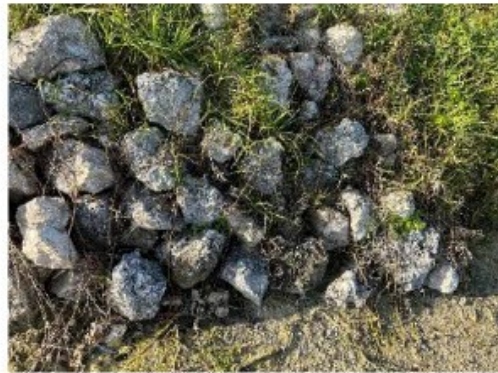
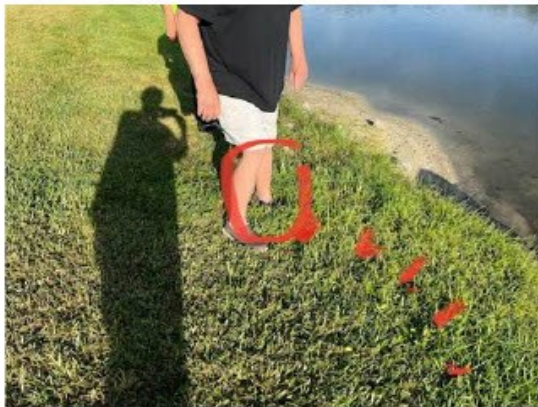
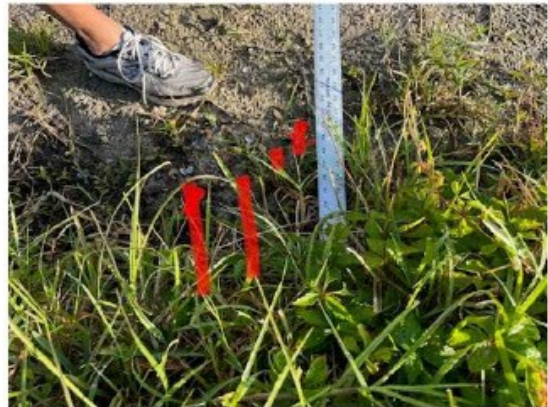
Riprap is crumbling. No geotextile bedding underneath will permit grass and weeds to grow through the riprap. Multiple small holes in the upper bank. 11" cavity under the bank (maybe the cause of the multiple holes on top of the bank). Riprap crumbling after only 2 years possibly indicates it was placed too steeply or not secured in place.

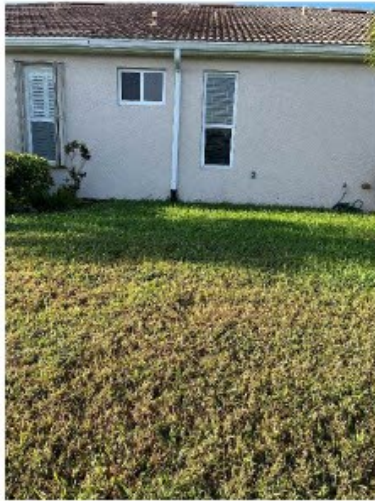
4263 Buried drainpipe (different contractor?) shows no continued erosion or recurrence of previous cut in the bank pre-burying. We should find out the contractor used and inquire about his methods.

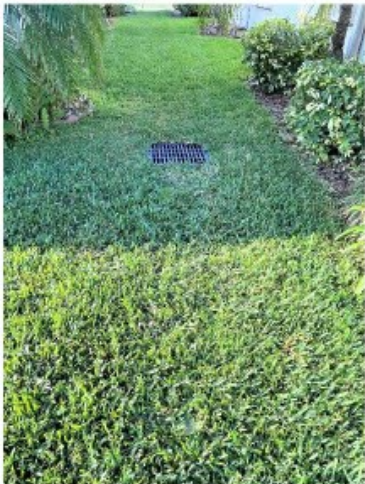
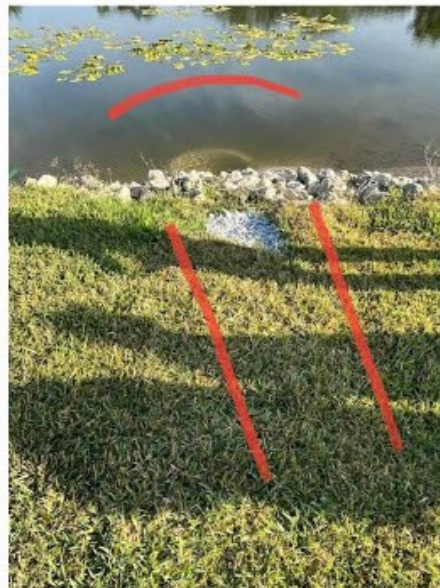
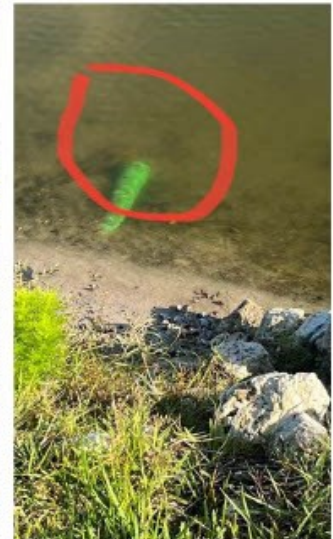
Catch basin installed between 4265/4268, also riprap. Continued erosion from trough through riprap caused bank to sink. Someone filled the hole with decorative white landscape rocks?? The left side of the riprap/bank is collapsing, and pipe is partially buried.

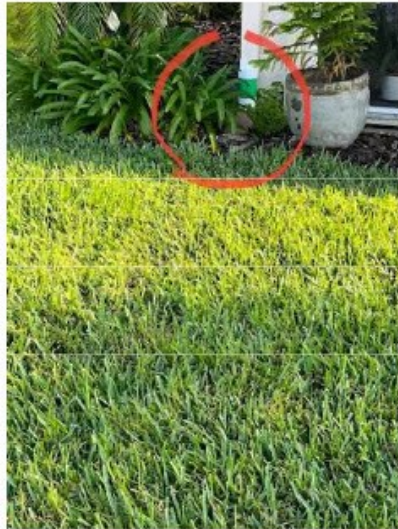
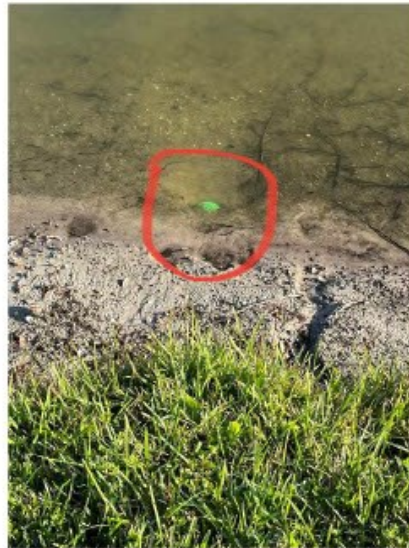
4269 & 4271 have buried drainpipes, but continued erosion has almost completely blocked their pond exits. To the right of 4269's drain exit is a small furrow carved by water exiting the bank...reason or origin unknown. 4271 has a 12" deep cavity under the bank.

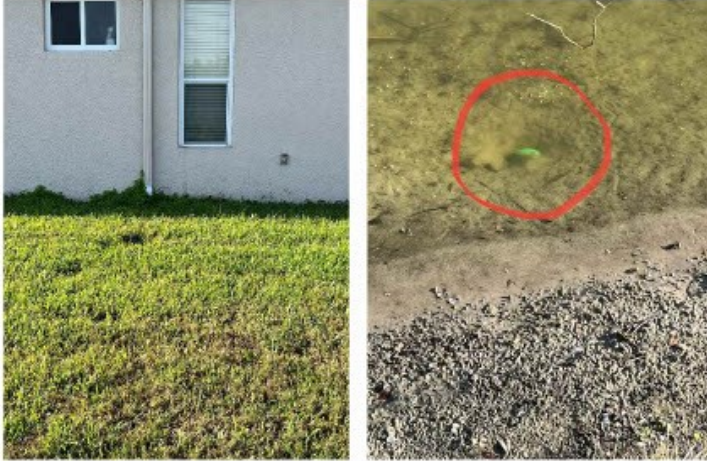
4273 buried – erosion depositing silt and partially blocking opening.

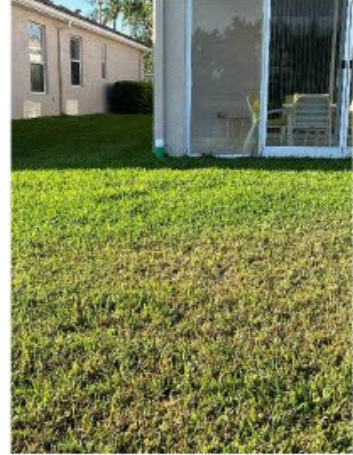
4275 buried drainpipe

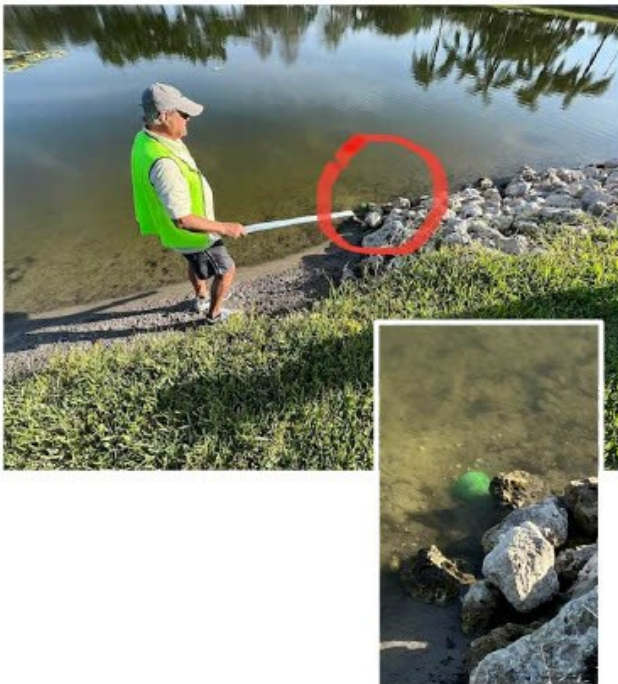
4275 Continued erosion depositing silt, partially blocking opening. Riprap slipping down slope into the pond.

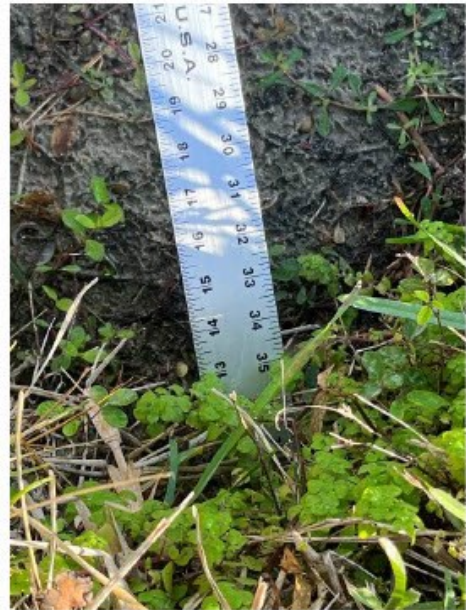
4275 12" deep cavity under bank.

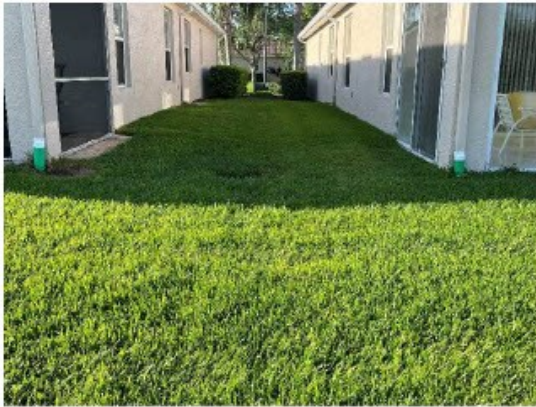
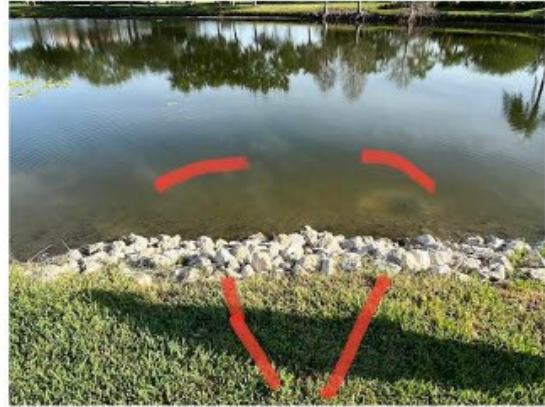
4275/4279 Catch basin and two buried drainpipes above riprap. Continued erosion through the riprap evidenced by sunken bank above riprap and silt buildup in pond. *Note:* Three separate trenches were dug to the pond; one for each drain and one for the catch basin pipe. Running the drainpipes to the catch basin & digging a single trench to the pond would have been less destructive especially since the bank was already compromised by severe erosion.

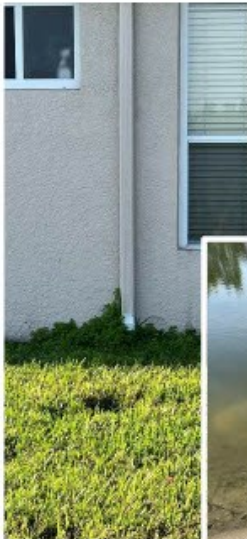
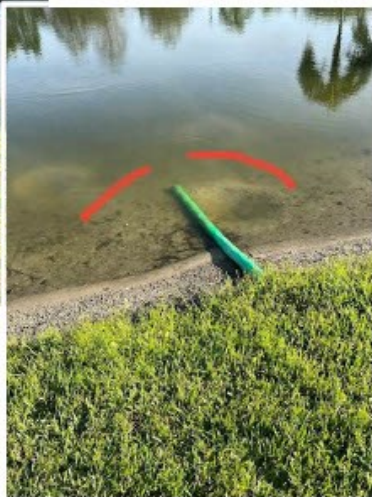
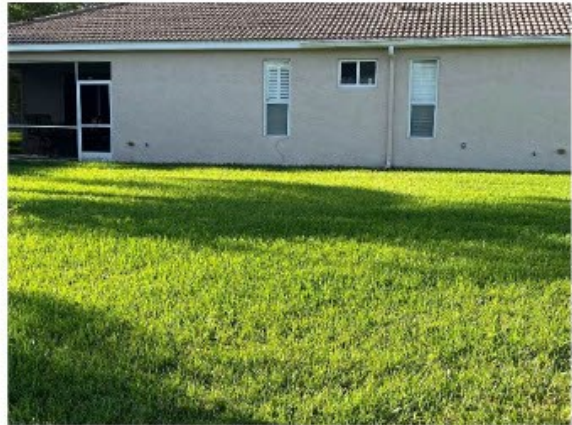
4281 buried drainpipe/continued erosion/silt around pipe opening.

4283 buried. 4285 No gutter

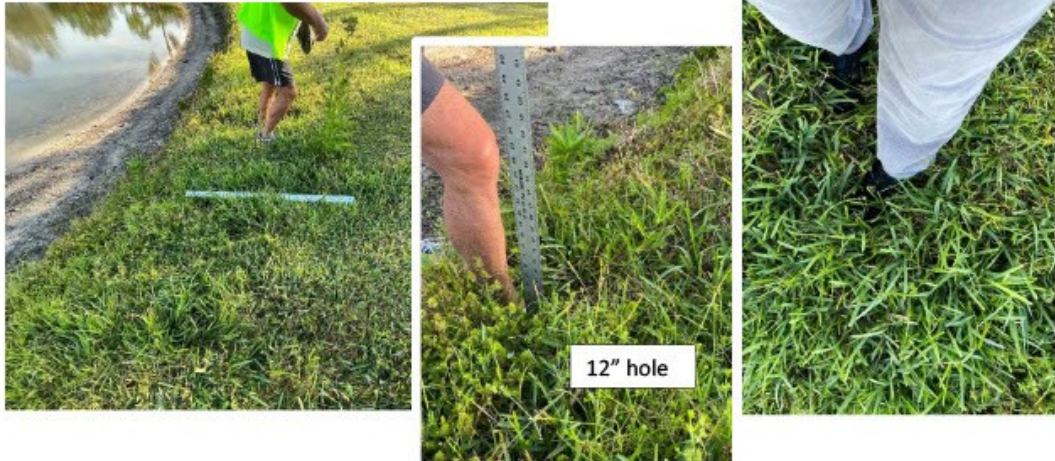
4283/4285/SE corner of Pond 8. Large wash out swale coming from house & street. Multiple holes 8 – 12" deep.

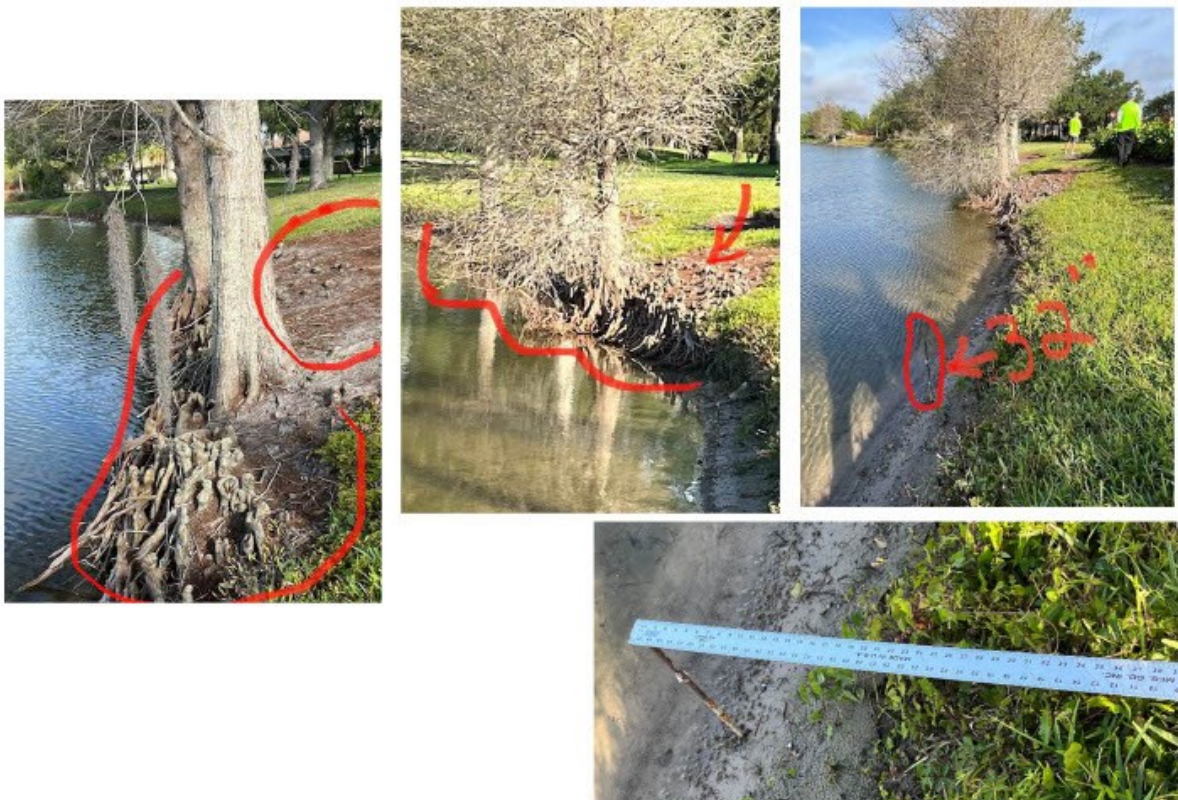
NE corner of Pond 8. Significant erosion around cypress trees both from pond wave action as well as from the top by rain or over irrigation. Closest tree trunk is almost completely off the bank. Rebar placed 24" from the bank several years ago now measures 32" from the bank = 8" lost bank due to erosion.

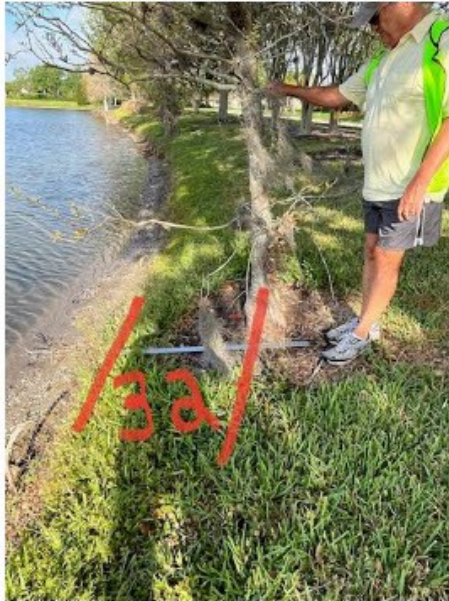
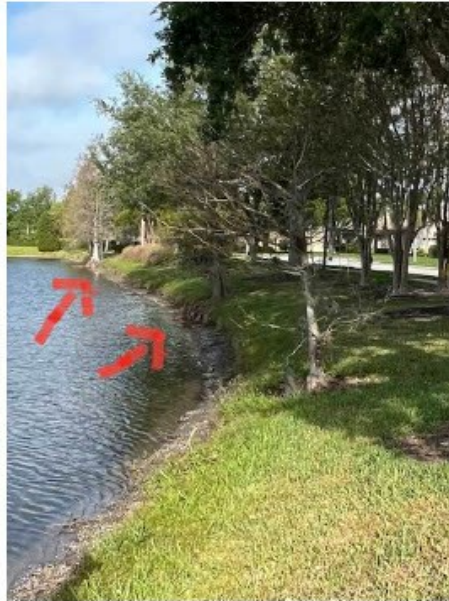
North side of Pond 8. Significant erosion around and under many of the trees.

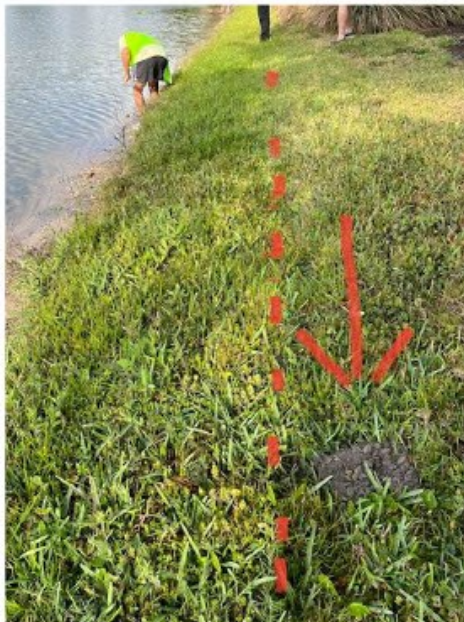
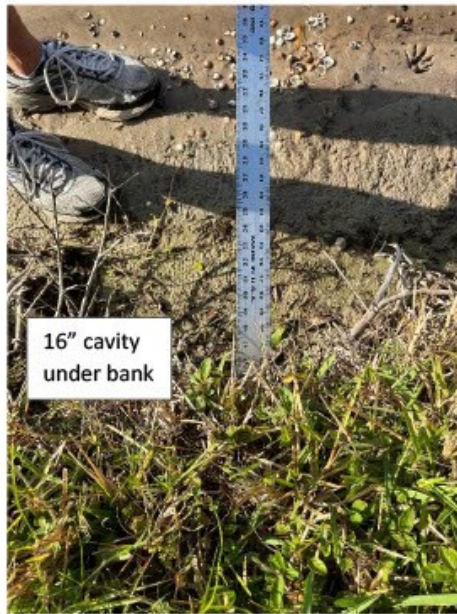
North side of Pond 8 across from 8154 Victoria. 16" deep cavity under the bank with signs of bank collapse below planted bed. Evidence of animal burrows that can increase soil instability and erosion.

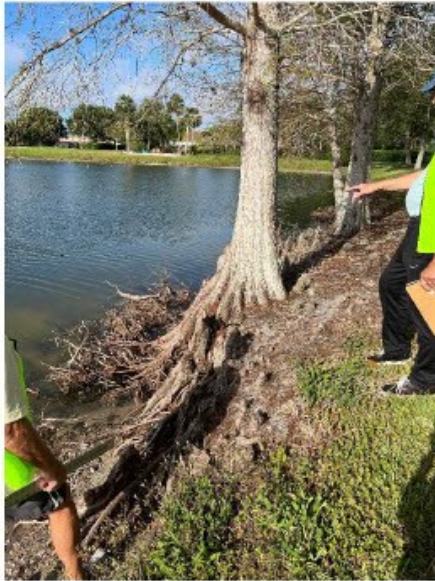
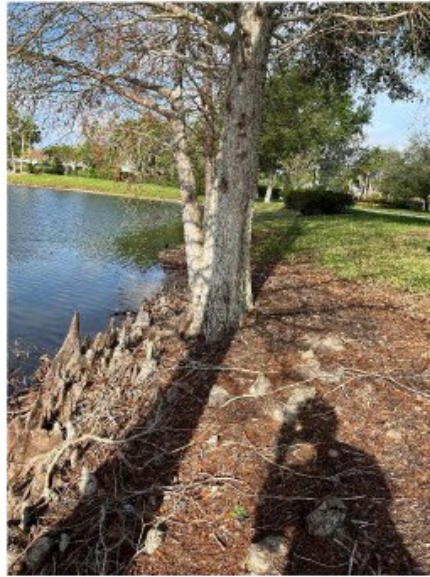
Northeast side of Pond 8 across from Victoria. More trees suffering from topside erosion (rain/irrigation) and wave action below.

My summary note: Based on what's been seen on this Pond 8 survey, homeowners should be encouraged to obtain guidance before burying their drainpipes. Many of the methods used have not proven to be an overwhelming success. There has been continued erosion post burying leading to the reemergence of gully's, swales, and holes. Also, the buried pipes are at risk of becoming buried themselves from the newly deposited silt. Clearly consideration should be given to other methods to minimize erosion from drainpipes. Directing drainpipes, where possible, to existing drains or catch basins, or to the street would lessen the impact on the fragile banks. Asking homeowners to share a drainpipe would also reduce trauma. The fewer cuts or disturbances that can be made in the yards and banks the better.

1. Serious evaluation should be given to the use of geotextile fabric beddings under any new riprap to minimize continued erosion.
2. Contact homeowner's whose buried drainpipes have not led to continued erosion and find out the contractor and methods used so they can be recommended to upcoming homeowners.
3. Investigate fill methods and materials with an eye on increasing stability and reducing secondary erosion.
4. Investigation into irrigation system to insure the amounts of water laid per cycle (especially at the pond edges) is sufficient to maintain the landscaping but does not contribute to topside erosion.
