Pond Survey Summary

The LakeRidge Falls (LRF) Roads & Grounds (R&G) Committee Pond's Crew conducted a physical inspection and prepared an individual survey of 13 stormwater ponds in the community, during the early part of 2023. We did not survey Pond # 7 (by the back gate) as it is not connected to the other 15 ponds, is not maintained as a pond, and has been planted as a wetland. In addition, we did not have sufficient time to complete surveys of Ponds 2 and 16 before late spring rains limited our full access to these two ponds. The Ponds' Crew recommends conducting inspections and preparing surveys of these two ponds during the next dry season in 2024. The 13 individual surveys, for the most part, reflect our observations and are, therefore, the "facts" we found. These individual surveys stand on their own as direct observations, supported by photos and measurements. The recommendations we make, therein, are those that are obvious, such as burying, or redirecting pipes, and adding catch basins.

Pond Crew 2023

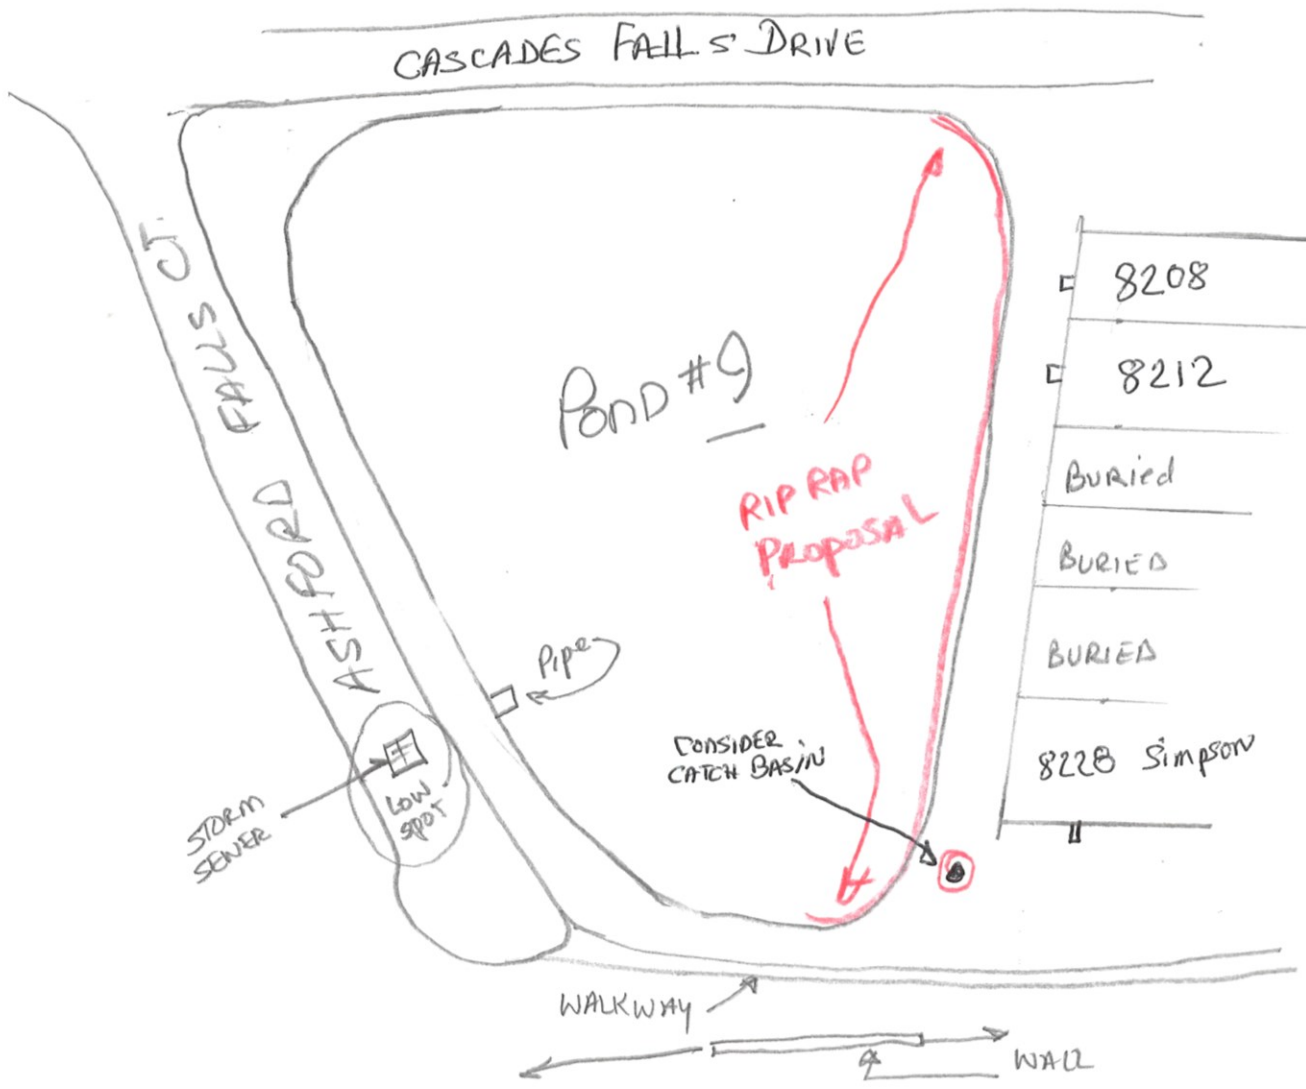
SEVERITY RATING: Average

1. Encourage the owners of 8208, 8212, and 8228 Simpson Falls Court to have their pipes buried: 8208 and 8228 should consider joining their buried pipes with any catch basin that goes into the pond corners. All pipes should be buried or diverted before any remediation of the damage caused in the backyards is attempted.
2. Consider installing a catch basin in the SE corner of the pond slightly below the swale described above; consider a catch basin as used in Pond 8.
3. Reuse rocks in the SE corner, to fill in deep washouts.
4. Need to evaluate the impact of the irrigation system on the erosion here, especially along the south side. Need to explore as well the use of ground cover plants along this side.
5. Once the cause of the erosion on the south side is clear we need a plan to fix it.
6. Find a new home for the 6 ducks

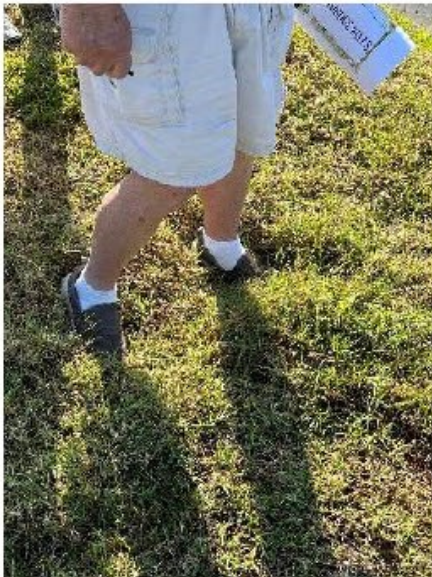
Across from 4159 – 4165 Cascade, there are multiple 4 – 6 in depressions 2 - 4ft from edge likely caused from soil erosion underneath the grass. Unable to evaluate the ledge at water's edge due to water level in pond. Across from 4165 there is a large erosion cut at water's edge.

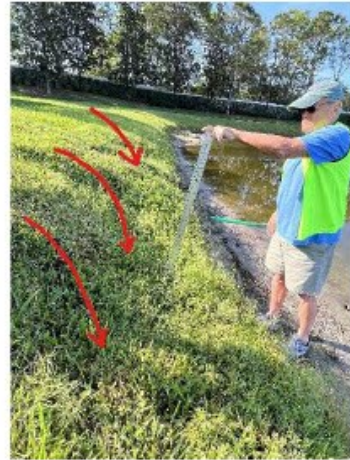
8216, 8220 & 8024 recently buried their downspouts. Don't know if the ground was filled flush after the spouts were buried or if the loosened soil caused by burying the spouts allowed continued erosion, but additional backfill is needed to fill holes and washout cuts still present where the spouts were buried. There is evidence of collapsed ledges (arrows), perhaps caused by erosion carving out cavities under the edges as shown in previous photos. The whole length of this side of the pond is riddled with 4 – 6" holes.

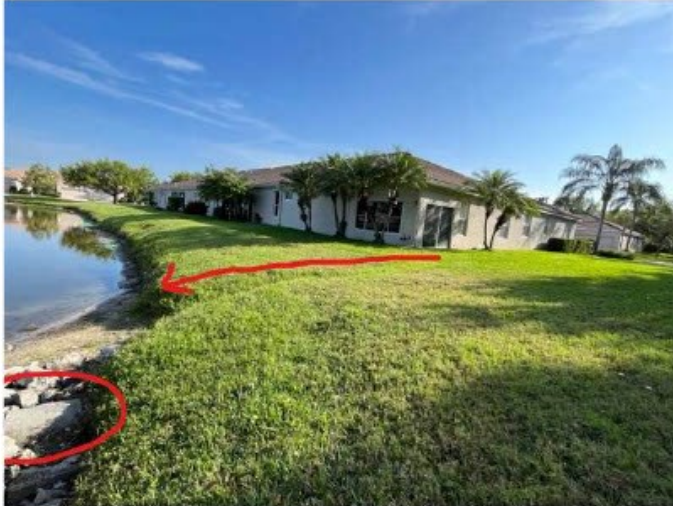
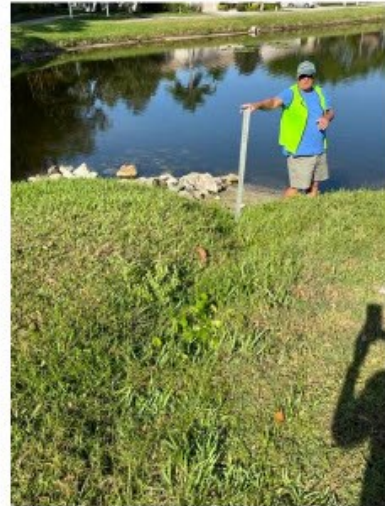
SE Corner Simpson and sidewalk alongside of 8228 Simpson. Long and deep washout crevasse adjacent to the riprap that covers a previously buried concrete stormwater pipe coming from the road. 8228 also has an unburied drainpipe.

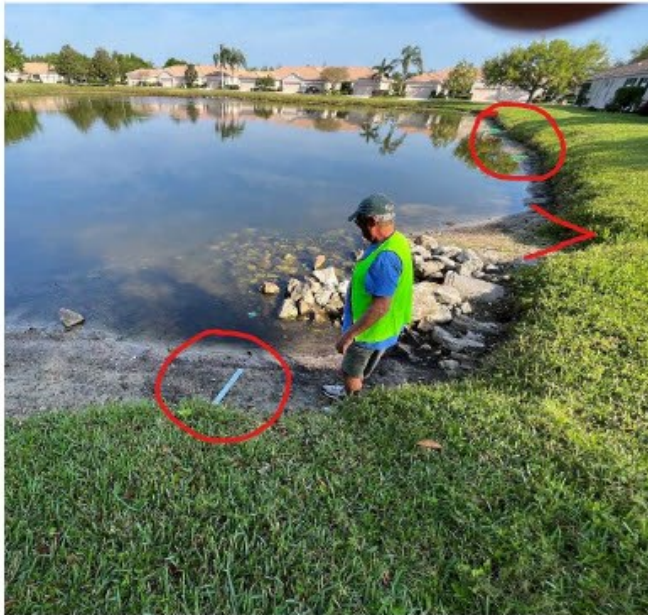
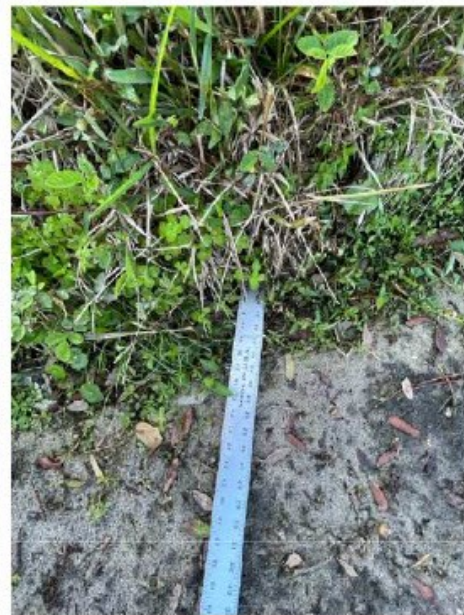
SE Corner Simpson and sidewalk alongside of 8228 Simpson. View below shows 3 buried drainpipes, the large washout next to the concrete pipe, and the location of a 16" deep cavity under the ledge.

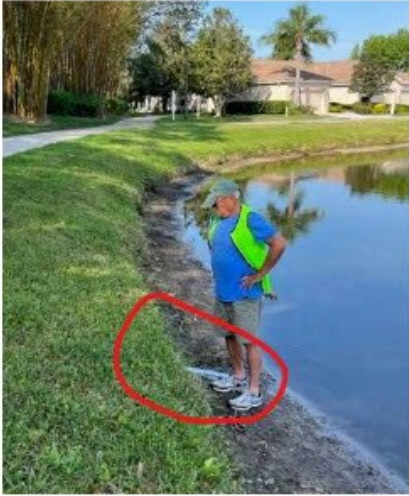
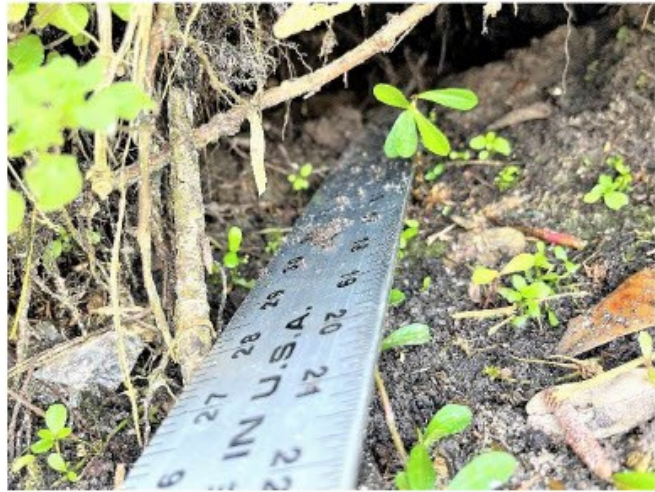
Mid-way along sidewalk side of Pond 9 we measured a 16" deep cavity under the ledge with a close-up inside. At the SW corner with Ashford Falls we took another cavity measurement with a close-up that measured .

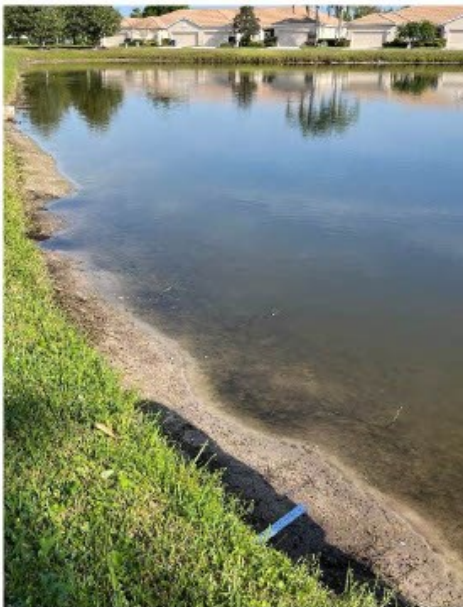
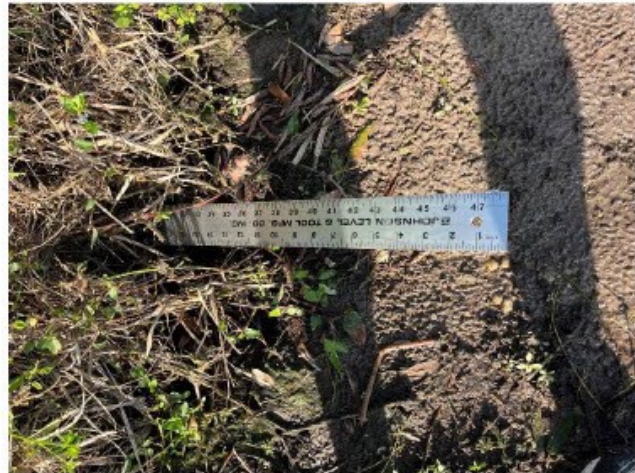
At the SW corner with Ashford Falls we took cavity measurement of 32".

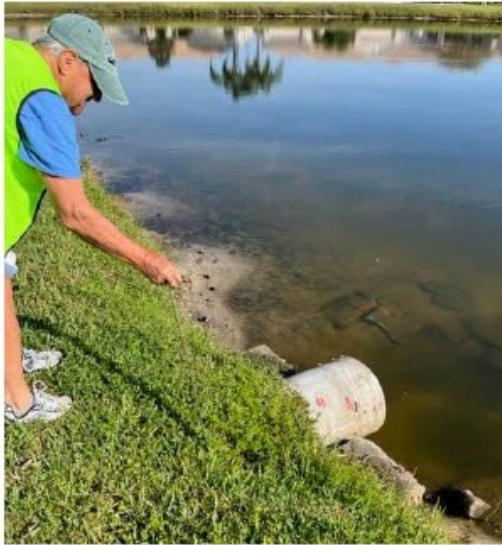
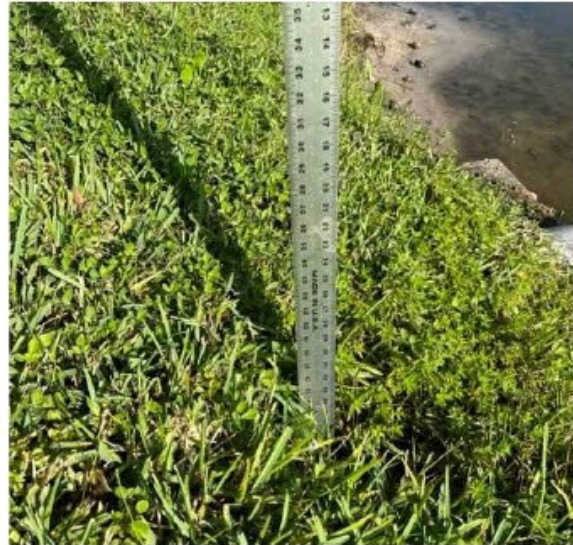
SW corner with Ashford Falls we measured a 13" hole by the buried concrete storm drain along with several other smaller holes.

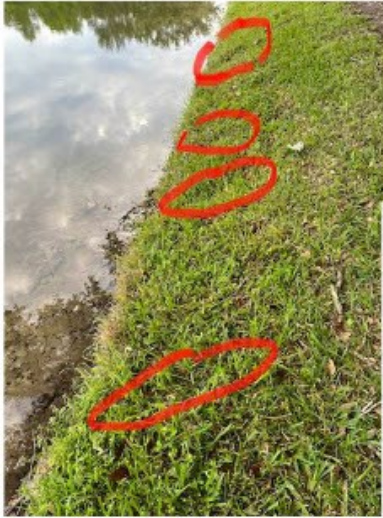
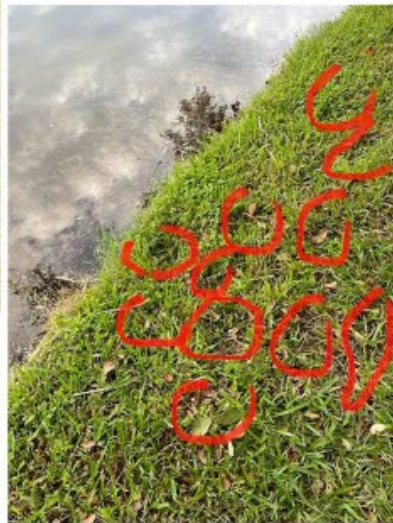
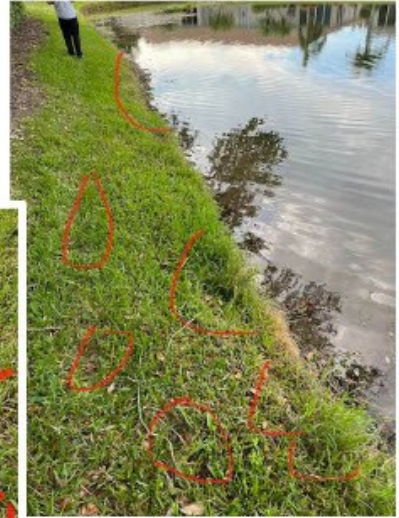
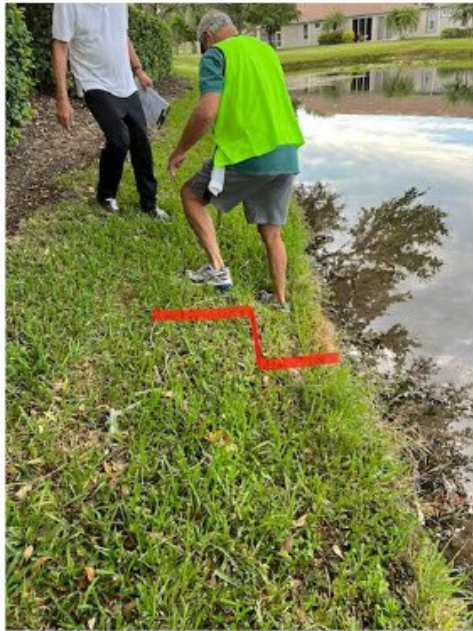
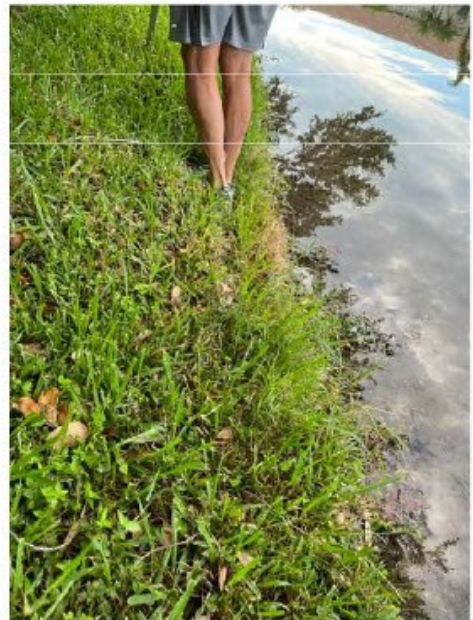
North side: The bank is soft & mushy with many small holes and has collapsed in some places mainly below the shrub plantings. Possibly the result of over watering.

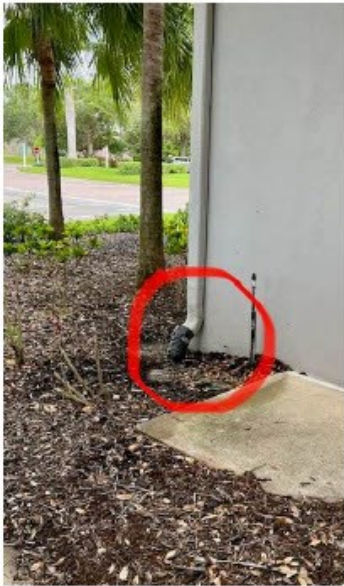
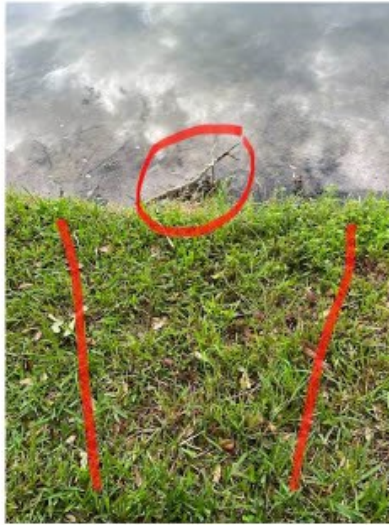
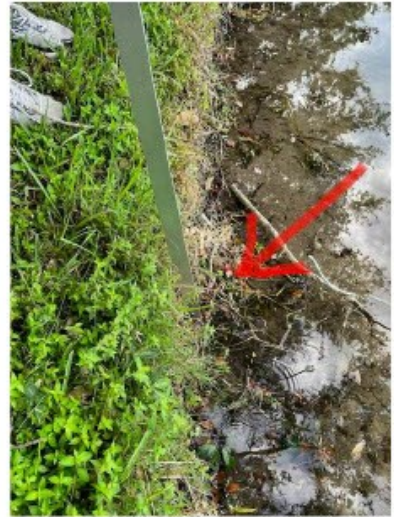
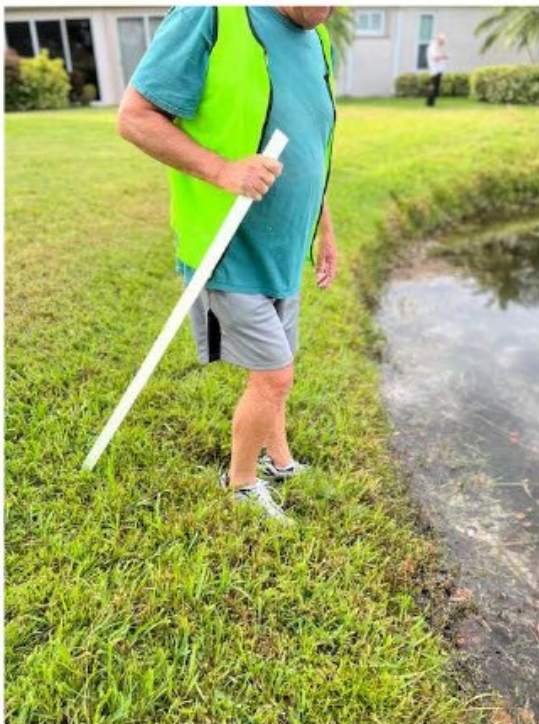
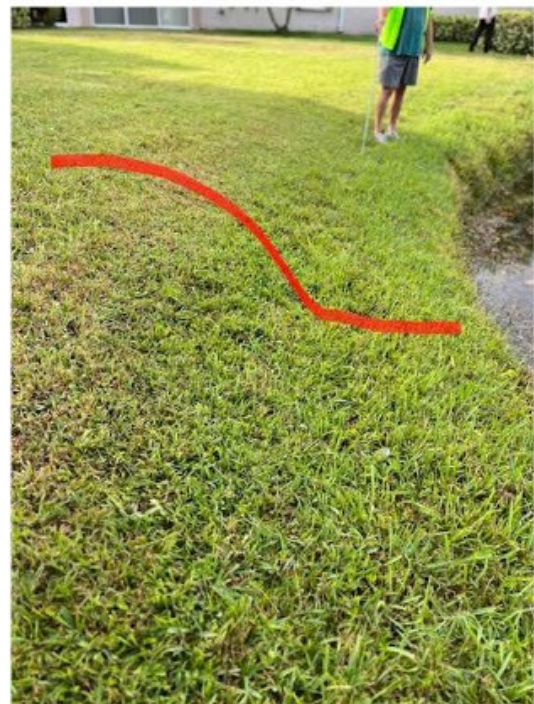
Top: Clubhouse drainpipe is buried and runs under the sidewalk and plant bed. Deep cut hidden by grass from plant bed to the barely visible pipe exit in pond. Bottom: Soft, collapsing bank.

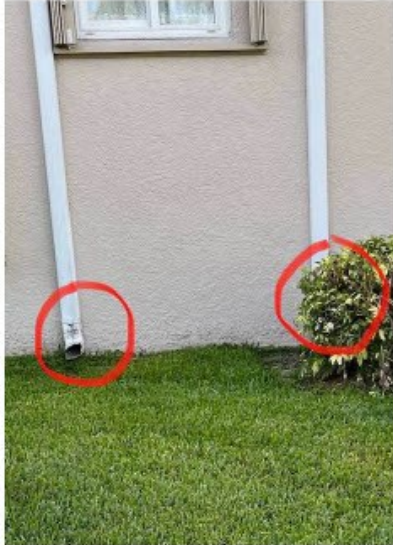
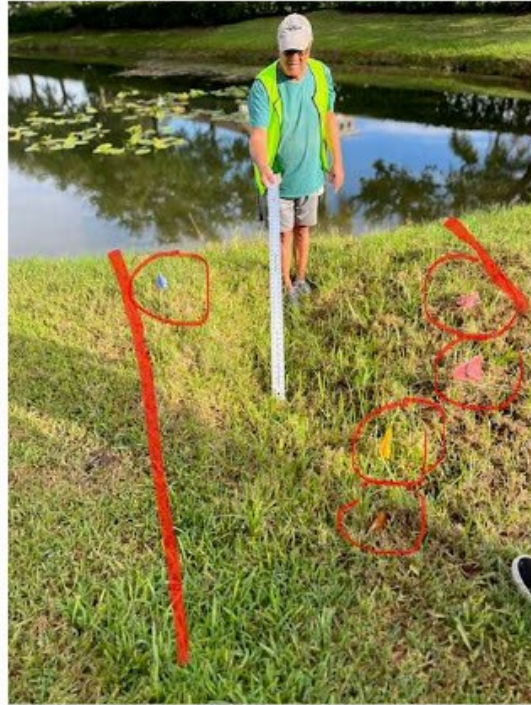
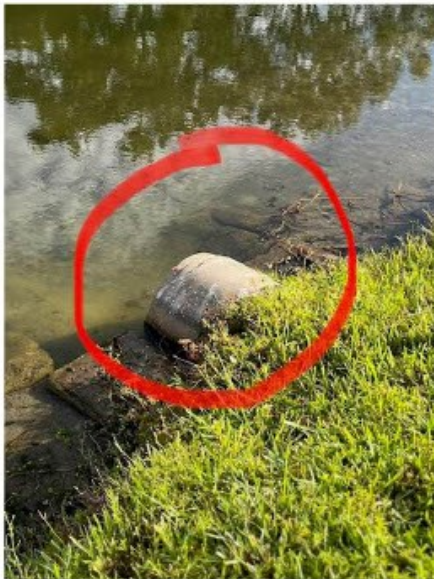
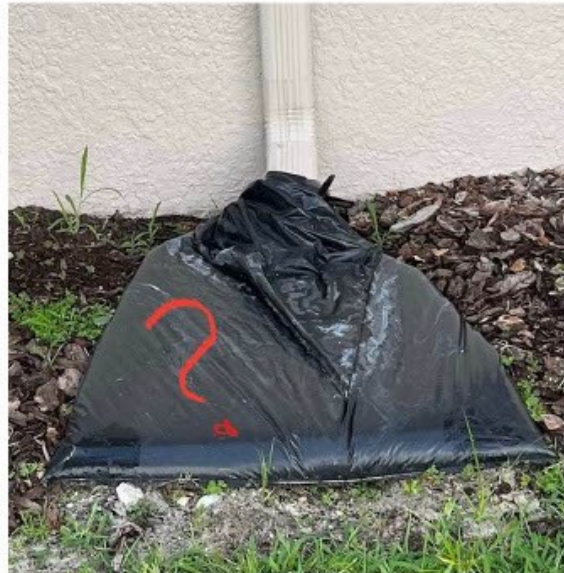
Top: 4237/4339 have unburied drainpipes. 8in deep by 8ft wide cut/swale filled with holes marked by flags. Bottom L: 26" cement culvert from road drain Bottom R: 4229 mystery water-filled garbage attached to the bottom of the drainpipe.

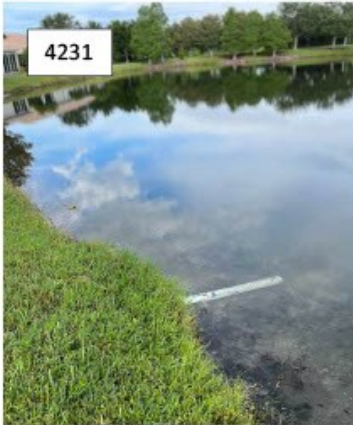
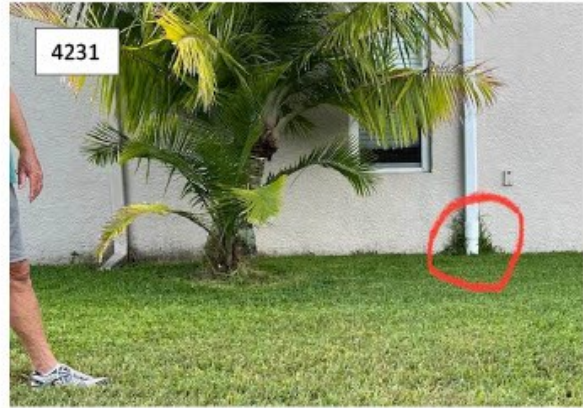
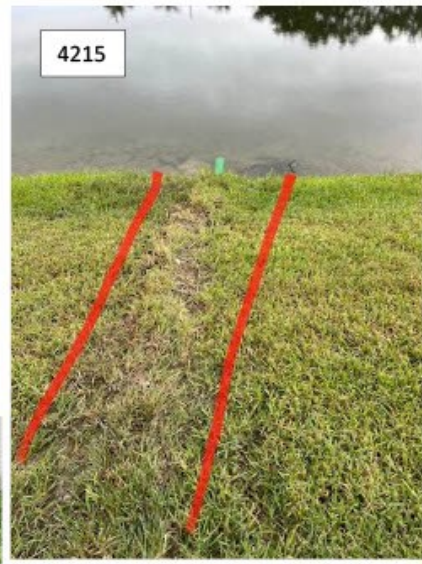
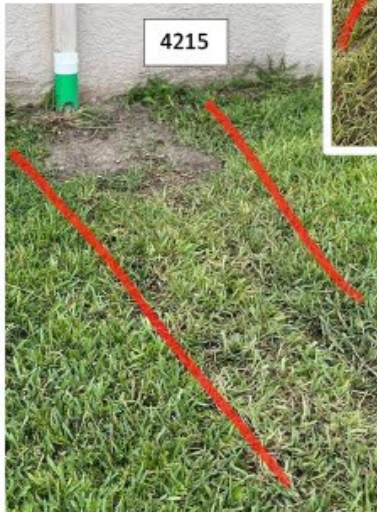
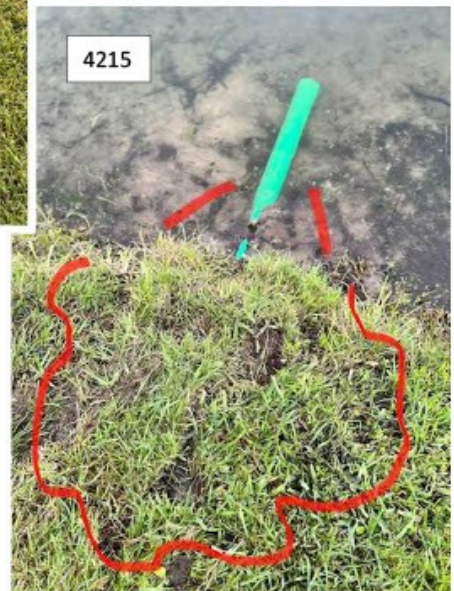
Top: 4231 has a buried drainpipe & no cut in bank. Middle & bottom: Newly buried drainpipe. Lower left: Note the poor bank reconstruction with loose sod/soil eroding into the pond already and beginning to cover the pipe.

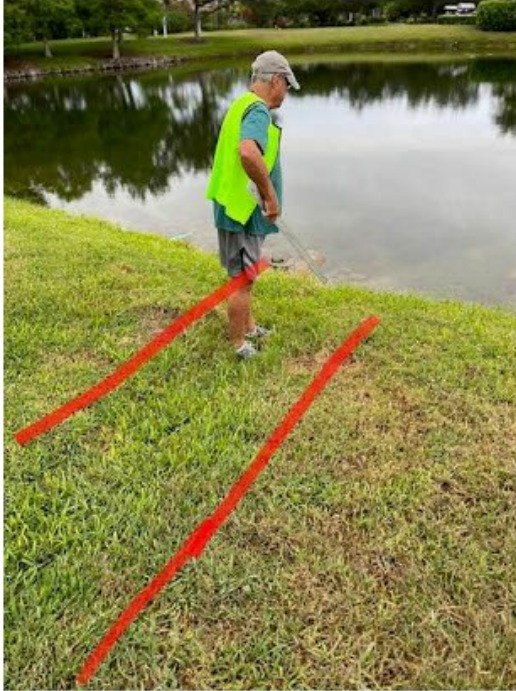
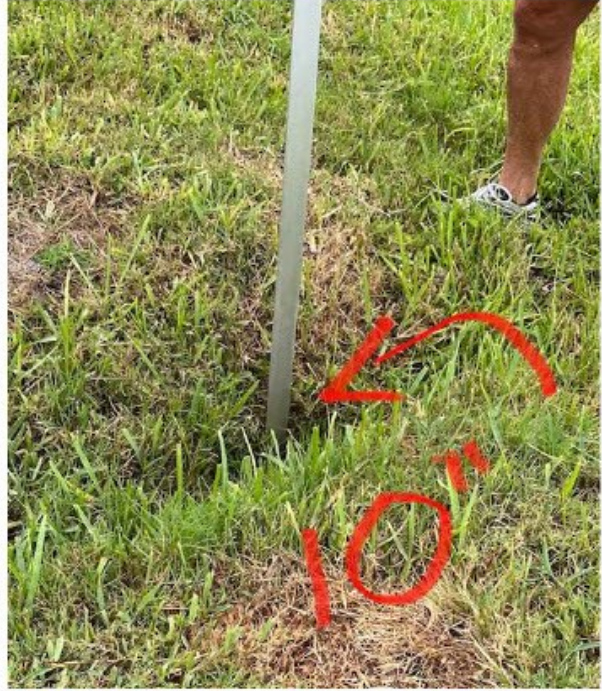
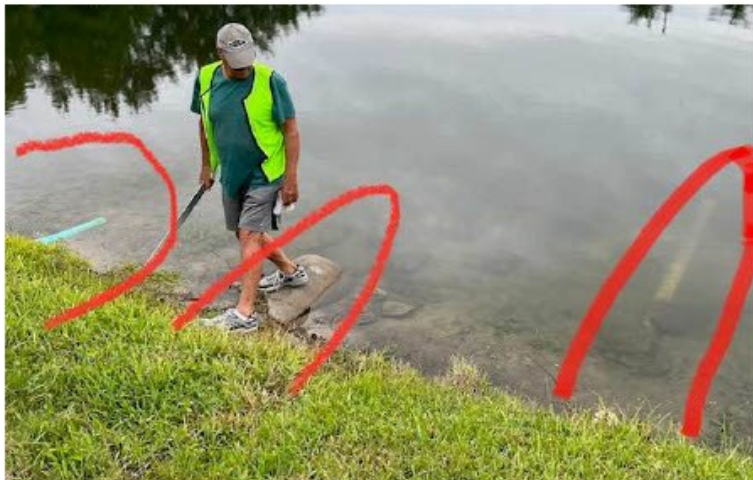
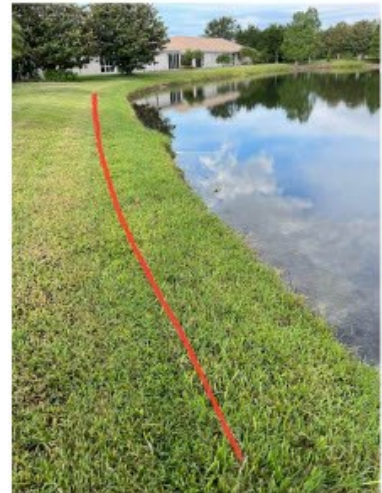
Top: 10" deep swale between 4215/4211. Bottom left: Blue buried pipe from 4211; 26" concrete culvert from street drain; white pipe from the well in pond #11. All three have signs of continued erosion with sagging ground and soil beginning to cover the pipes. Bottom right: mini "no-mow" zone?

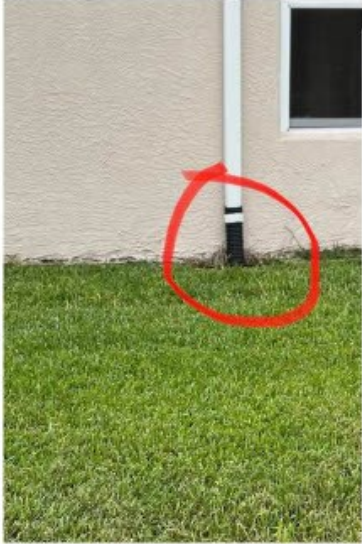
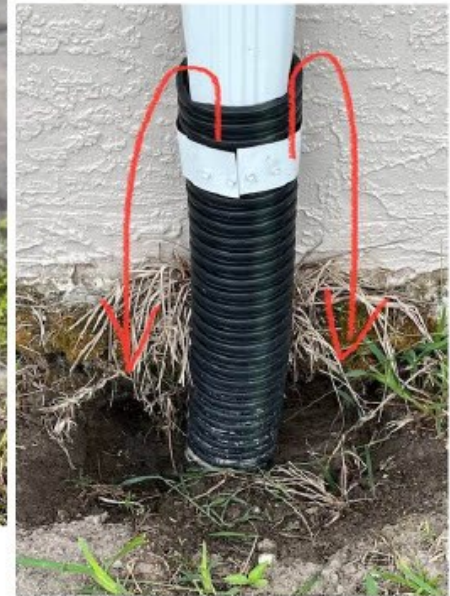
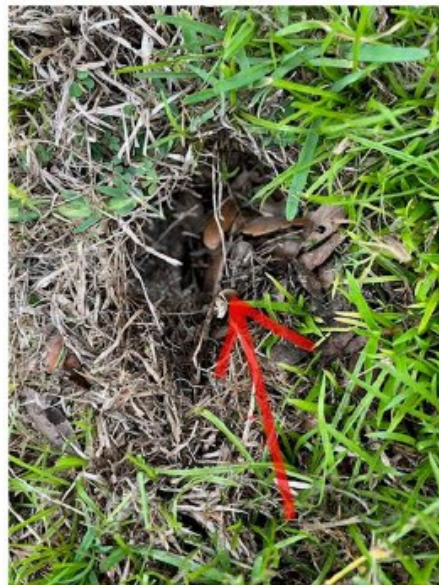
Top: The pond exit of the buried drainpipe at 4209 is completely blocked by continued erosion causing the rain water to back up and overflow the connection. This has resulted in a large hole around the pipe that extends under the foundation.
Bottom: Buried drainpipe at 4205 exits in the lawn 6ft from the pond edge. Exit is filled with grass and soil.

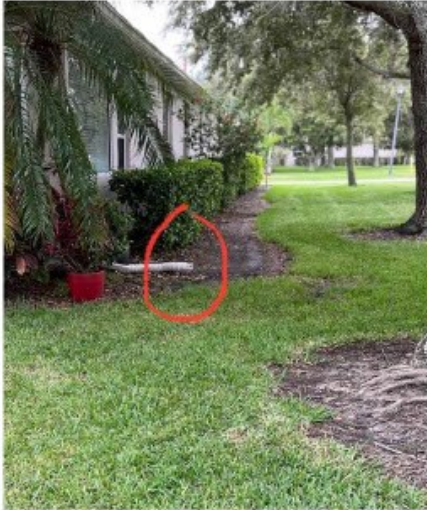
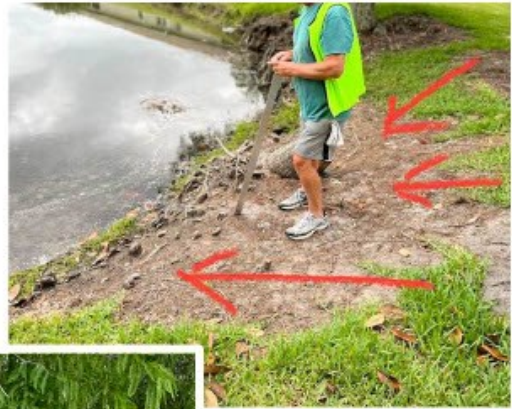
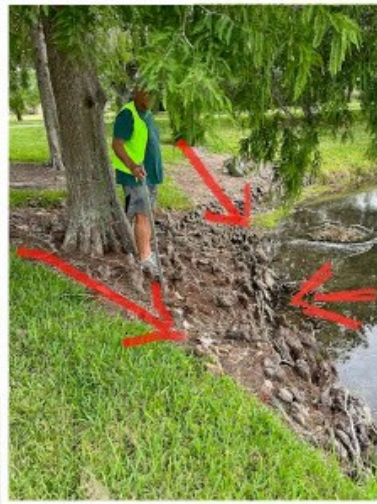
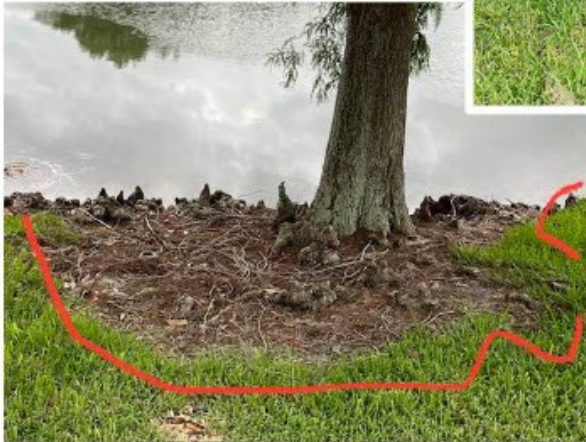
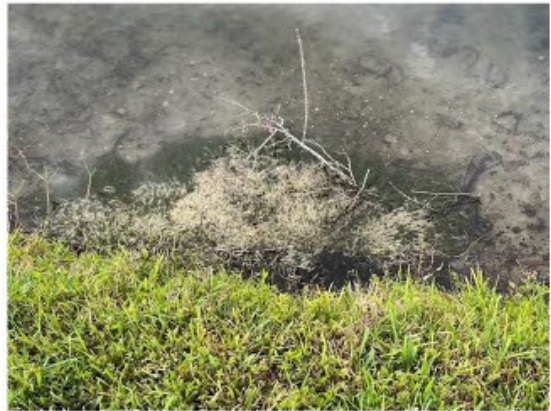
4205 Drainpipe is not buried. Soil erosion not caused by wave action but by top side erosion due to rain or excess irrigation has left bare ground and exposed tree roots. Lower right: : Frothy pond scum

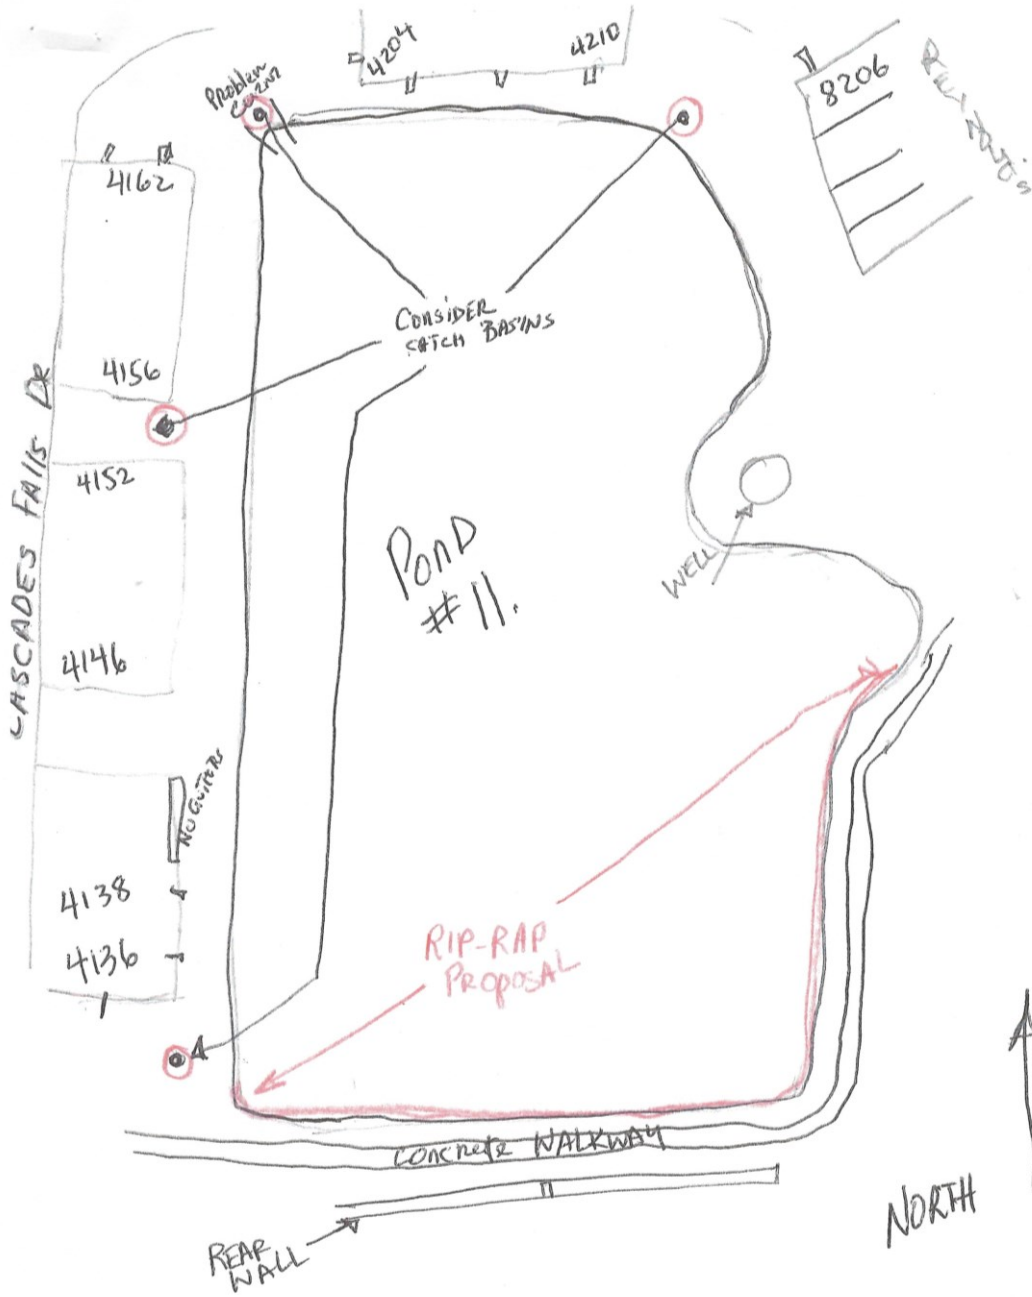
*NOTE The south and lower east side of this pond (Community property) has a gentle slope that might support a plant solution. i.e., erosion is coming from above. At this point, the reason is a mystery. Perhaps it is, as suspected, over-irrigation? We can not fix it until we solve the why? We should consider a change in irrigation and possibly a ground cover to either absorb or force the runoff along?

SEVERITY RATING: Above average

1. Encourage all owners noted to bury or redirect the downspouts away from the pond. Consider catch basins similar to those installed in Pond 8. Buried downspout pipes should be joined by other close pipes to cut down on the number of pipes entering the pond.

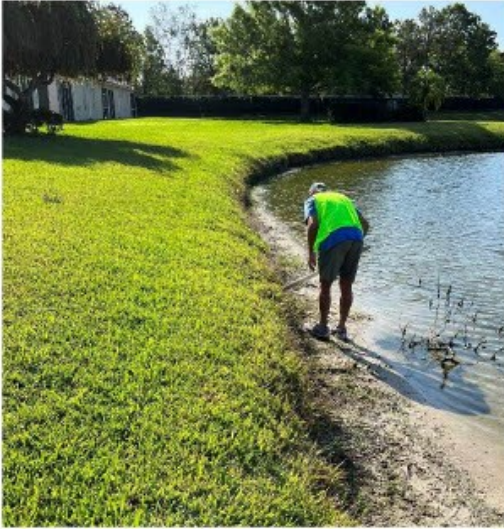
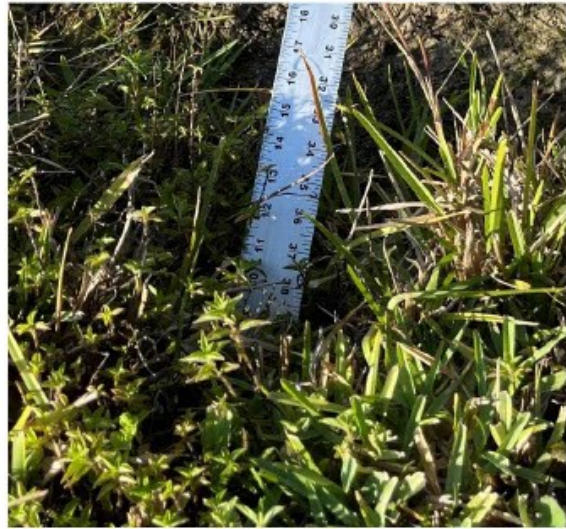
NE corner Cascade & Reynolds Falls. 10" cavity under bank behind 8206. No buried drain spouts on 8210, 8214, & 8216. Many indentations in the backyards, but no significant erosion marks seen on the surface from the drainpipes, nor cuts at pond's edge.

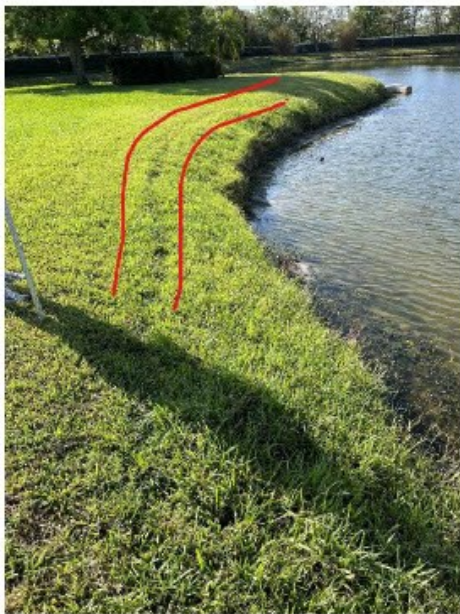
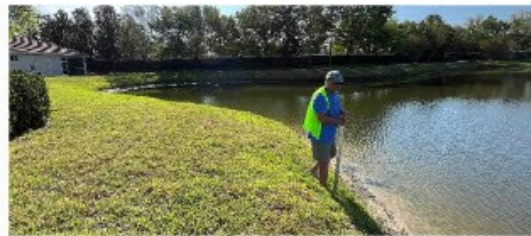
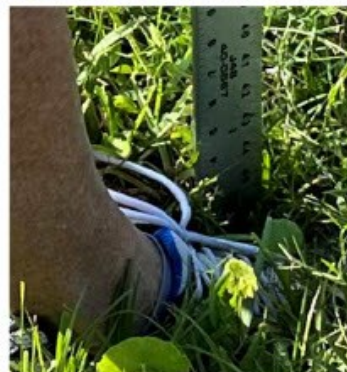
Unusual indentation along the bank edge behind 8210, 8214, & 8216. Could be from the mower, (but why only one indentation, a mower should leave two?). Beyond that adjacent to the pump the ground is very mushy, and the bank may be beginning to collapse (4" fall off along edge). Unable to determine if there are undermining cavities at the water line.

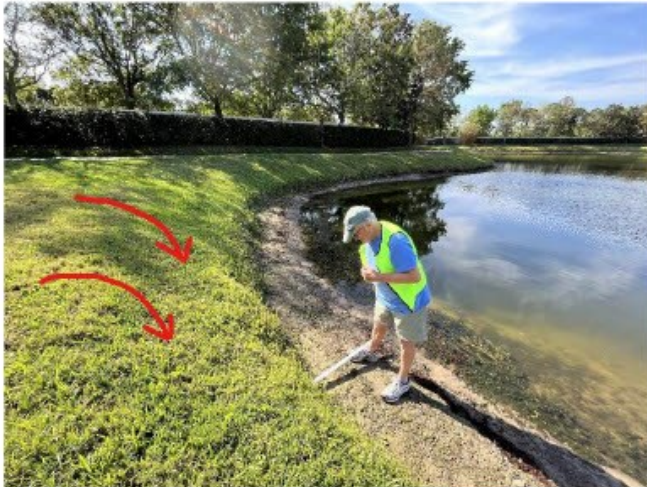
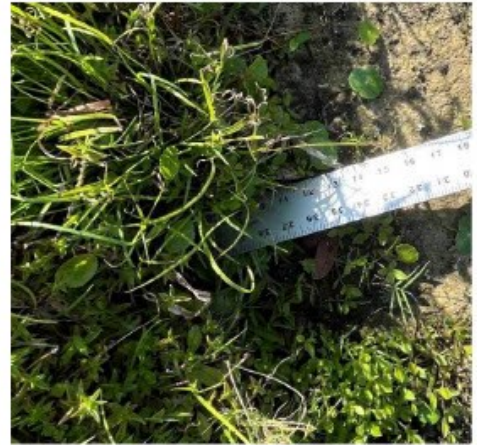
Just past the pump at the first bend by the sidewalk there is more evidence of bank collapse. The drop-off follows the same line as the indentation seen in the previous photo and there are a 10" & 12" cavities measured under the bank in several places.

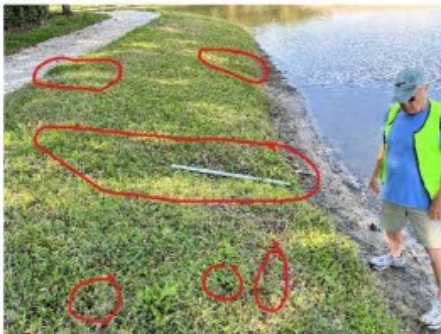
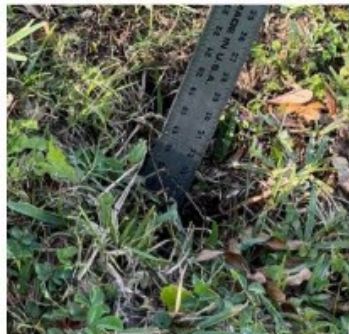
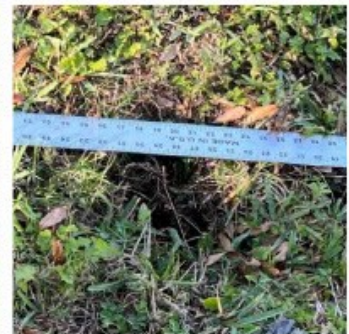
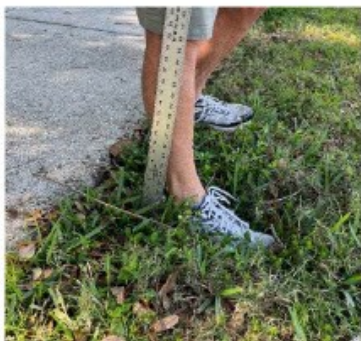
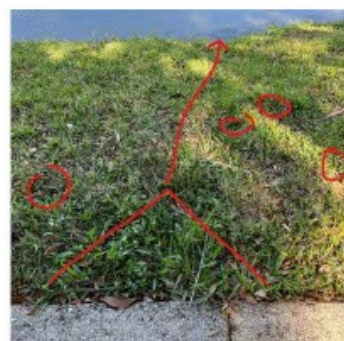
Along the first bend by the sidewalk there are 5"x15" holes, trenches, and erosion under the sidewalk. Multiple little holes along much of the bank look like animal burrows. These would make the soil very unstable and, with heavy irrigation and rain, likely contribute to topside erosion.

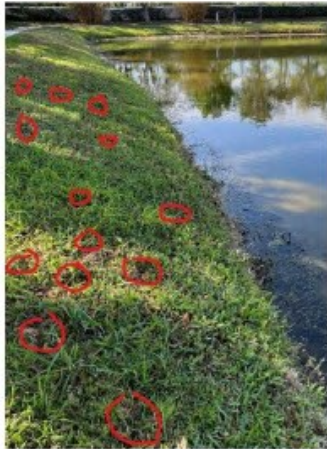
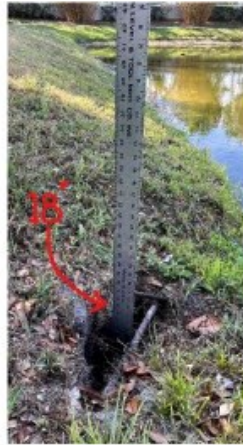
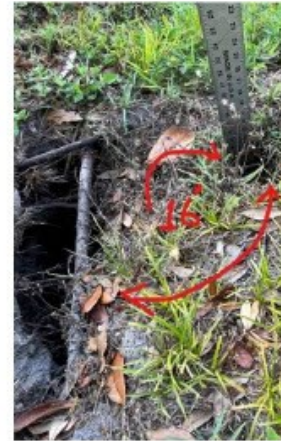
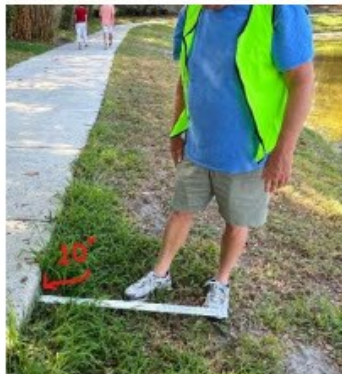
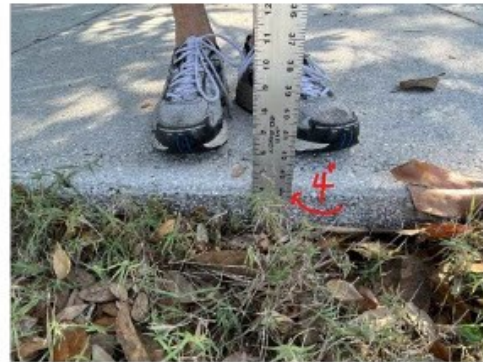
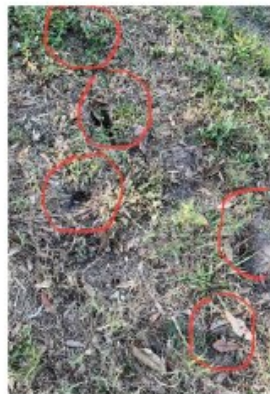
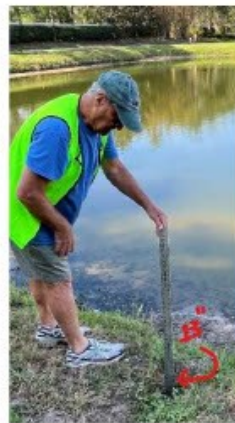
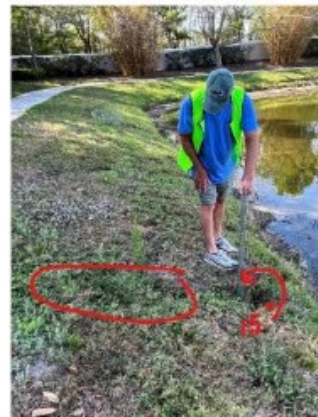
The animal burrows continue down the East wall after the bend all the way to the South wall. The entire eastern stretch is riddled with holes & burrows, and the waterline is collecting grasses, weeds, and algae. These are representative photos. There are too many holes to photograph all. The sidewalk is undermined/washed-out in several places as much as 6" d x 10" w due to runoff from the slope along the East fence making erosion cuts to the water. This can only be from rain and over-irrigation as the pond does not reach this high.

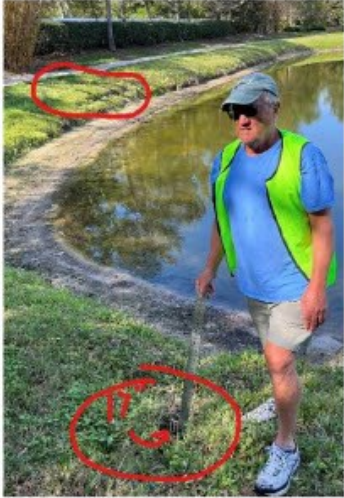
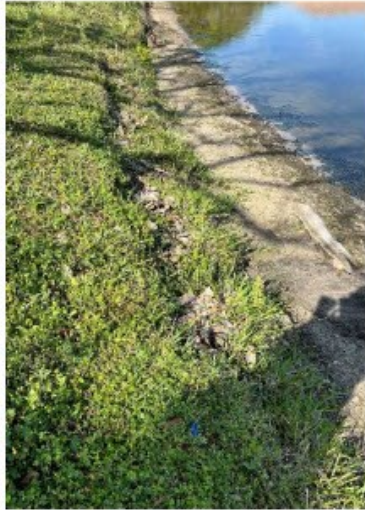
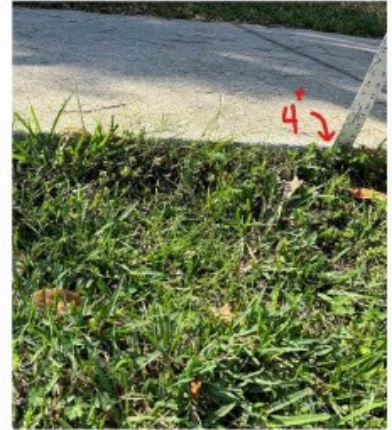
17" hole at lower Southeast corner. Rain or irrigation from the slop is undermining sidewalk down(right photo) to the bank. Bank below sidewalk has collapsed (upper circle and middle) .

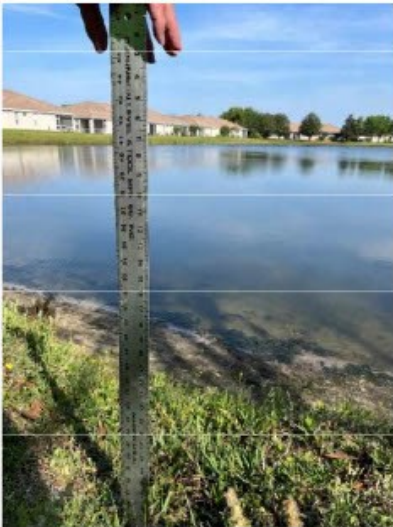
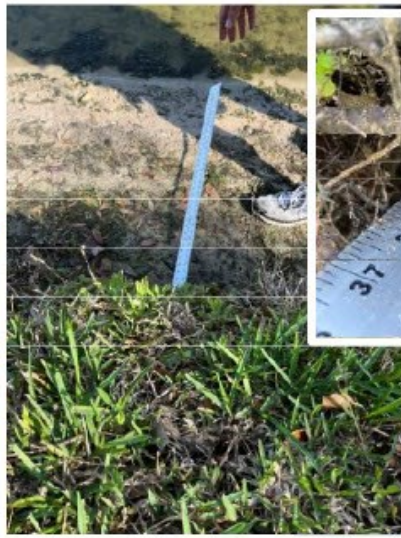
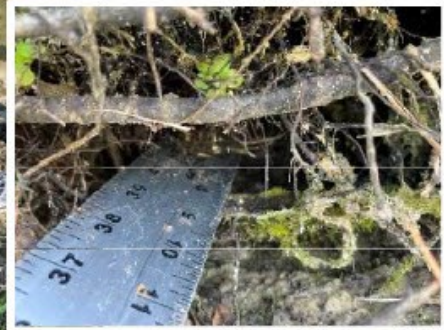
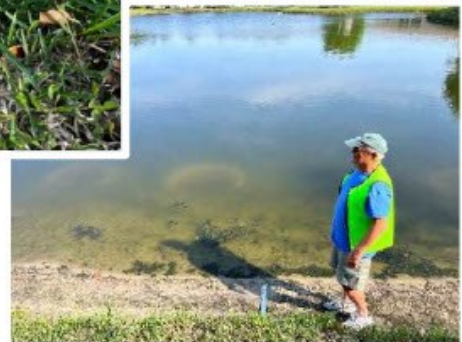
15" deep vertical hole (left) & 9" deep horizontal cavity (middle & right) along south bank below sidewalk washout

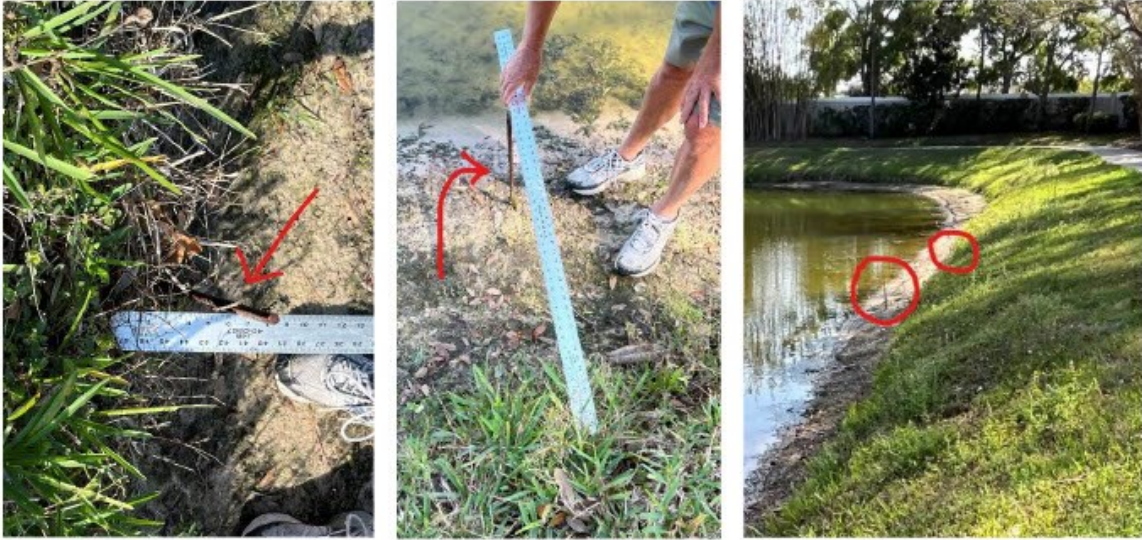
South side along sidewalk: 2 Rebar markers, originally placed at 24". One is 6" and one is 35" from bank.

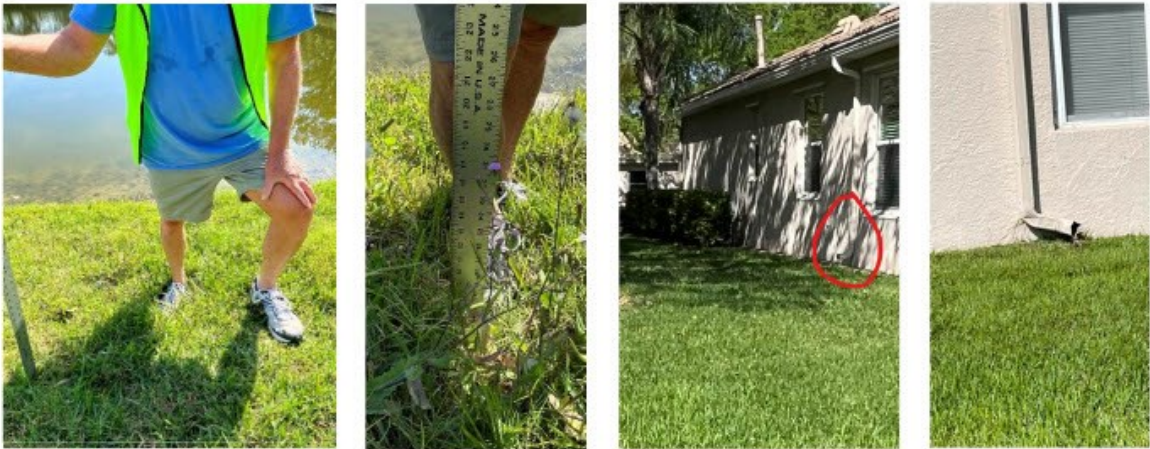
Southwest corner behind 4136/4138 Cascade. Bank collapsing and numerous 6 – 9" holes. Unburied side & rear drainpipes.

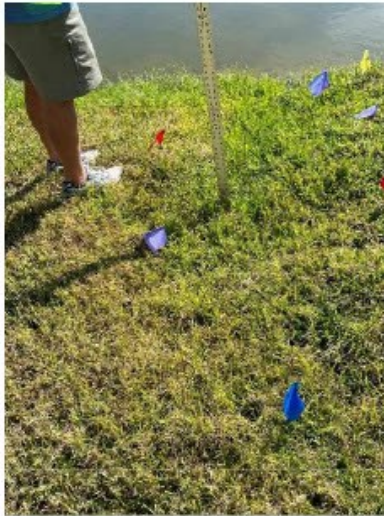
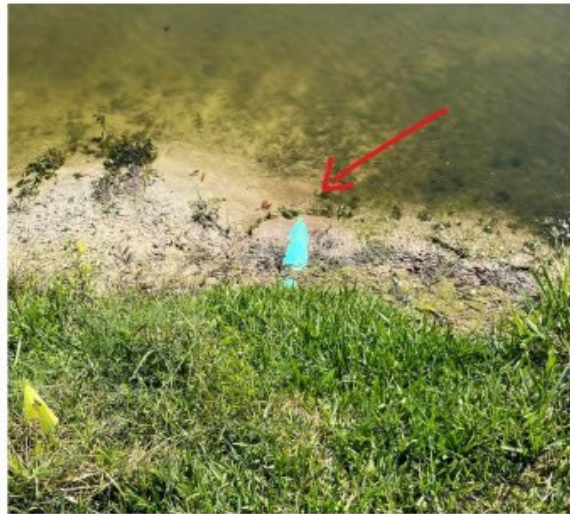
4148 Cascade. Buried drainpipes. Owner has marked off wide area that is soft, depressed & lumpy. Continued erosion after burying and backfilling has completely covered & blocked the drain pipe exit in the pond.

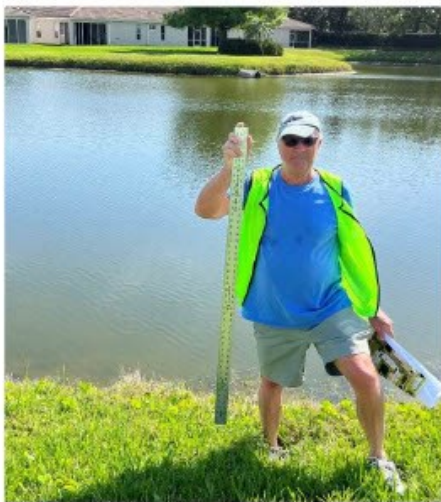
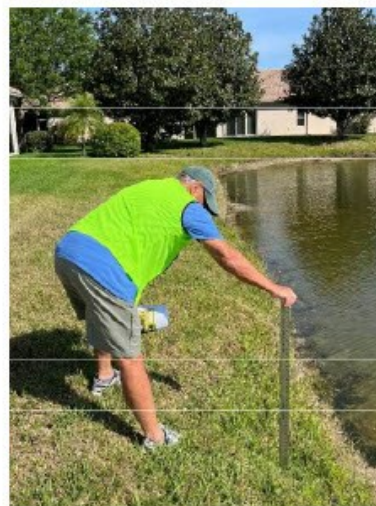
Bank drop-off/collapse behind 4152 & 4156. Evidence of erosion under the bank at the water line across the pond by the well.
