Pond Survey Summary

The LakeRidge Falls (LRF) Roads & Grounds (R&G) Committee Pond's Crew conducted a physical inspection and prepared an individual survey of 13 stormwater ponds in the community, during the early part of 2023. We did not survey Pond # 7 (by the back gate) as it is not connected to the other 15 ponds, is not maintained as a pond, and has been planted as a wetland. In addition, we did not have sufficient time to complete surveys of Ponds 2 and 16 before late spring rains limited our full access to these two ponds. The Ponds' Crew recommends conducting inspections and preparing surveys of these two ponds during the next dry season in 2024. The 13 individual surveys, for the most part, reflect our observations and are, therefore, the "facts" we found. These individual surveys stand on their own as direct observations, supported by photos and measurements. The recommendations we make, therein, are those that are obvious, such as burying, or redirecting pipes, and adding catch basins.

Pond Crew 2023

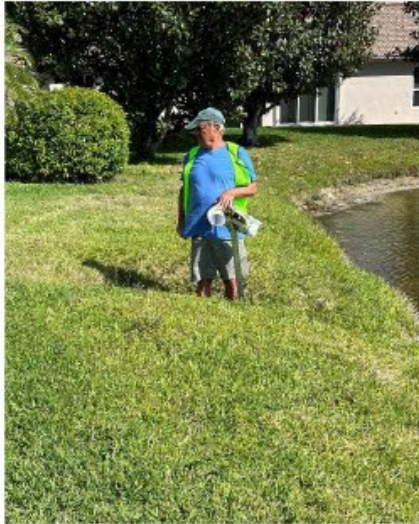
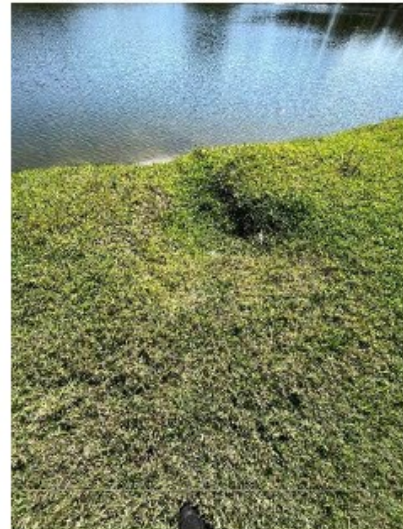
18" deep washout behind 4160 Cascade. Drainpipe not buried.

1. Encourage all owners noted to bury or redirect the downspouts away from the pond. Consider catch basins similar to those installed in Pond 8. Buried downspout pipes should be joined by other close pipes to cut down on the number of pipes entering the pond.

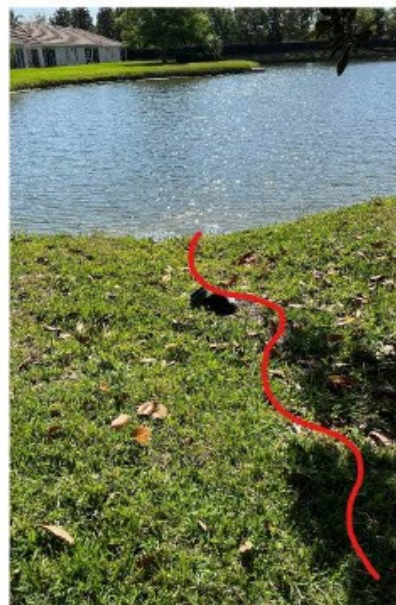
Northwest corner, Cascade & Cascade, a large swale between the buildings has been repaired several times. Apparently unsuccessfully as significant erosion persists. While drainpipes may contribute to the swale, it's clear that over-irrigation/rain must play a part. Perhaps a catch basin or terracing might reduce the impact of flow from drainpipes and road.

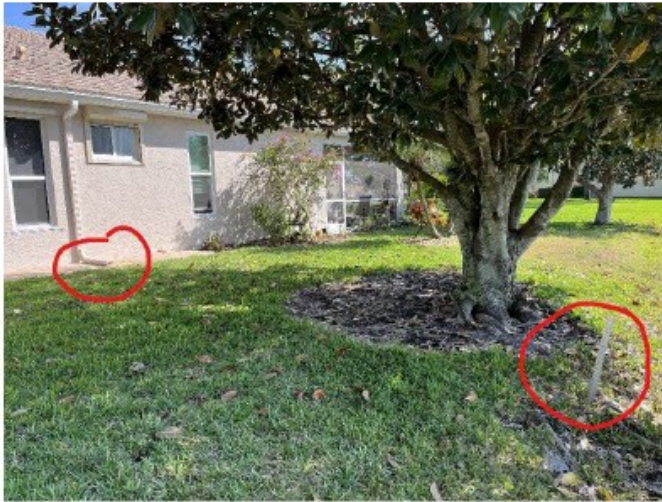
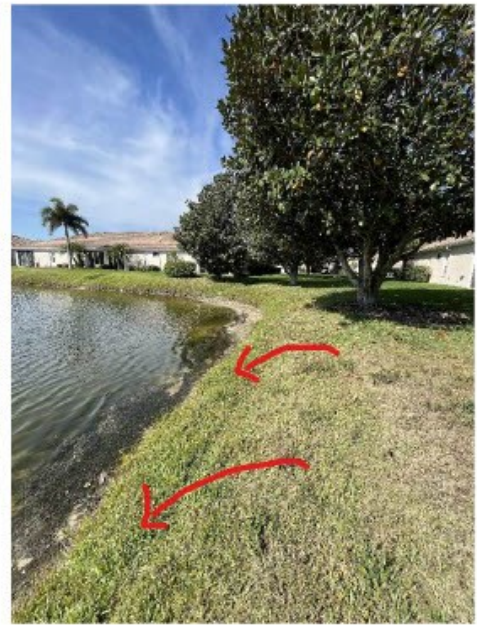
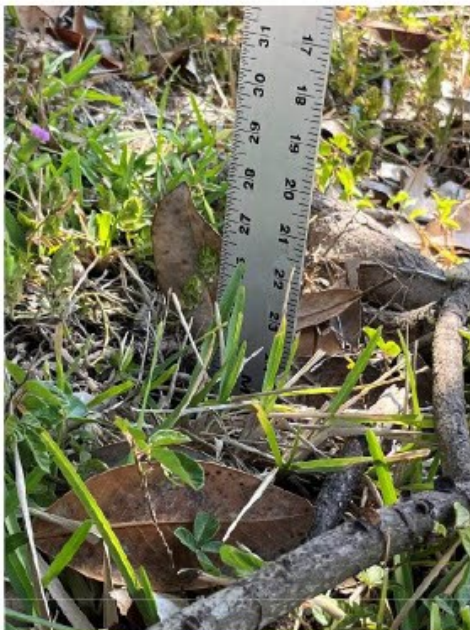
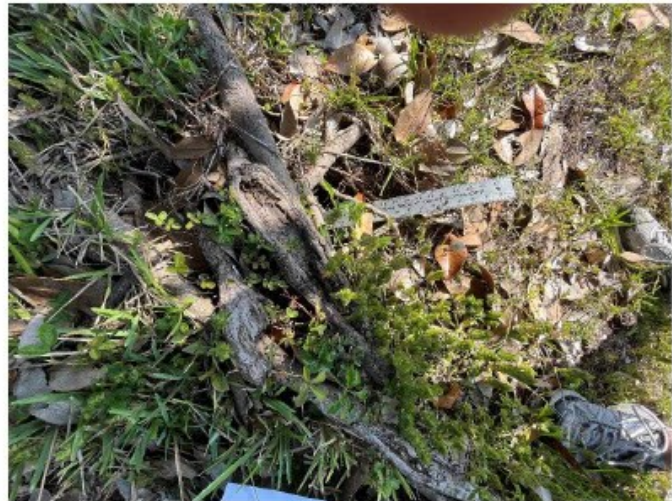
North side behind 4206 Cascade. Drainpipe not buried. A large Magnolia tree has significant washout under and around the roots. 25" deep hole vertically and a 35" cavity horizontally beneath the roots! An arborist should check the stability and safety of this tree. The bank is collapsing along North side.

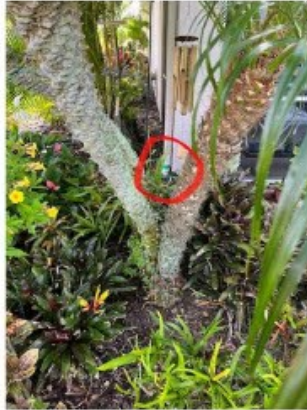
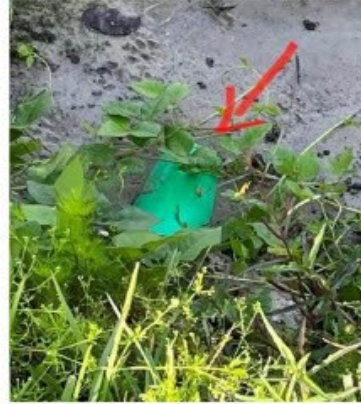
Downspout is buried but continued erosion after burying, has covered, and completely blocked the pond exit.

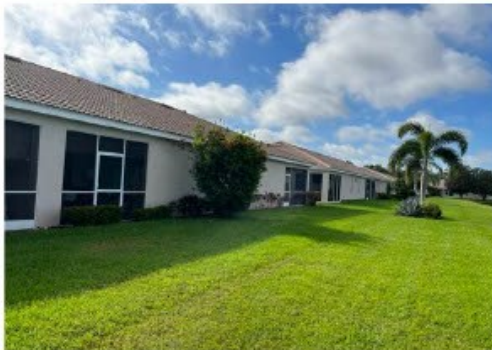
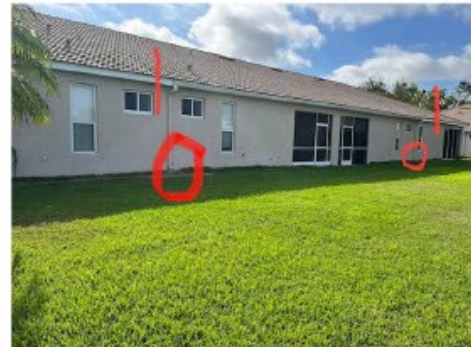
No gutters on units 4169 – 4147 Cascade. Unburied downspouts on 4145 & 4143. No significant signs of erosion except between units (below). The ground is also fairly level and a distance from the pond which may allow the water to be percolate into the ground before it reaches the bank with or without downspouts.

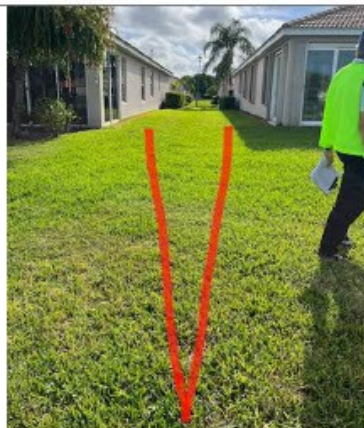
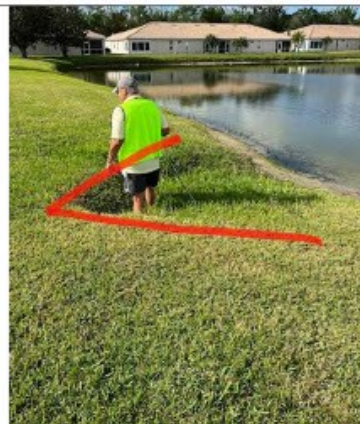
20" deep x 4 – 5 ft wide coming from between units 4155/4151. No gutters or downspouts, however the double amount of rain coming from two rooftops to a common area coupled with irrigation may be what caused the swale.

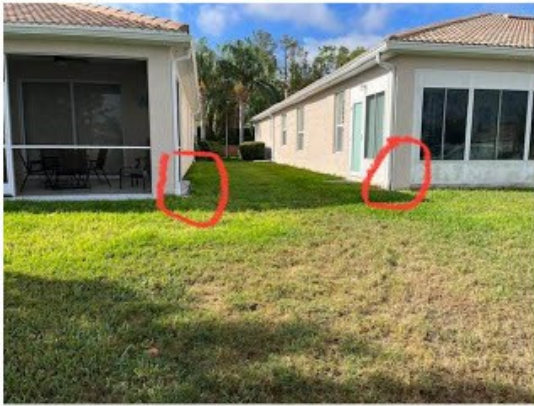
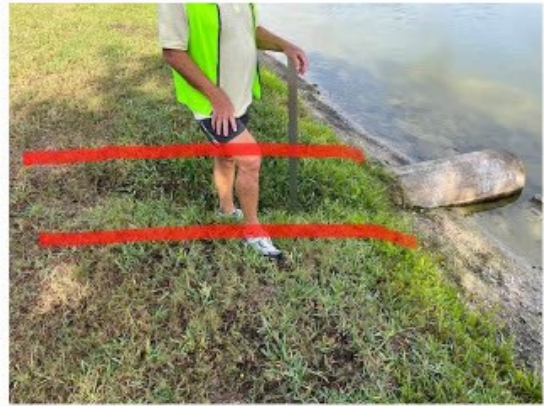
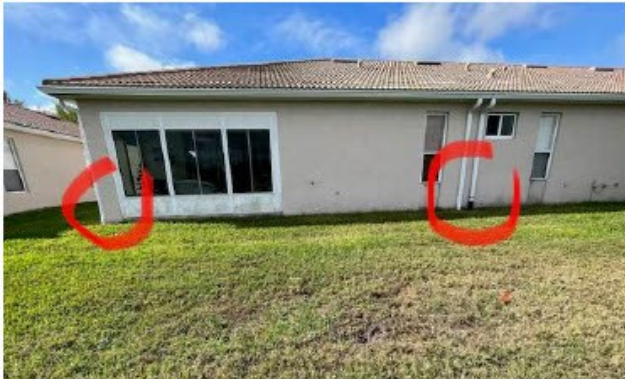
4127/4123 Both have 2 drainpipes buried. There is an 8" swale to the right of the concrete drain pipe coming between the units. The ground next to the swale (upper right) and above the exit pipes(bottom left) is chopped up and collapsing. Improperly packing of buried drainpipes often result in loosened soil in the trough and continued erosion. 4123's pipe is capped with a grate supported by a concrete block.

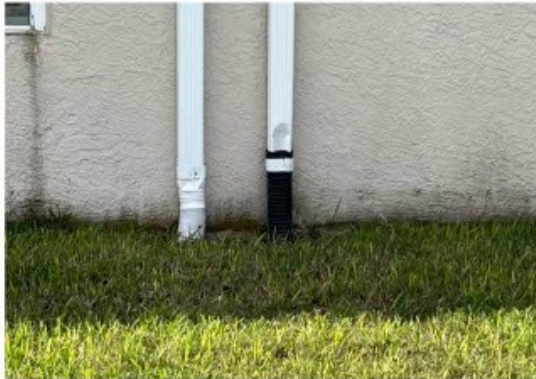
4121 (above) drainpipes are buried but the exit is partially blocked by silt from bank. 4119 (below) has an unburied drainpipe and a 10" deep by 5' wide swale. If not done well, buried pipes can cause almost as much damage as unburied.

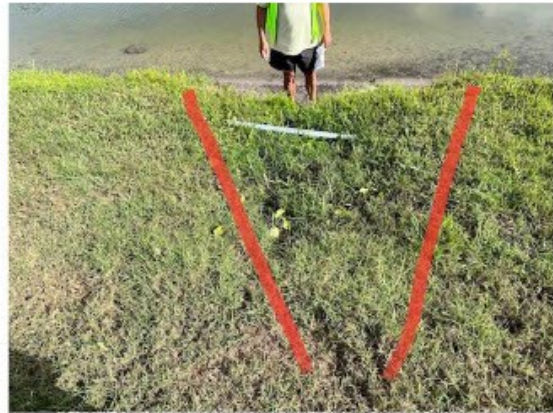
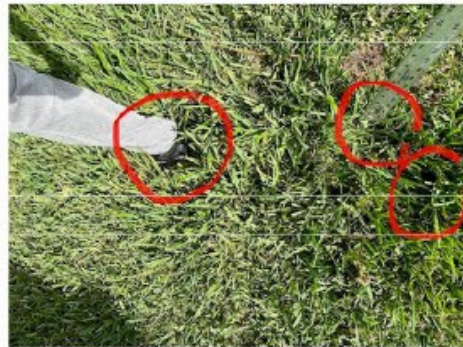
4115/4111 (above) No gutters but again double the water from the two roofs plus irrigation is likely what caused the swale between units and cut in pond bank. 4053 (below) No gutters/no cuts. Again, flat yard may allow water to percolate before it gets to the bank. However, there are numerous holes in the yard between unit and bank.

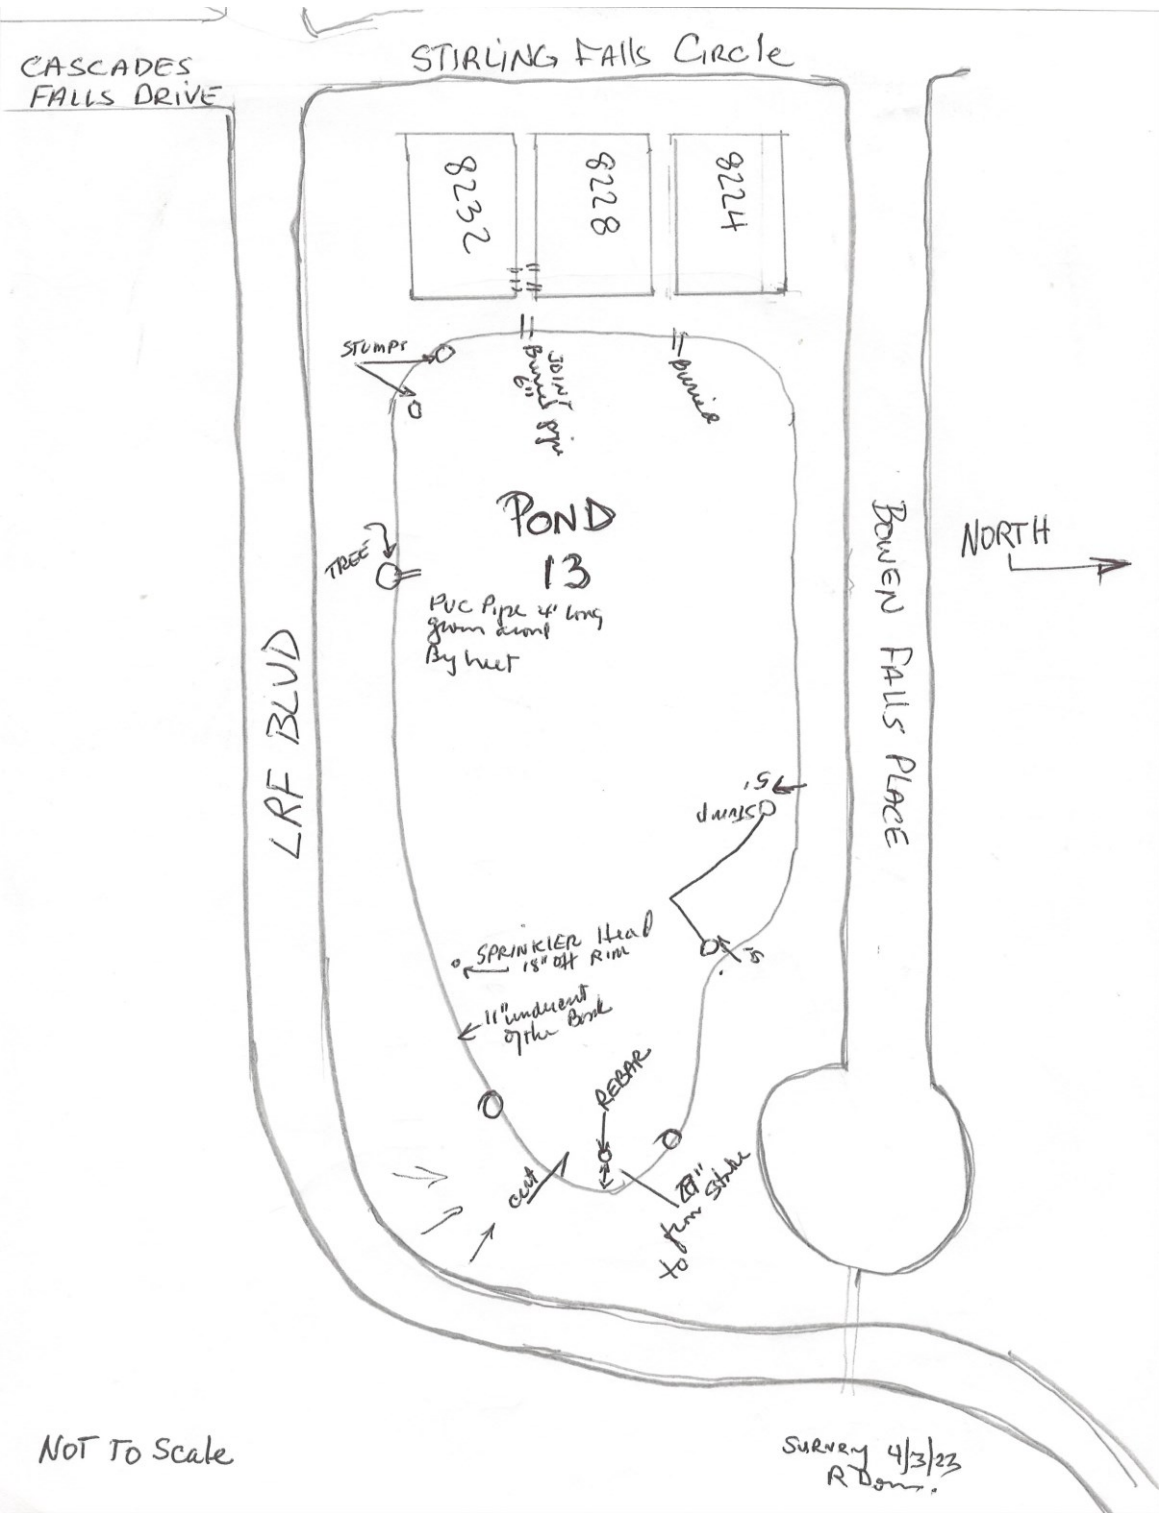
There are three single-family homes on the west side of the pond. The three homes were the original models for the developer. #8232 and #8228 Stirling each have two downspouts each connected to a single 6-inch corrugated pipe, that is buried, leading into the pond. #8224 has a similar pipe leading into the pond as well. The owner of #8232 stated that he has resided there for 15 years and the pipes were existing as is before he took possession. There is a good chance the developer installed and buried what we found today. The pond wall on this west side has collapsed the same as the other sides, but there is a 22" cavity under the bank between 8228/#8232 (photo) probably why the bank collapsed. However, there are no cuts or

gullies from roof or yard runoff. We found a 17” cavity in the SW corner. The SE corner of the pond, just south of the previously mentioned rebar is affected by runoff from the Blvd roadway (irrigation?) and evidences a small cut at the adjacent pond edge.

SEVERITY RATING: Average

TO DO: Look into the irrigation issues.

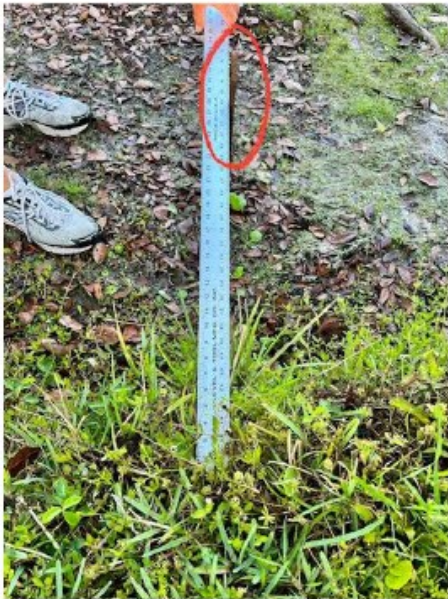
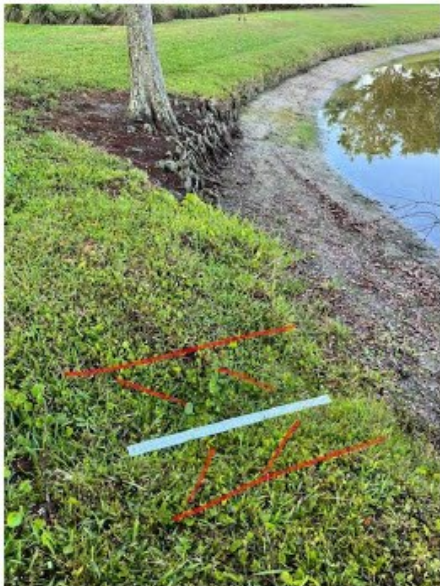
Top left: East side where rebar was placed 24" from bank edge several years ago. Currently at 20" apparently due to bank collapse. Top right: Erosion areas SE corner both from the top (irrigation) as well as from pond action. Bottom: close-up photos of above areas. The swale in the lower left corner due exclusively to top erosion by rain or irrigation as the pond level does not reach this high.

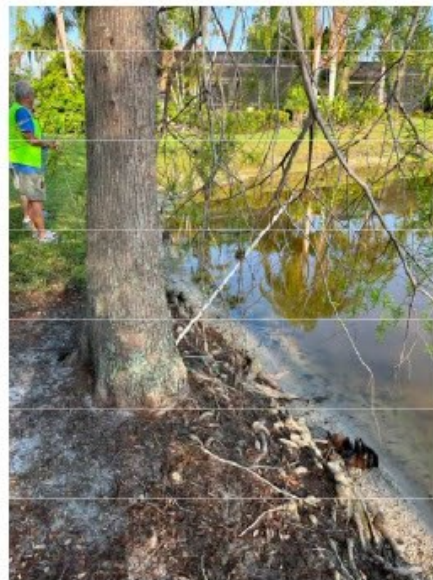
Approximately a 13" cavity under bank extends along most of the south side of the pond. Top right photo: 11" cavity under the bank and a corroded sprinkler head sitting 11" into the pond. Bottom photos: Washed out soil around Cypress roots from run off from sprinklers. White PVC pipe embedded in cypress tree.

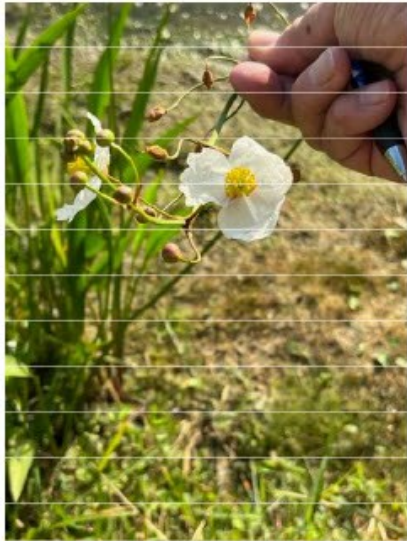
One of a few aquatic plants (Arrowhead/Duck Potato) left over from a planting several years ago that was subsequently removed. 8232/8228 Sterling combined to bury a single drainpipe. Note the exposed terminal end exposed above the water (?) Also note the scum and bubbles along the bank. The bubbles are usually caused by stagnant water, hot weather, and an excess of dissolved or decaying organic matter (fish waste, grass, leaves, etc).

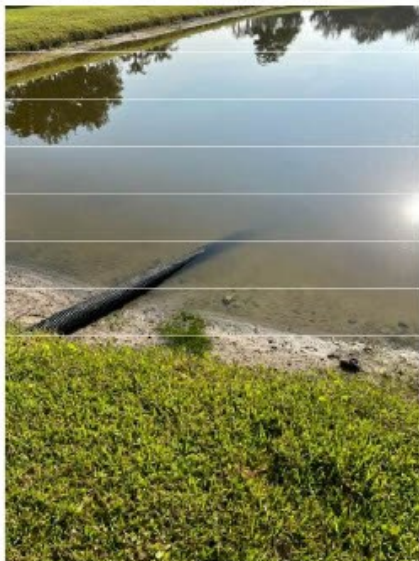
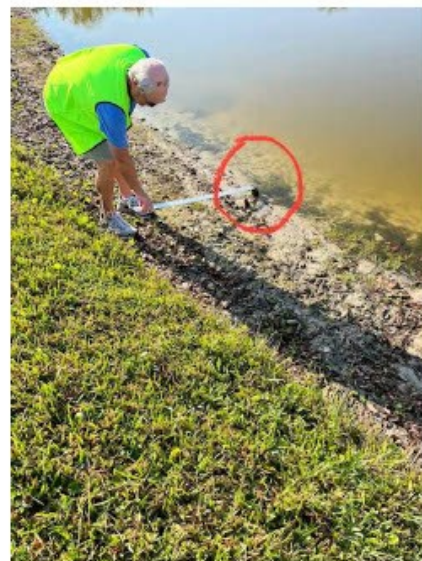
8228/8224 Buried drainpipe also appears to be shared.

Tree stump 5ft from bank across from 4019 Bowen.

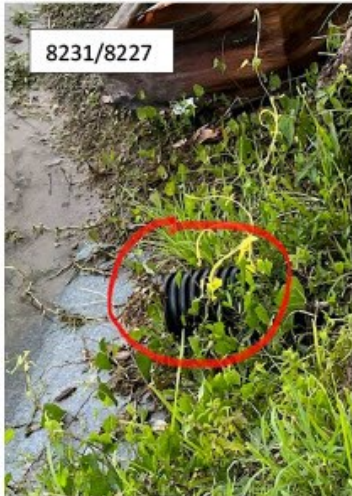
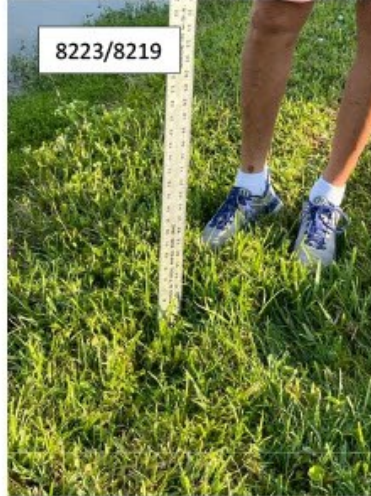
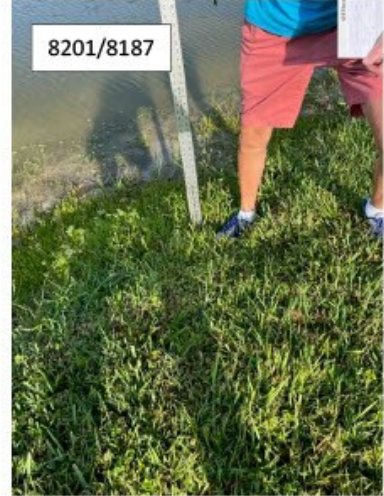
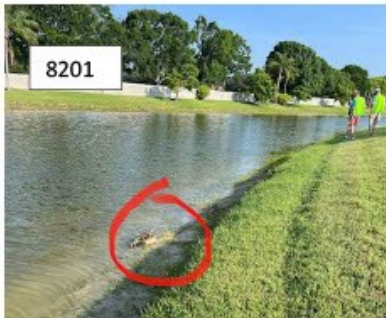
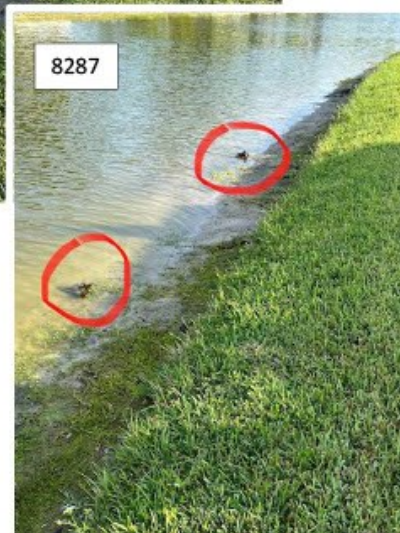
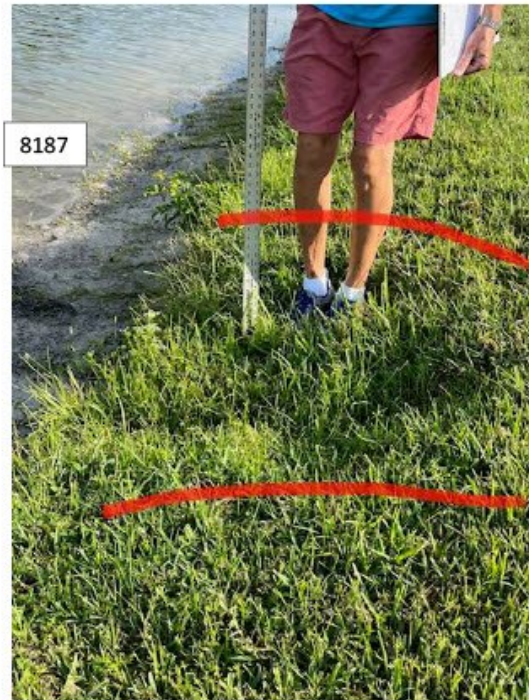
Buried pipe shared between 8231 & 8227 Stirling Falls Circle. Swale between 8223/8219. 8201/8187 also has a collapsed bank. Drainpipes not buried. Stumps in the water behind 8201 & 8287.

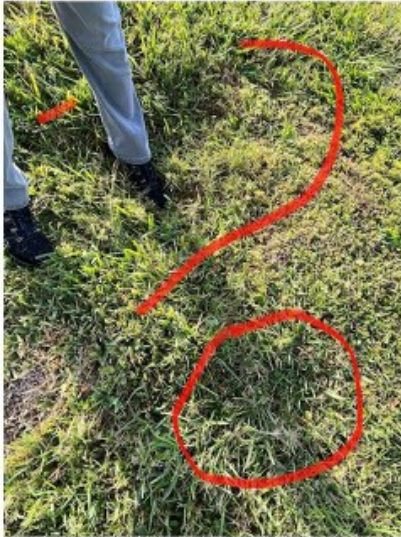
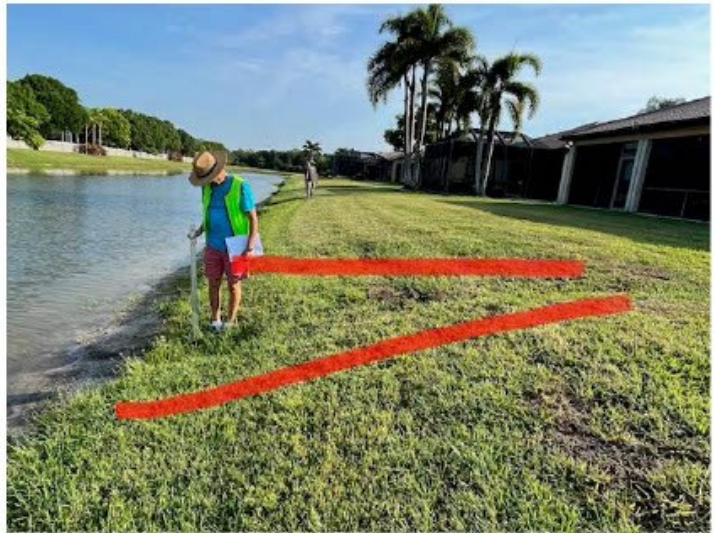
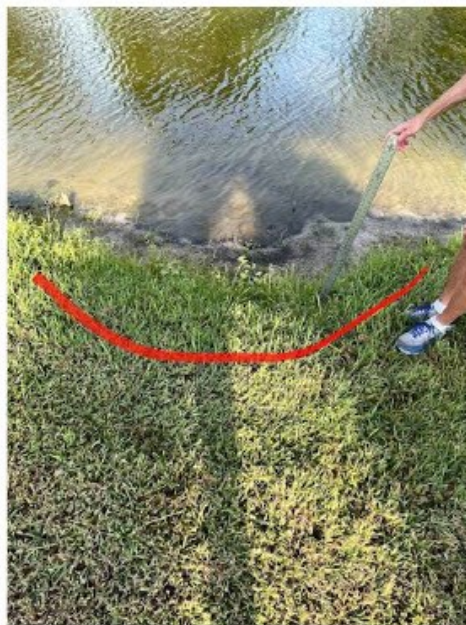
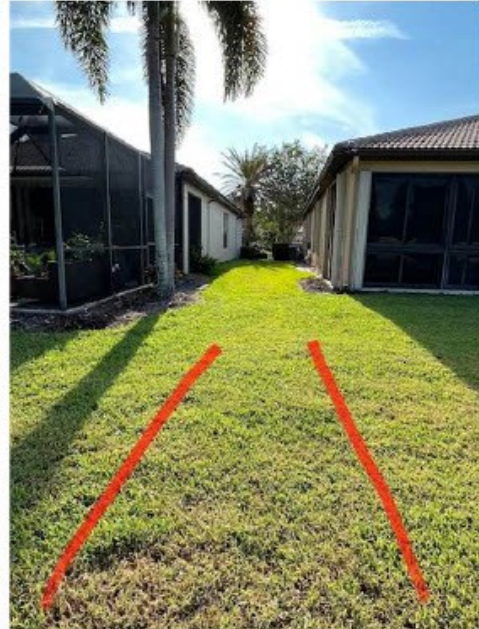
8179/8171 Stirling. The lawn area also looks as if it's been dug up and there are numerous ankle-deep holes (L). 8 to 15ft swale between the homes (R). Cut in the bank between 8175/8171 and swale between the houses (bottom).

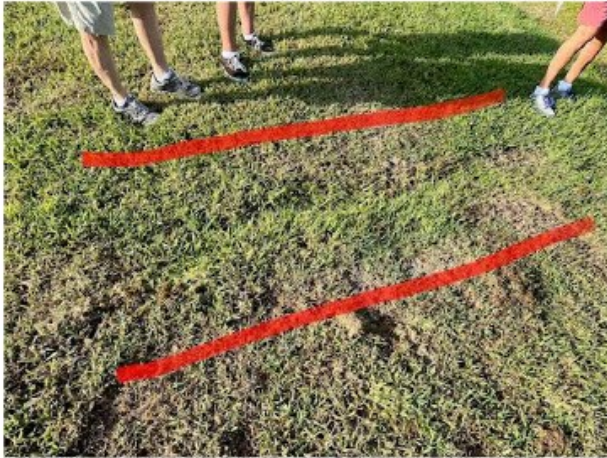
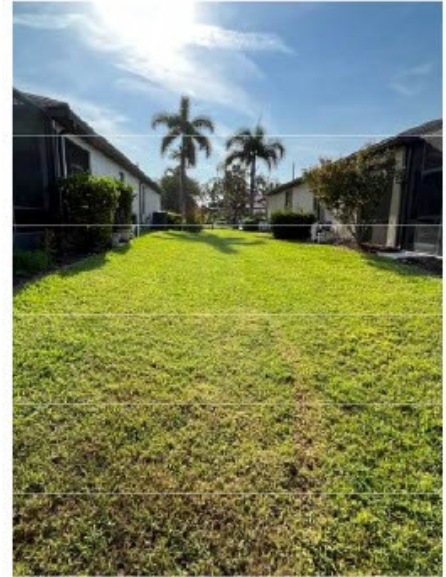
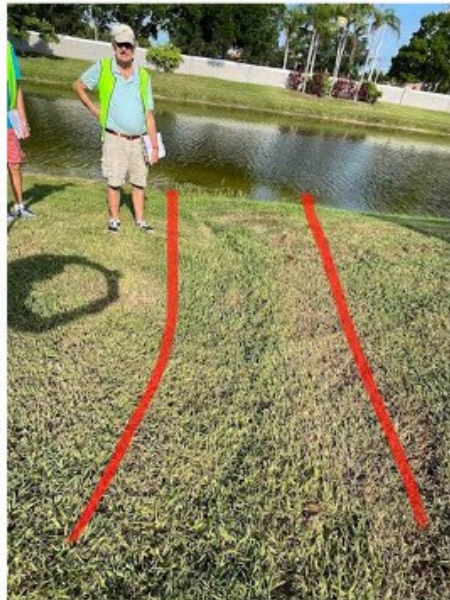
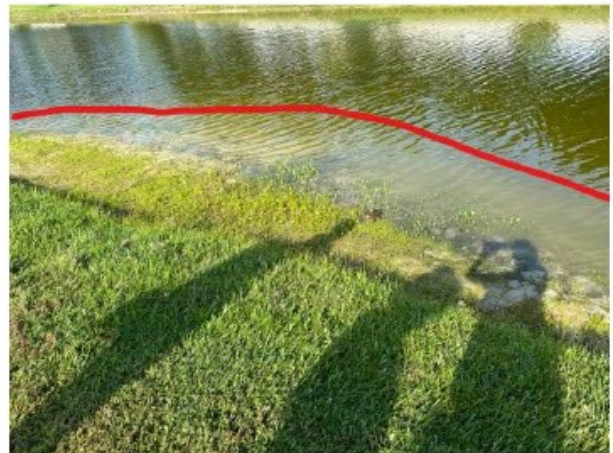
Swale between 8163/8159 Stirling. The sand from when the pool was dug was deposited in the pond (bottom R).

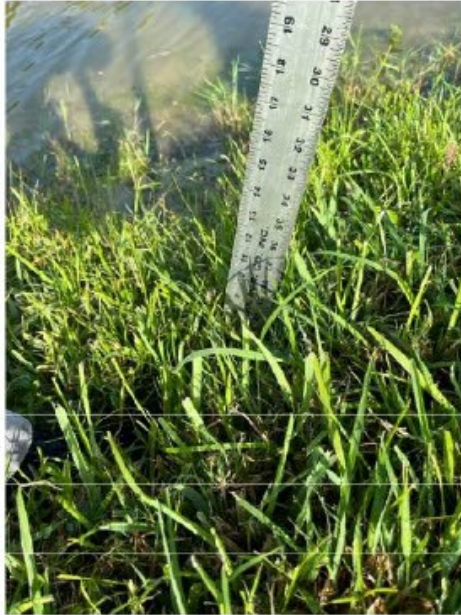
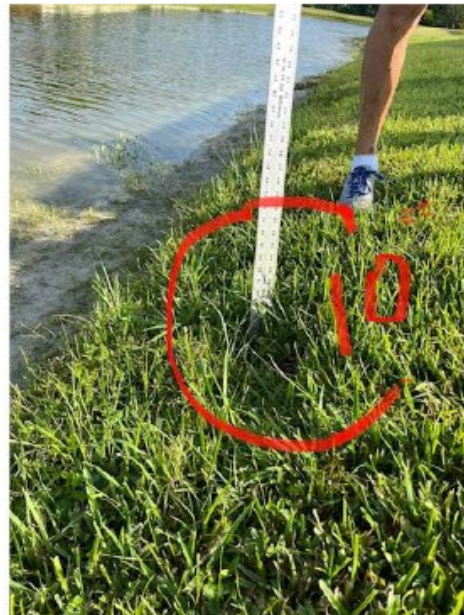
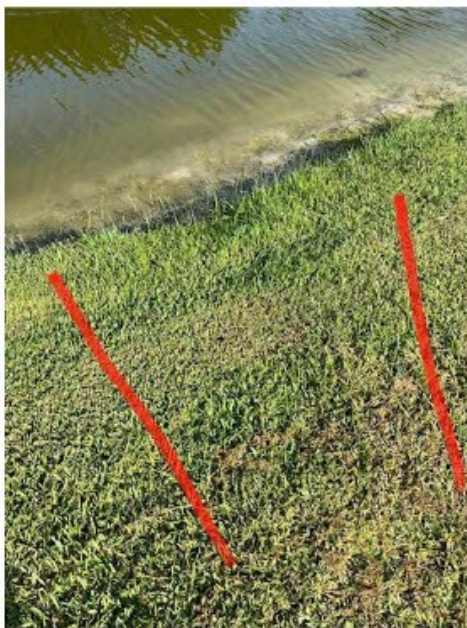
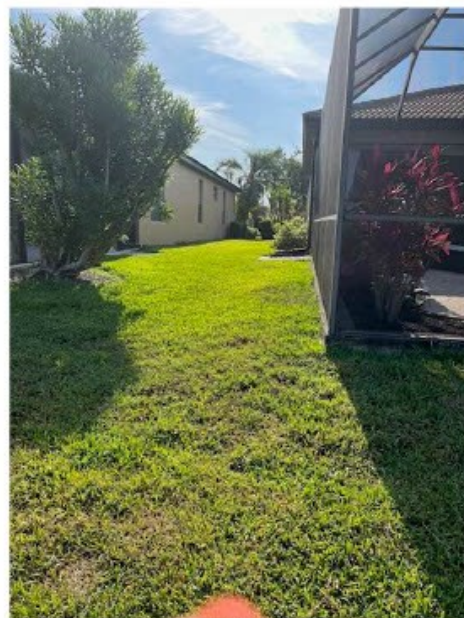
10" hole/cut in bank and swale between 8155/8151 Stirling (top). Drainpipes not buried. Similar issue between 8151/8147.

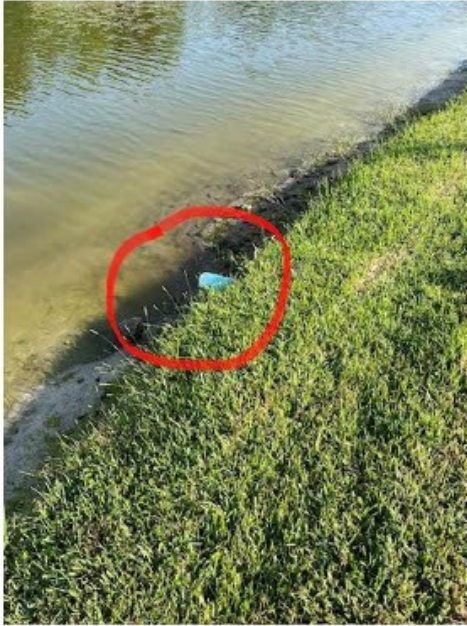
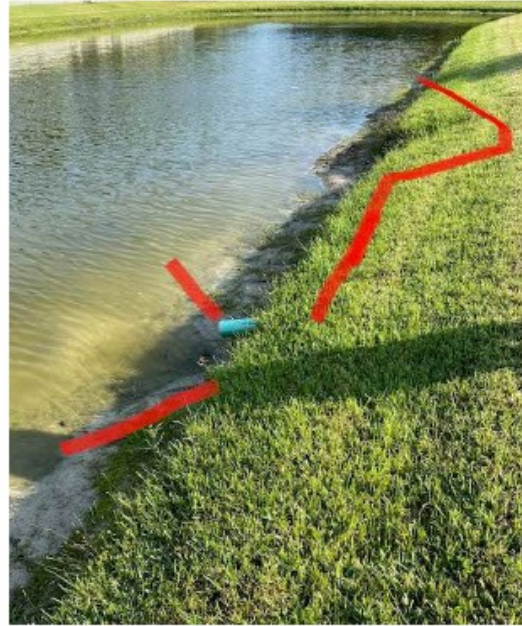
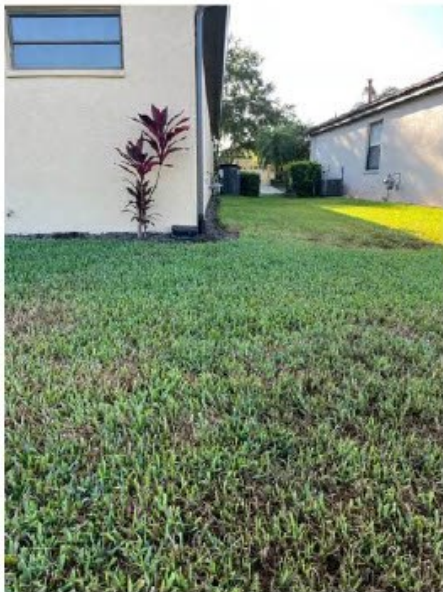
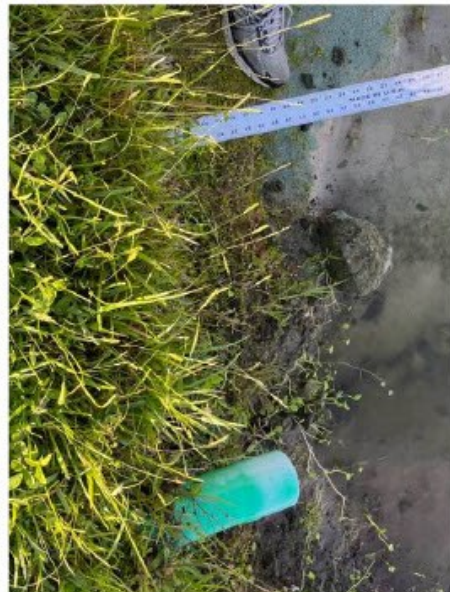
Drainpipe buried at 8143 Stirling. Force of water from direction of buried pipe is causing a trough in the pond bottom. A cut in the bank is visible at the next property. 9" cavity next to buried drainpipe at 8139 (bottom).

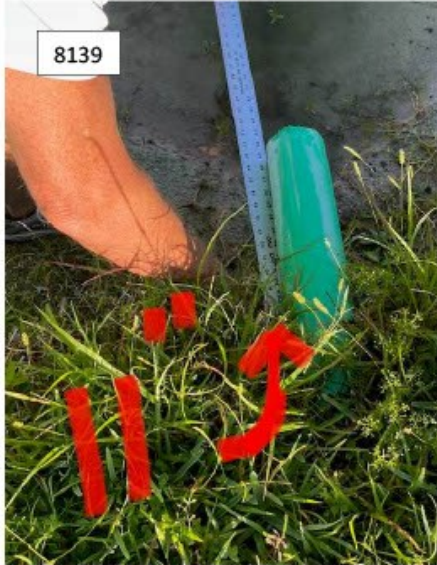
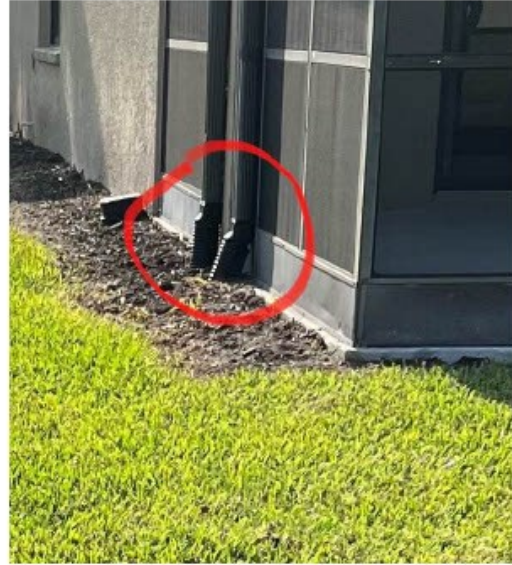
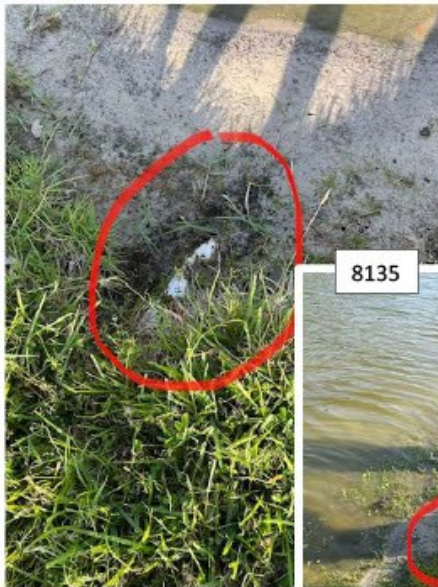
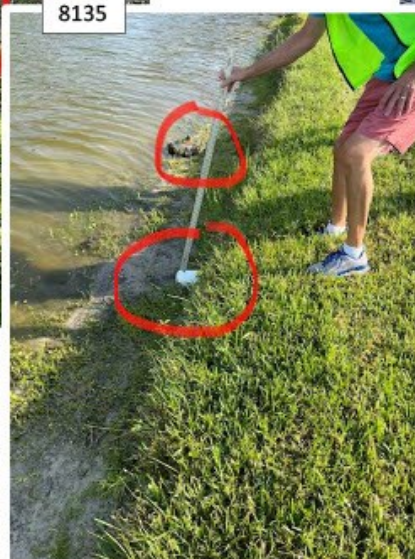
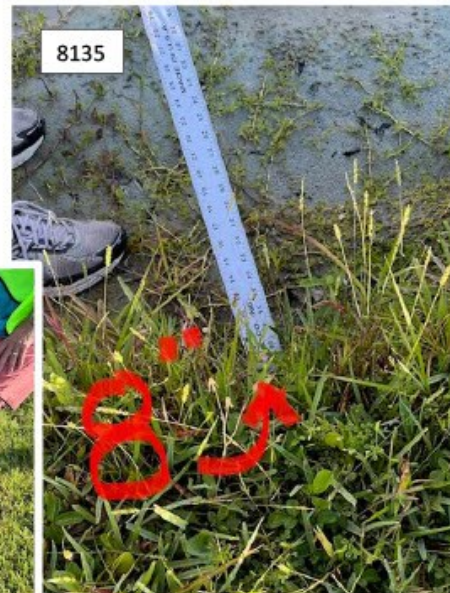
11" cavity under bank next to buried drainpipe at 8139 Stirling. Two drainpipes buried at 8135. One is almost covered by silt and completely blocked by further erosion after burying. 8" cavity under bank at 8135

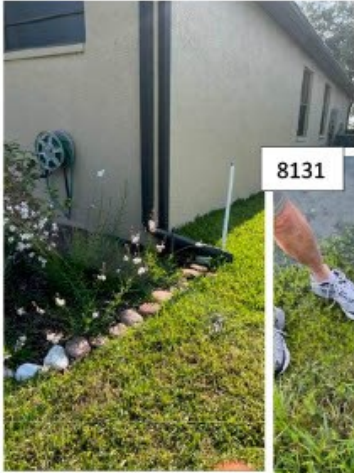
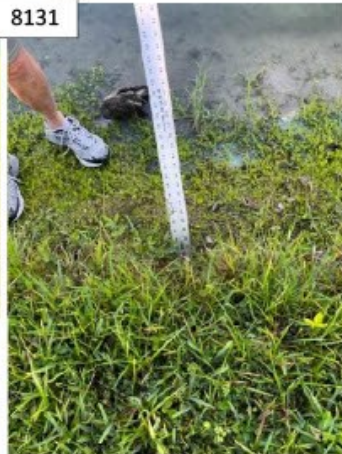
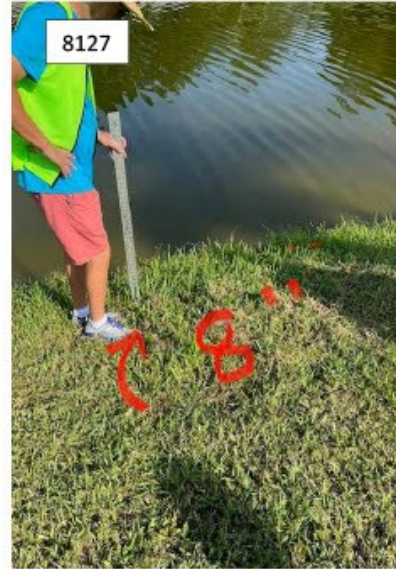
Upper photos: 8131 Stirling. Drainpipe not buried. 10" undercut at bank. 8" bank collapse at 8127.
Lower photos: 6" undercut at north east corner (L). Approximately a foot of thick grass/weeds on the littoral shelf along northern edge of pond (R). No bank undercutting noted but the water was too high to confirm.

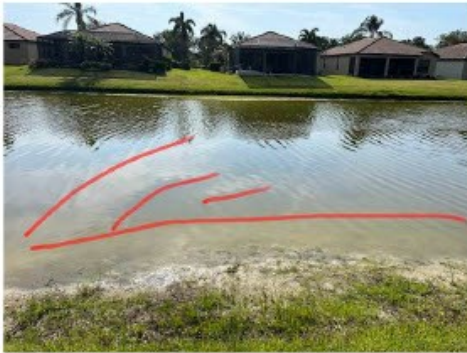
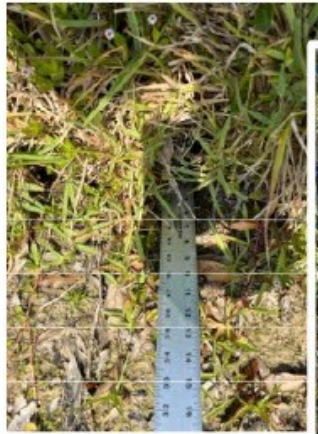
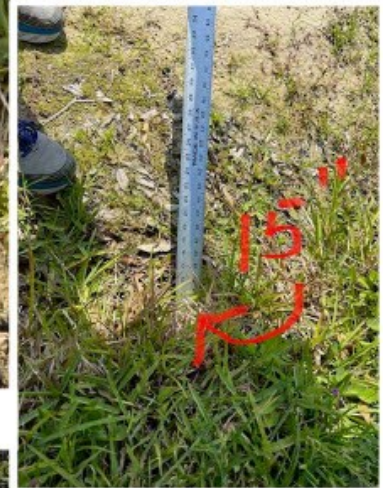
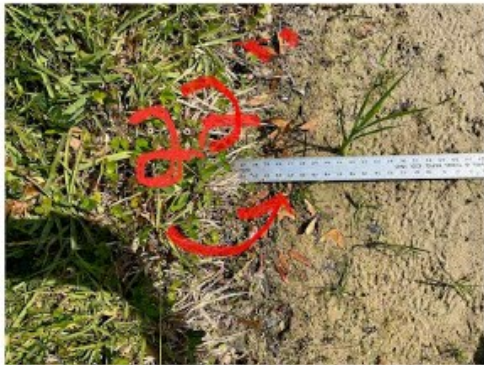
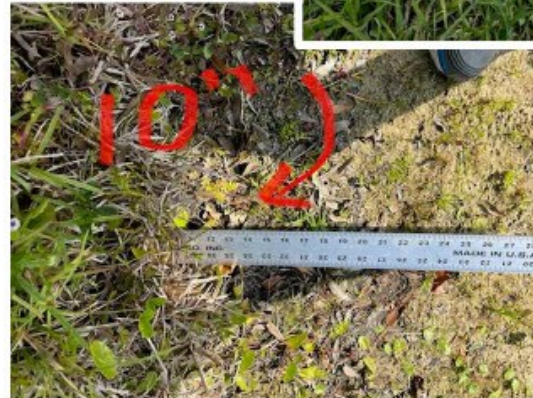
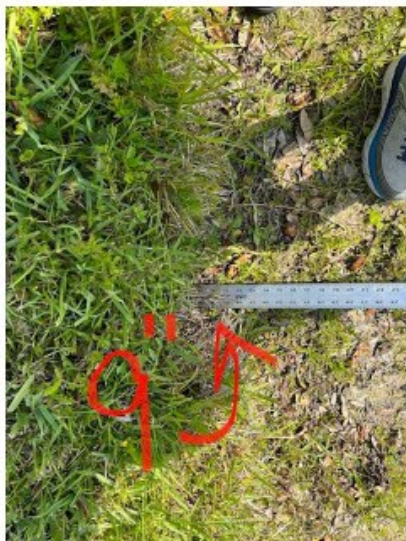
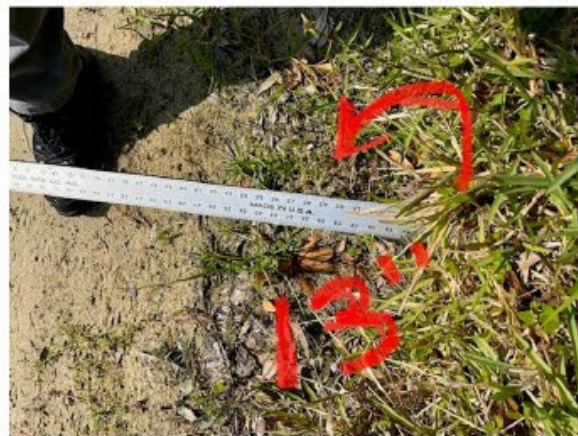
Upper left: Midway down west side there is silt build up into the pond. Cause unknown. Beginning on the west side across from 8215 Stirling where the water level was low enough to permit examination of the bank from the littoral shelf, there was an almost continuous 8" to 22" deep cavity under the bank extending all the way to the south side. (Some holes may have been cause by animals)

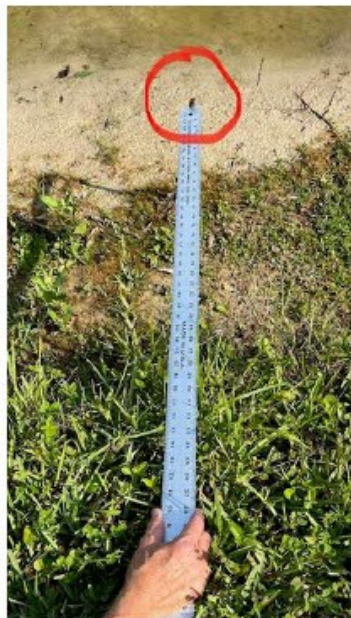
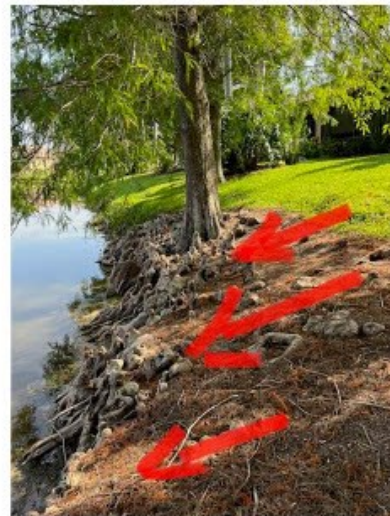
On the south side, bank collapse is caused from top side erosion by rain or irrigation since water level of the pond does not reach high enough to have caused erosion and exposure of the Cyprus knees and bank collapse. Lower left picture shows the position of the rebar which was placed at 12" and is now approximately 30" from the bank. The southwest side (top left) could be graded for plants, but the southeast side (top right) requires something more aggressive.

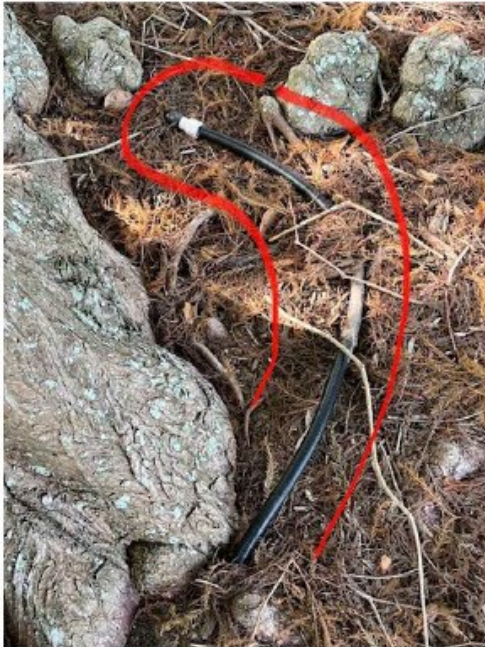
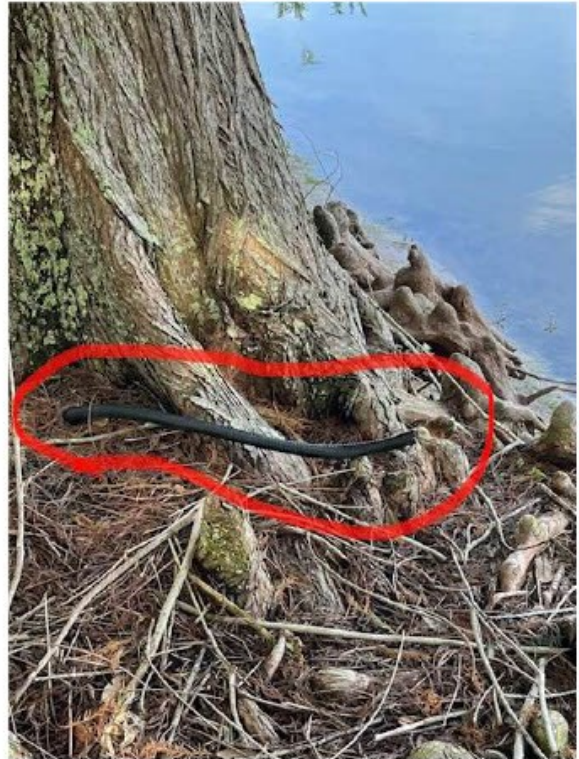
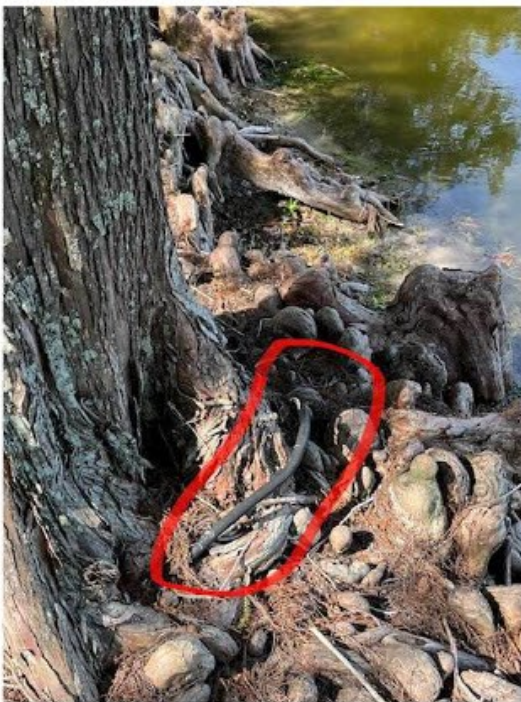
South side cont. More topside erosion from rain or over-irrigation. Sprinklers at the base of the mature trees. Should be disconnected if they haven't been already. Mature trees do not need a dedicated sprinkler head and it could contribute to erosion around the roots.

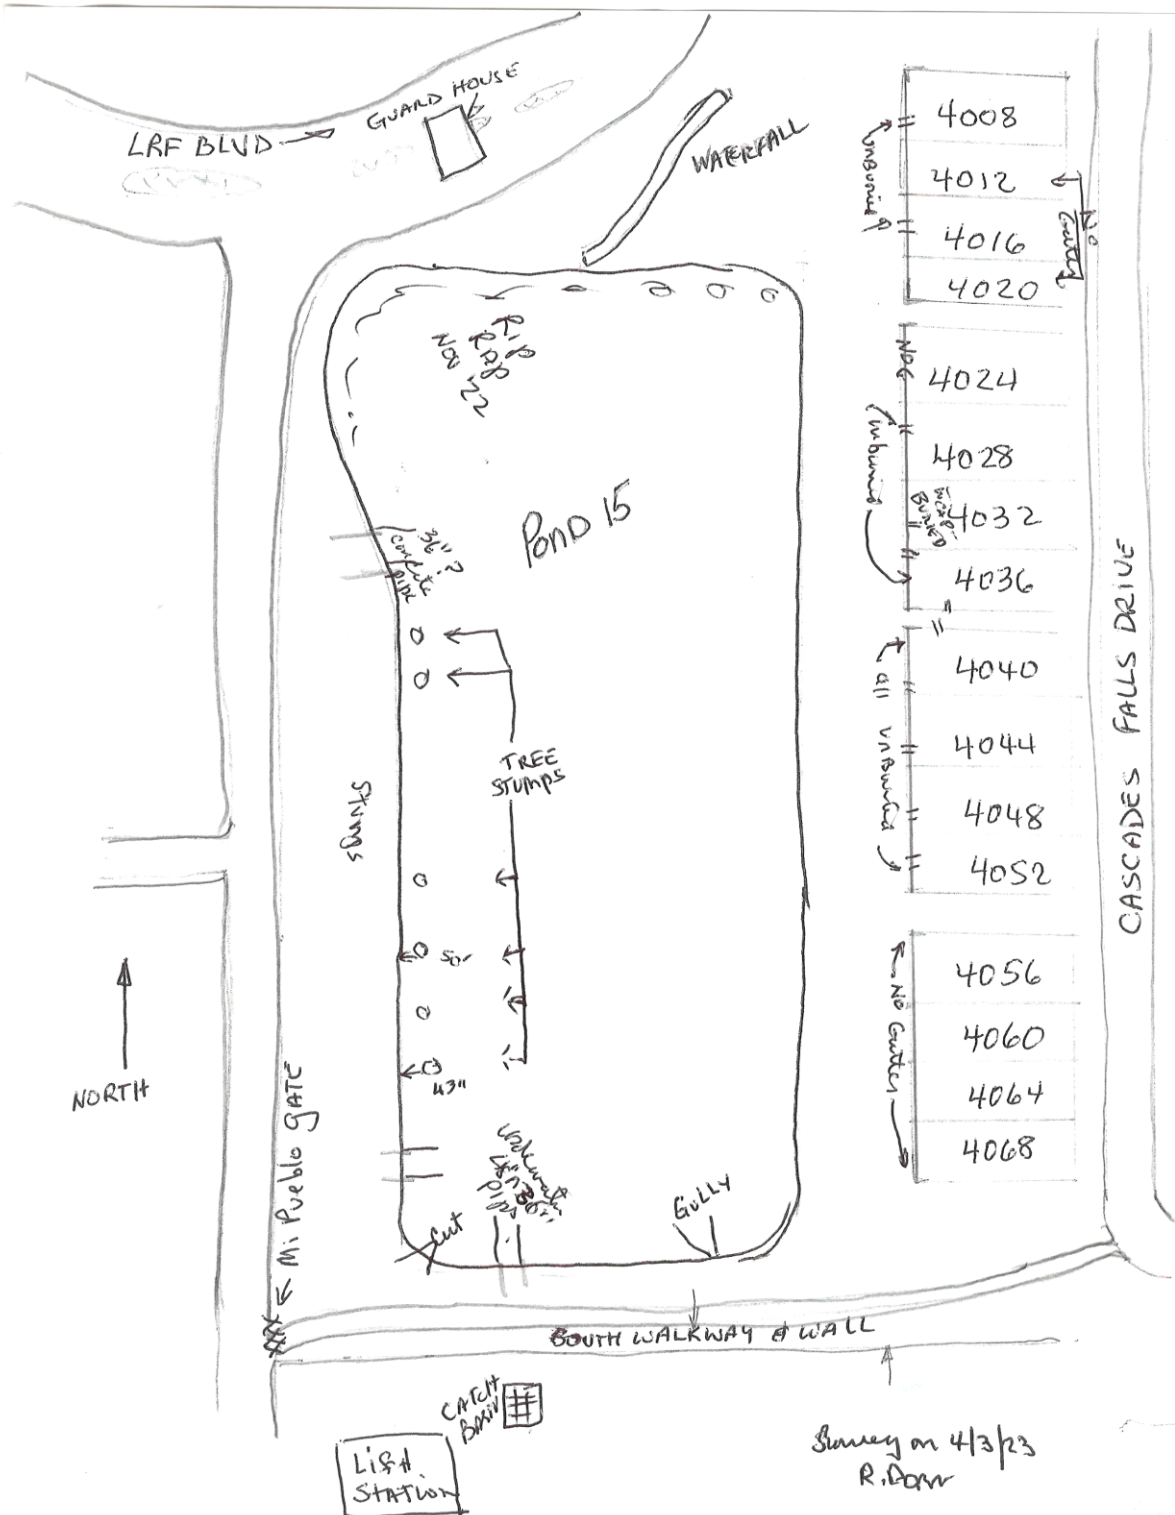
The west side of the pond backs up to and follows the outer community wall. At the current low water level, it was noted that a line of tree trunks line the pond bottom about 40 to 50 inches from the inside of the pond rim. Again, see the hand-drawn map attached.

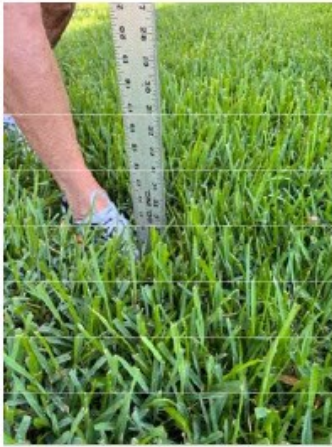
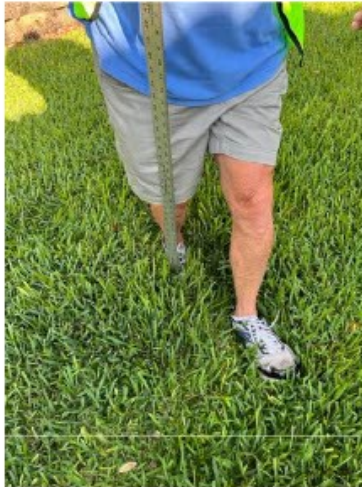
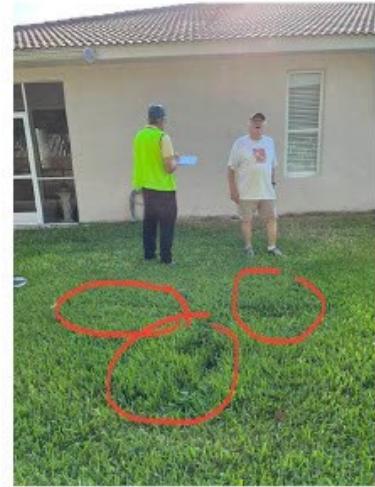
Multiple holes/depressions behind 4008/4012 Cascade 3 units away from the pond. No downspout on 4008/ no gutter on 4012.
