Pond Survey Summary

The LakeRidge Falls (LRF) Roads & Grounds (R&G) Committee Pond's Crew conducted a physical inspection and prepared an individual survey of 13 stormwater ponds in the community, during the early part of 2023. We did not survey Pond # 7 (by the back gate) as it is not connected to the other 15 ponds, is not maintained as a pond, and has been planted as a wetland. In addition, we did not have sufficient time to complete surveys of Ponds 2 and 16 before late spring rains limited our full access to these two ponds. The Ponds' Crew recommends conducting inspections and preparing surveys of these two ponds during the next dry season in 2024. The 13 individual surveys, for the most part, reflect our observations and are, therefore, the "facts" we found. These individual surveys stand on their own as direct observations, supported by photos and measurements. The recommendations we make, therein, are those that are obvious, such as burying, or redirecting pipes, and adding catch basins.

Pond Crew 2023

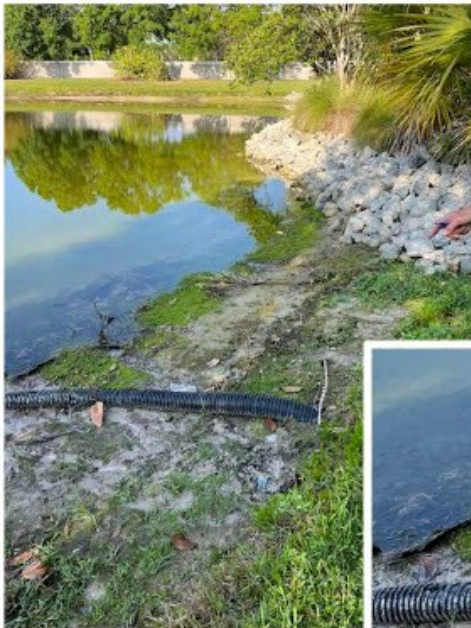
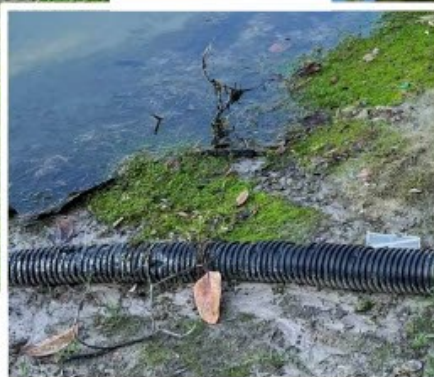
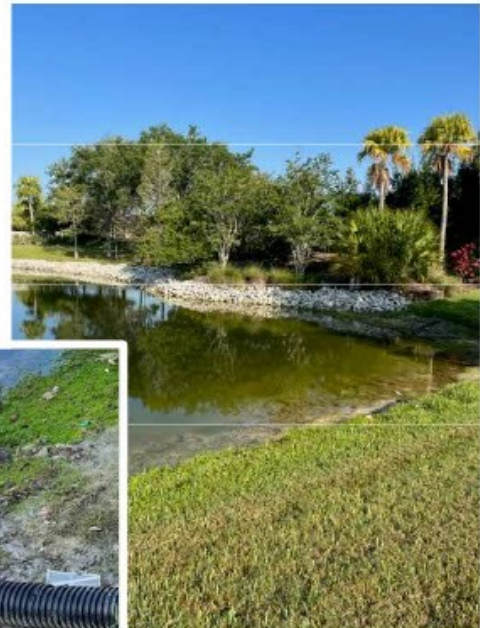
East side of Pond 15. Buried downspout 4032 with grate at pond end. Unburied downspout 4036. No notable erosion.

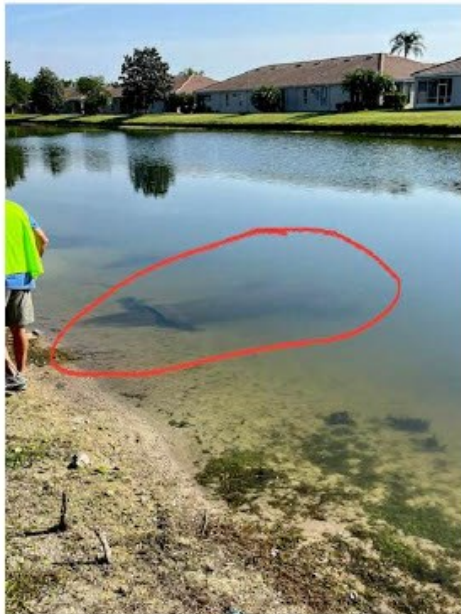
West side. Upper of two cement culverts on west side of Pond (connecting Pond 15 & 16?)

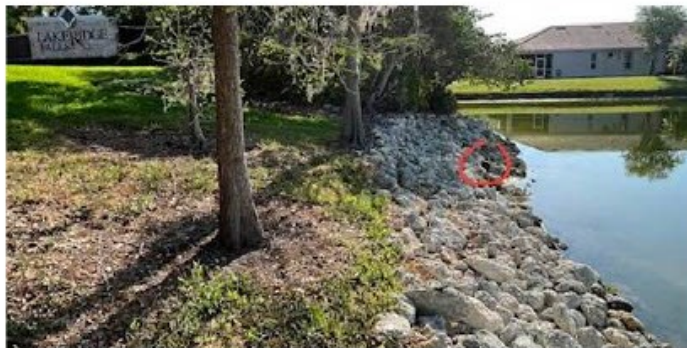
North side. Second buried pipe coming from entrance waterfall through riprap.
