May 2026

Annual Report

*Ponds Working Group (PWG) of
LakeRidge Falls*

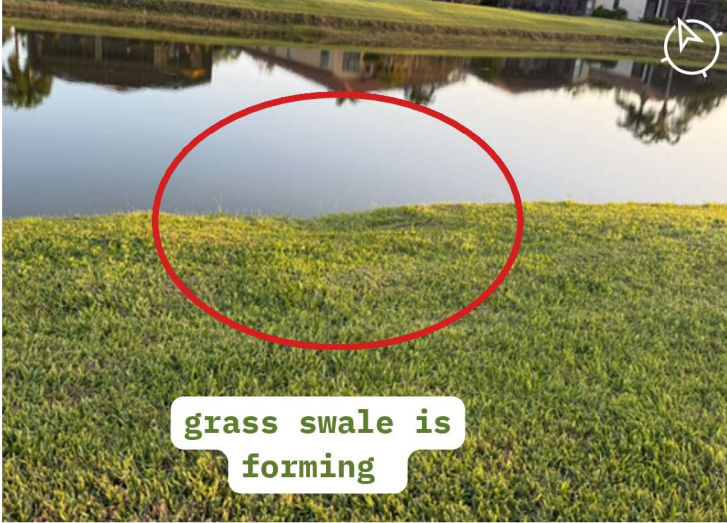
Photos were taken and show consistent collapse along most of the pond.

Jan 27, 2026 - Behind 4119 Mackay

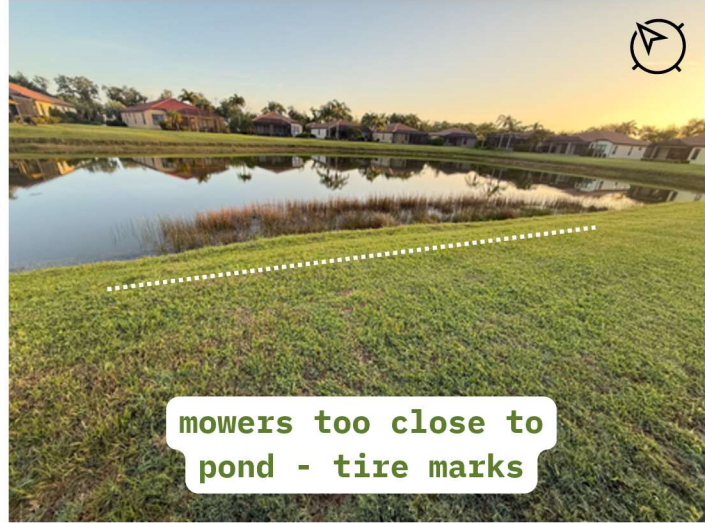
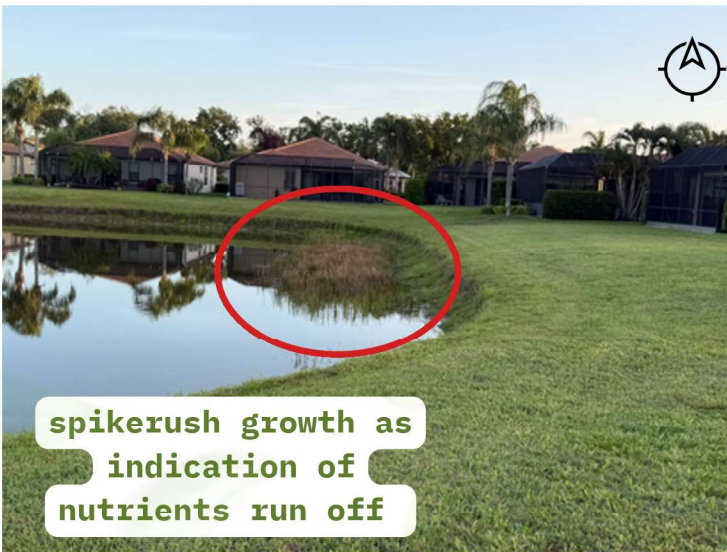
Behind 4141 Mackay

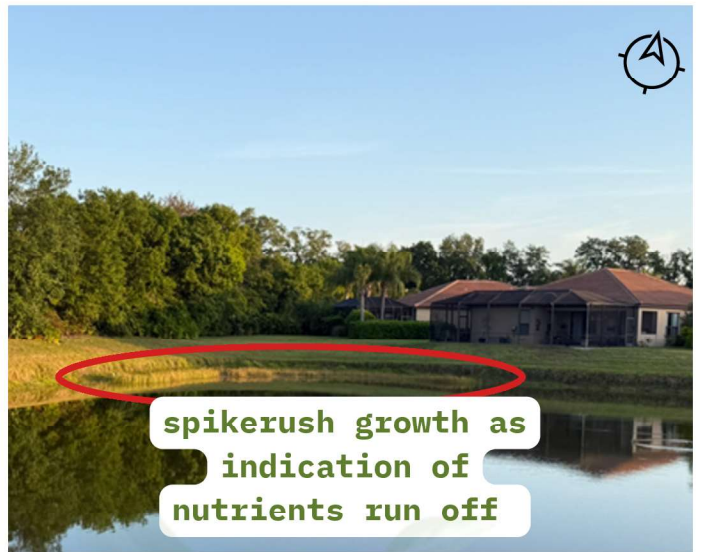
Behind 4269 Mackay

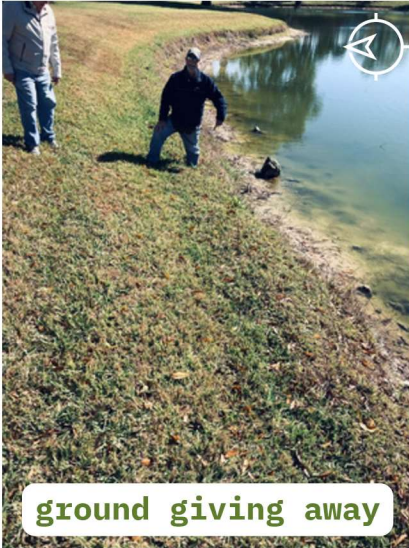
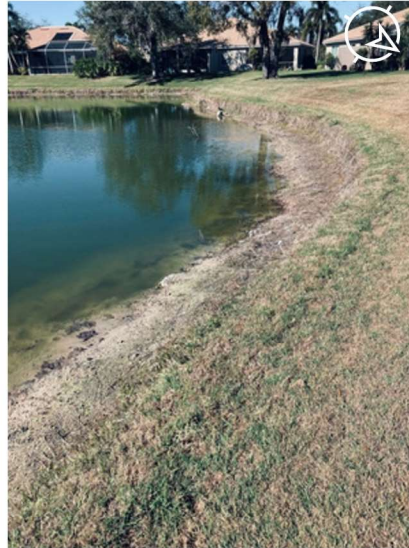
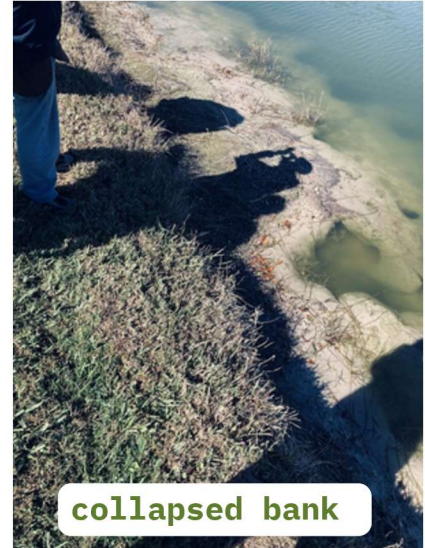
Photos were taken and they consistently show the bank collapse is taking place all along the bank of this pond.

01-27-2026 - North side of the Pond - 4444-4466 Kariba

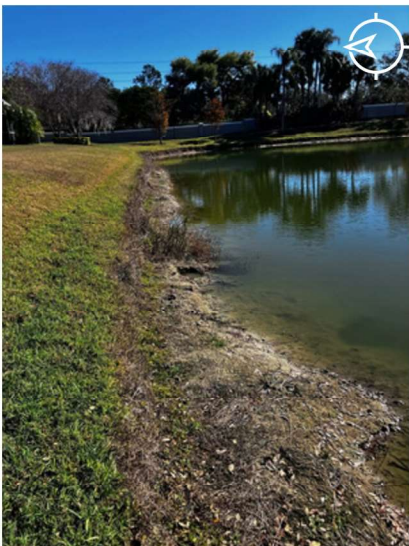
01-27-2026 - North side of the Pond - 4470-4478 Kariba

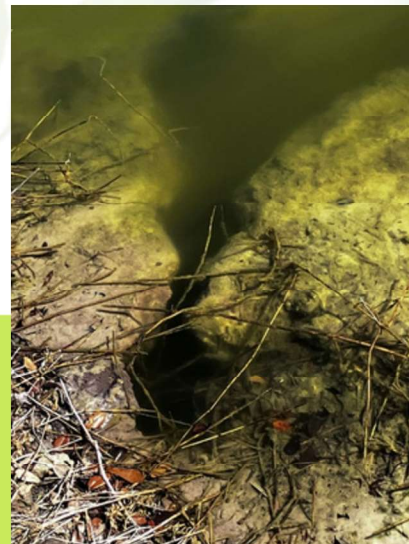
01-27-2026 - South side of the Pond near 4346 Kariba PAGE 10 OF 66

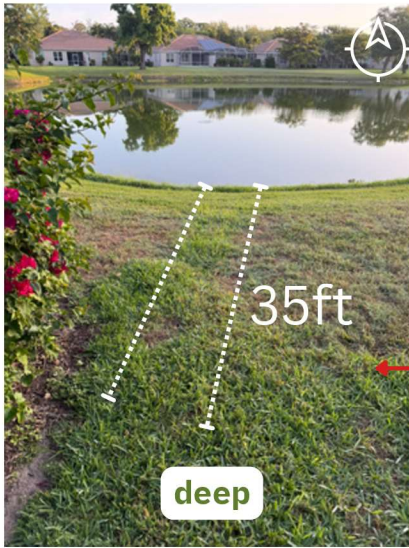
April 1, 2026 - South side - 4468 Kariba

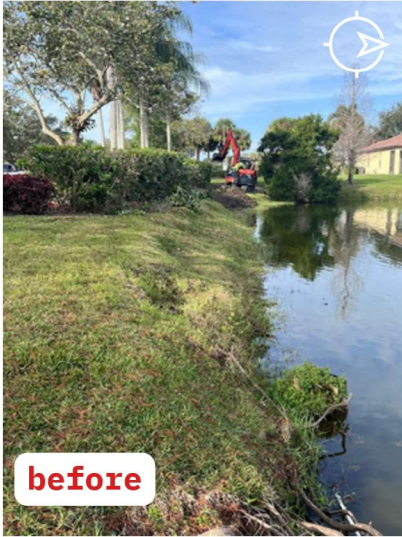
Jan 24, 2024 - South side of Pond 3 - Project Initiation

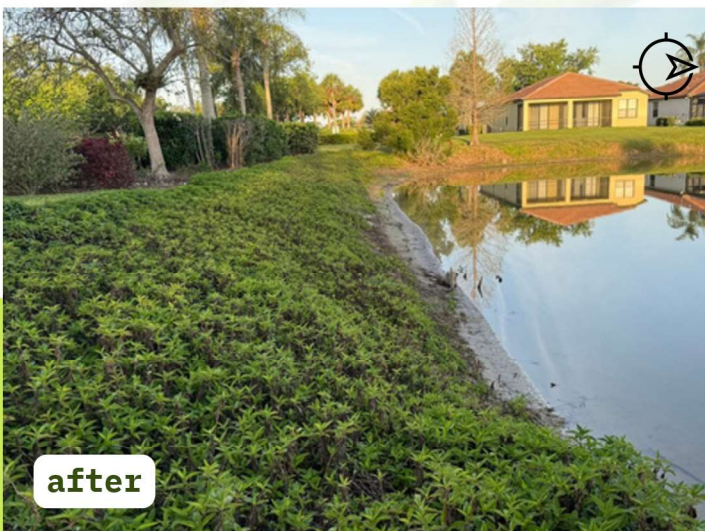
April 1, 2026 - South side of Pond 3

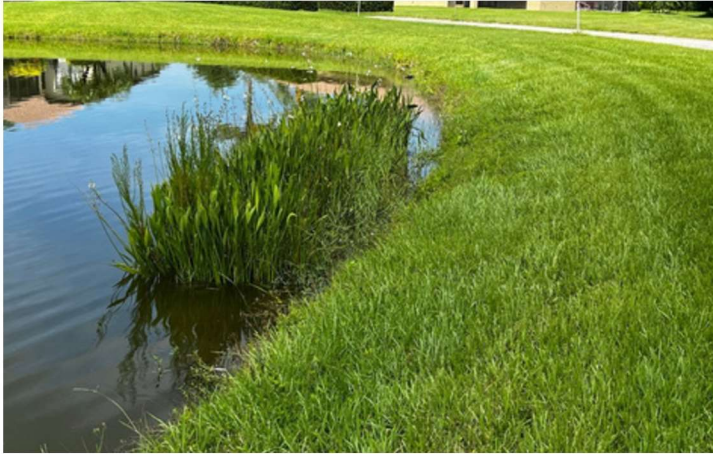
July 7, 2022 - North side of Pond 3

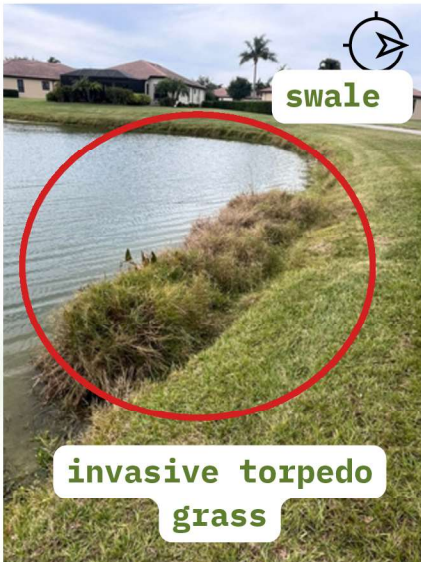
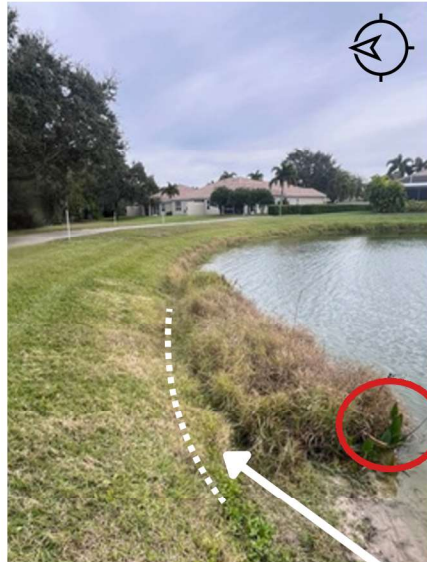
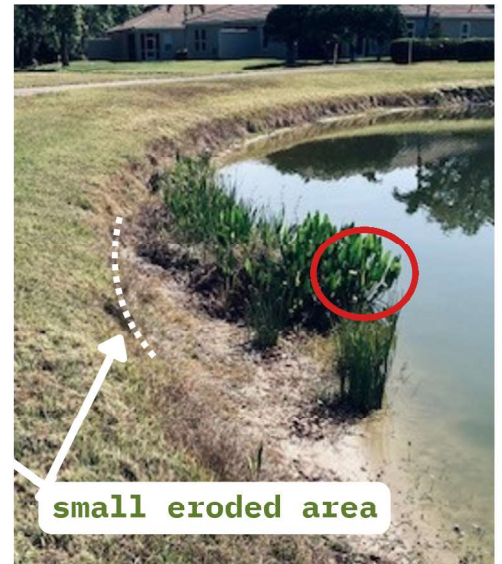
Jan 3, 2024 - North side of Pond 3

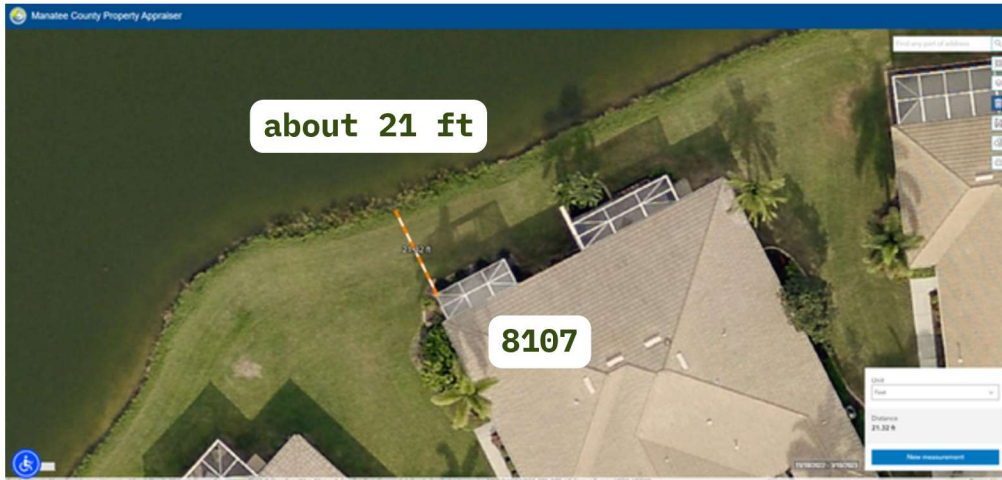
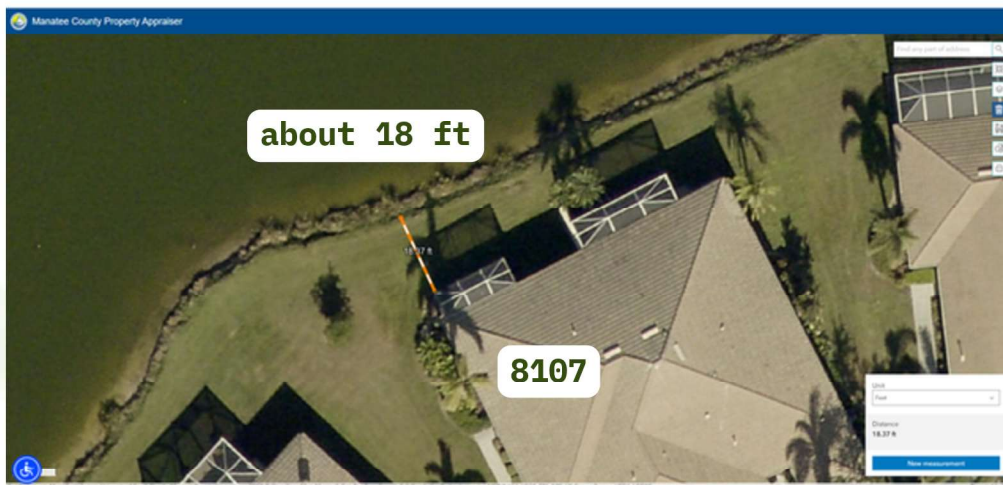
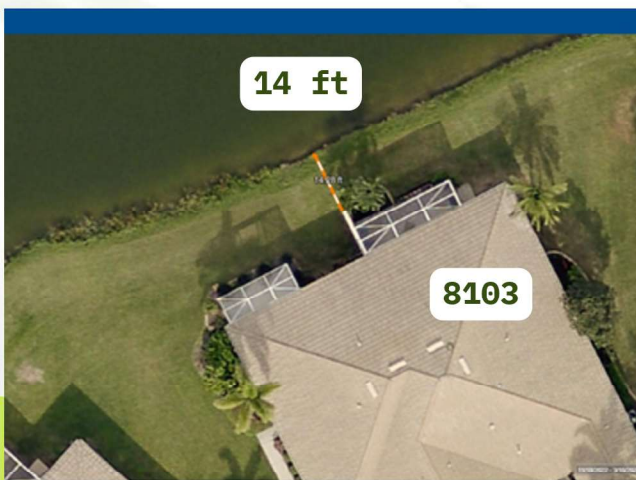
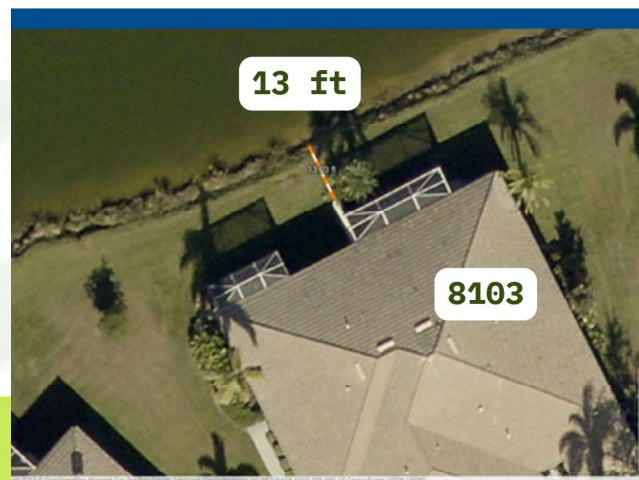
Pond #3 - N. East Side

Feb 18, 2026 - Imposed picture on top of the 2023 picture

the measurement on this page are rough approximates, for general impression only

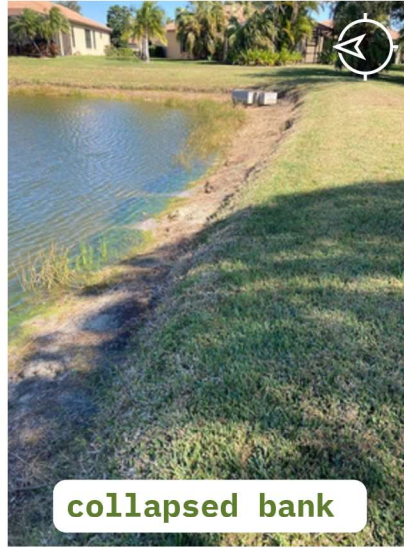
Pond #4

collapsed bank

01-28-2026

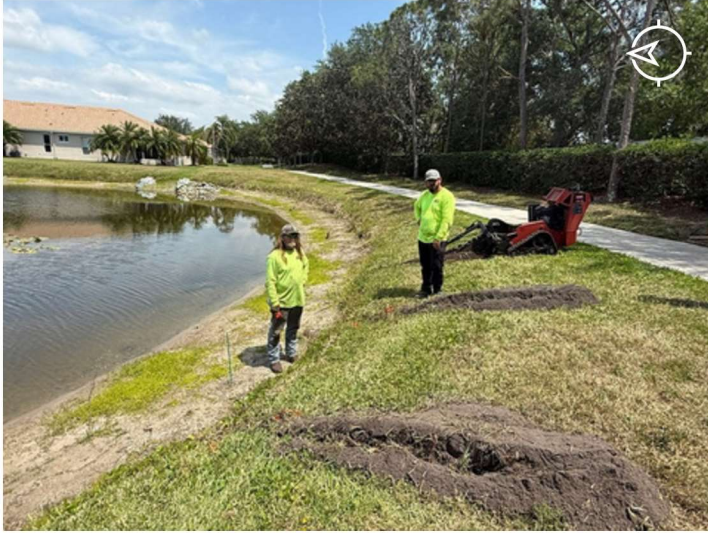
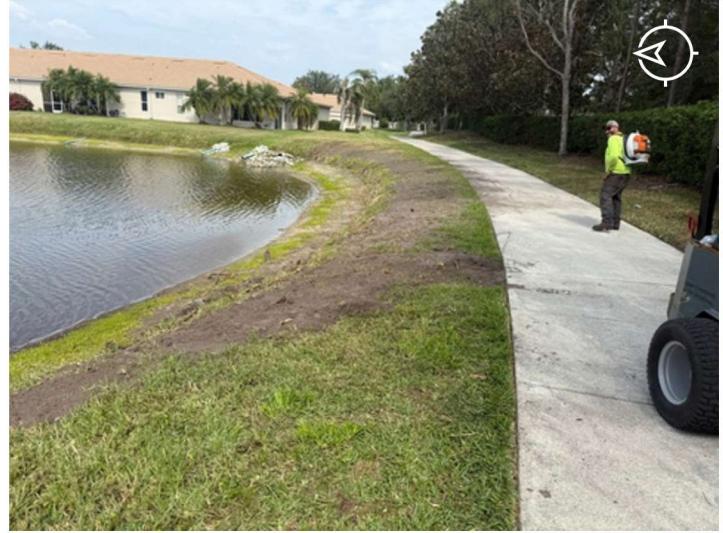
Pond #9

In pond 9 there is a Pipe about 15 feet south-east of the REBAR # 9-1. It is large possibly 36" in diameter and appears to be disconnected? Looks like it may run under our wall into the shopping center.

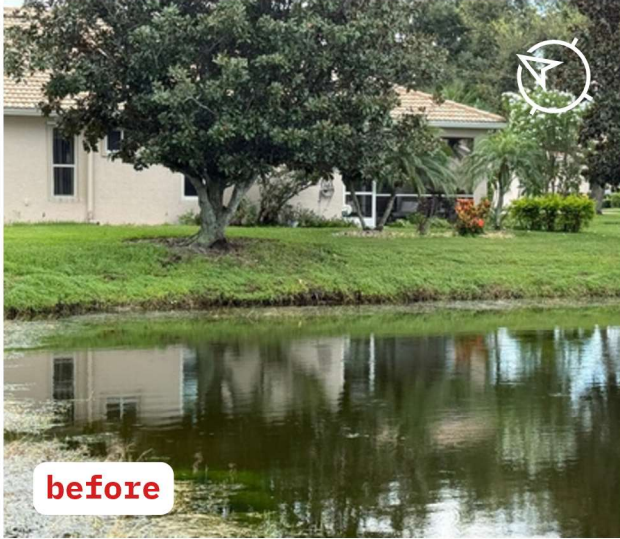
Pond #11 - North Side

before

Sept 10, 2025

Jan 6, 2026

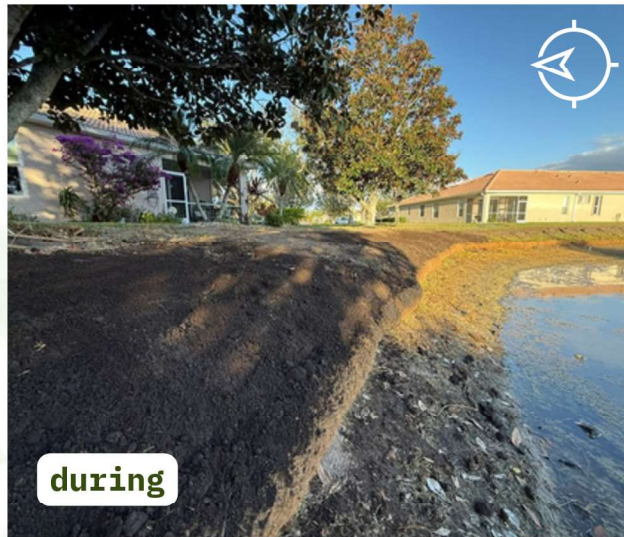
during

Jan 6, 2026

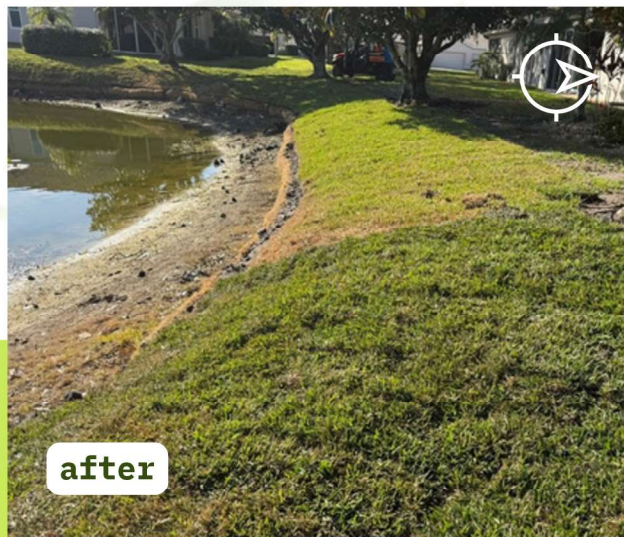
after

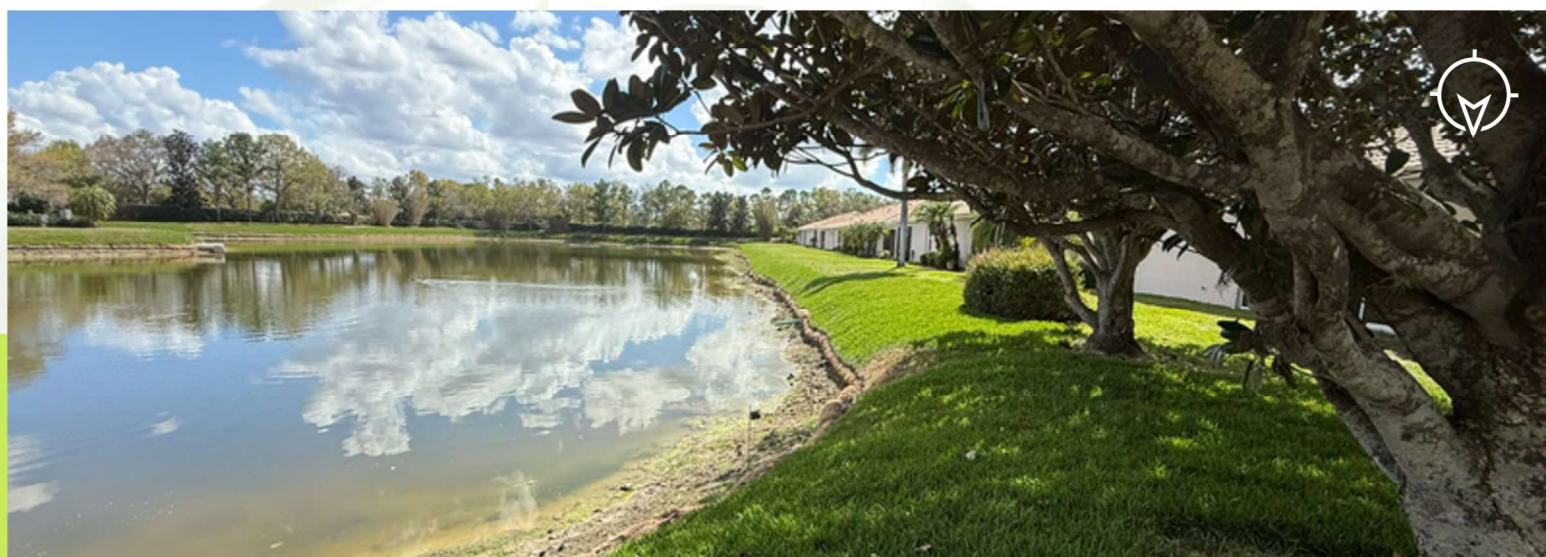
Pond #11 - South Side

March 6, 2026

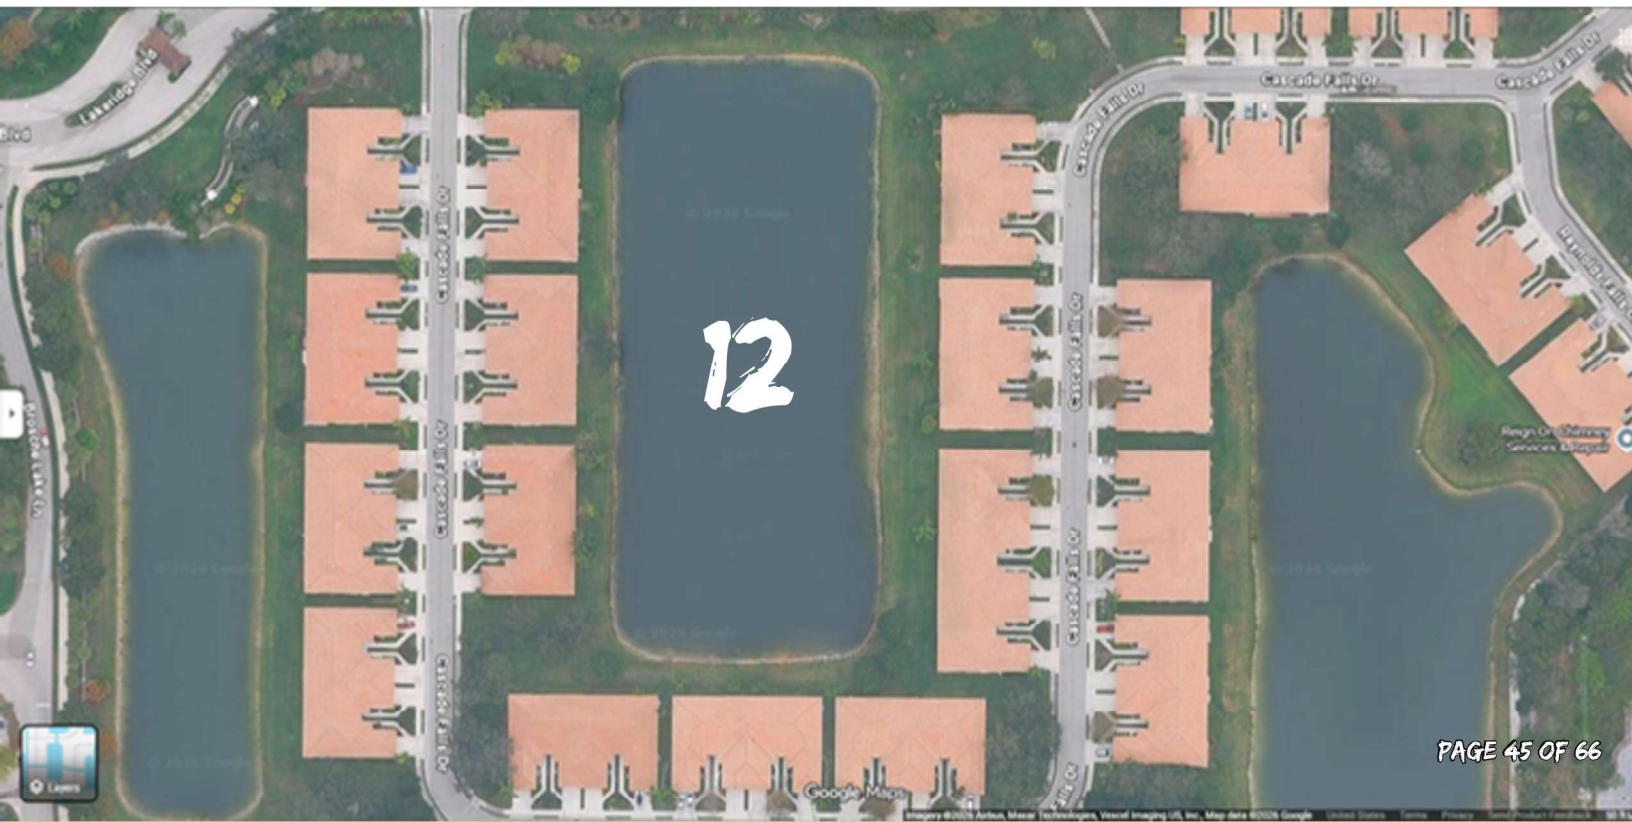
Pond #12 - East Side

The overall impression of the reviewers was that the pond was sustaining ongoing erosion as outlined in our previous report. The pond edge area, like all previously noted areas were in worse shape than outlined in our previous report. Not much had been done in the intervening time to bury pipes, fill holes or do anything else. The short yards were working with the rain to dissolve the yards even from the non-guttered roof run off. Several new cuts were noted, including one between 4163 and 4165 Cascades that was not present in 2023. Without exception all those noted areas earlier were worse now. There are at least 2 more cuts in the banks that are almost as bad as the one filled yesterday.

In our opinion, the east and west banks, could in 4 or 5 areas benefit from the type of repair made at 4155. However, the south side of the pond needs to be completely rebuilt. The banks need a drainage system, backfilled and sodded. From 4105 on the SW corner to 4143 the 14 back yards are 8-10 inches lower than the other sides of the pond and continuing to wash away. It would seem the PondTech Solutions would be an excellent fix for the south side.

Evaluation: Pond needs work sooner rather than later, particularly the south end and major voids.

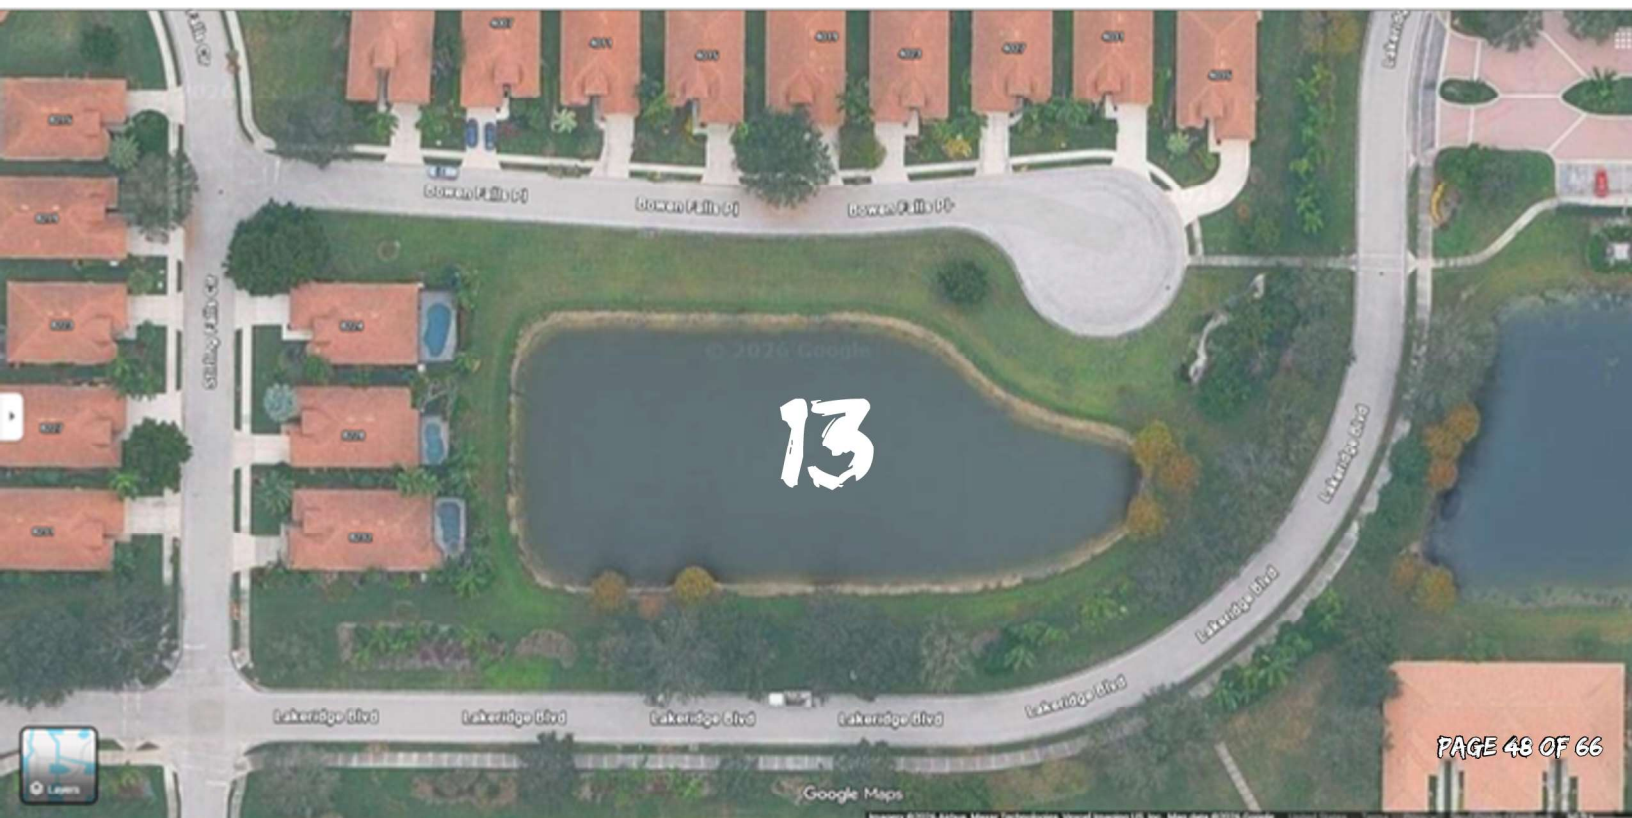
Pond #13

Starting in the Southeast the noted rebar could not be located. The cut adjacent to the former rebar caused by the flow from the Blvd. above, is dramatically more pronounced. It also appears the runoff is collecting debris and depositing that debris into the pond near where the stake was located. The debris is intertwined with new plants/weeds that are starting to get established in the vicinity. The cut needs to be filled, and a deterrent to cause devised. With the higher water level, it is difficult to determine if part of this bank has merely collapsed and taken the rebar with it. This is another example why rebar is not necessarily a good choice for long term measurement purposes.

Moving up the South side of the pond shows continuing erosion along the bank. In the past we have lost trees along this side, and the erosion is getting uncomfortably close to the above road bed. The West side of the pond is behind the three original model homes with the pipes buried by the developer. One of the 6" corrugated pipes that is leading gutter runoff from a shared pipe was apparently anchored at the end to the bottom of the pond. This pipe has broken loose, and its end is now floating loose on the ponds surface.

The Northern side along Bowen Falls Place evidences no change since last year.

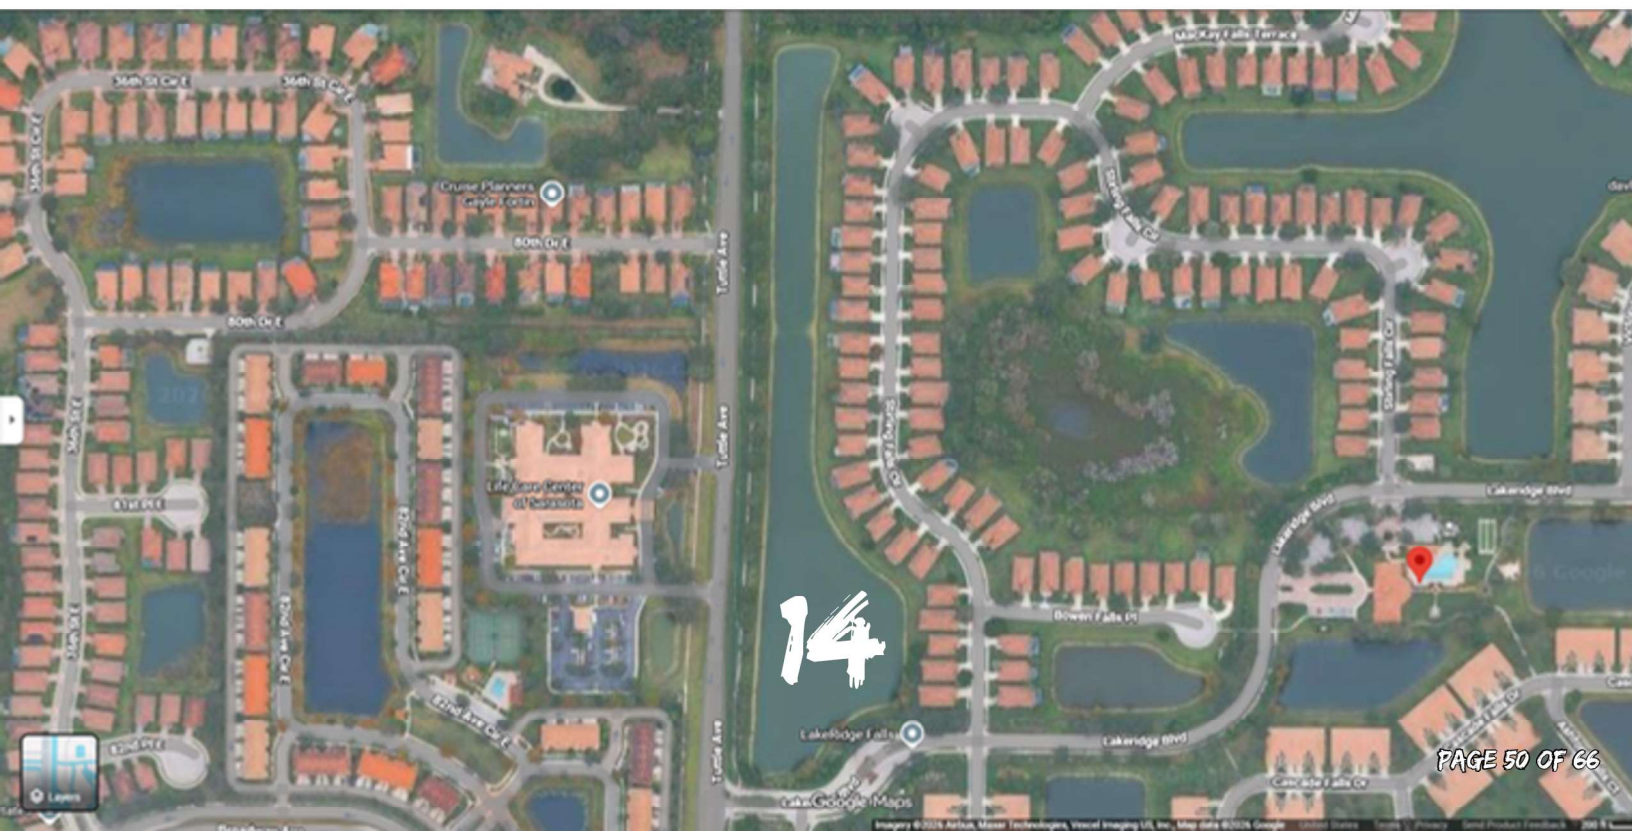
Pond #14

Rebar 14-3 (SW corner) Top 40 ¾", Bottom 28", Bar not close enough to an object.

This bank and where it wraps around the Eastern side faces an extremely sharp drop in the pond center. Where this bank collapsed the material has been completely washed away. It is hard to imagine any technique but a heavy bulkhead, that will hold back this area from eventually sliding away into this pond.

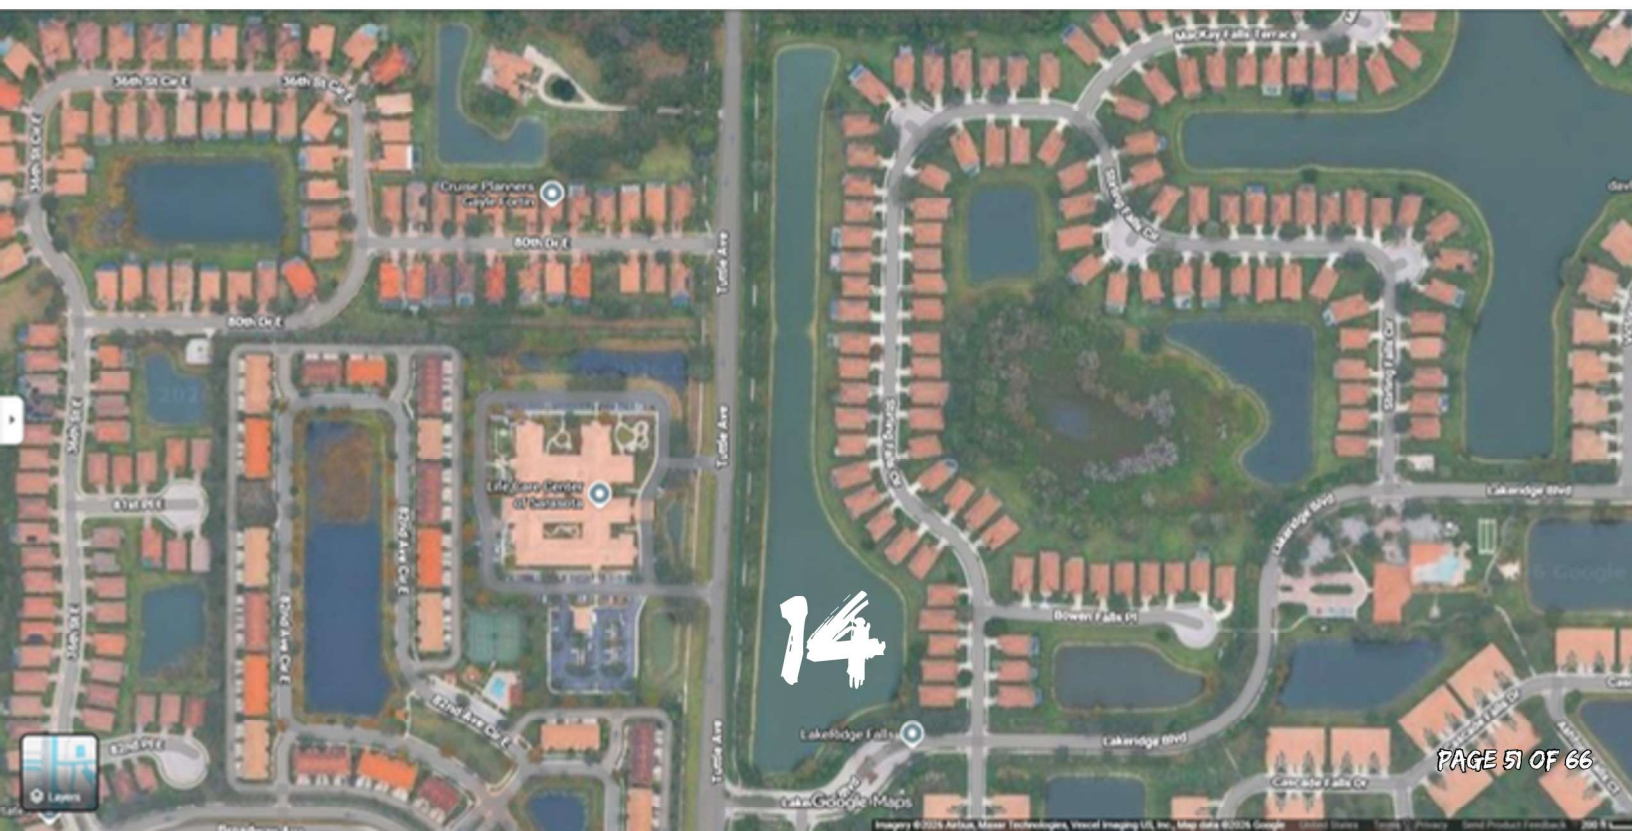
Pond #14 - West Side

LATE FEB 26 MAJOR BANK COLLAPSE

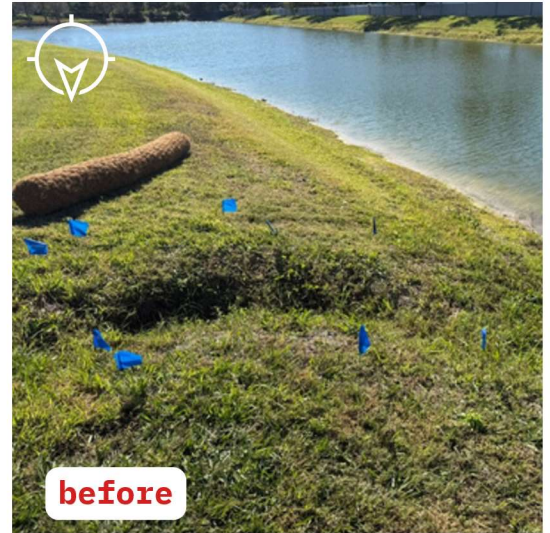
Jan 20, 2026

Oct 15, 2025 - Behind 8179 Stirling

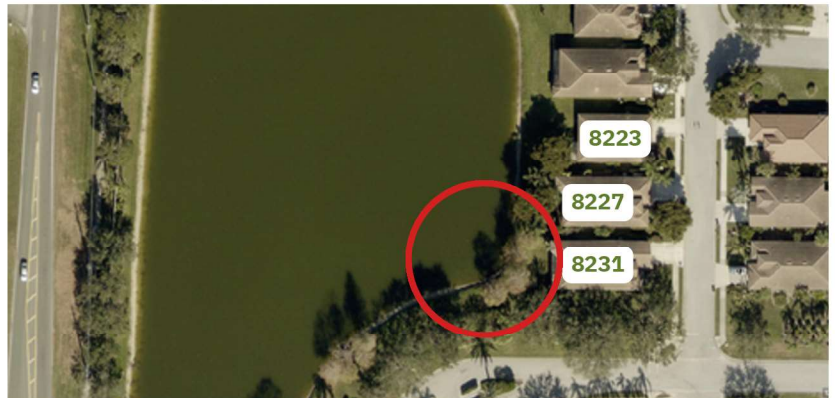
Sept 18, 2023
Mower in the pond

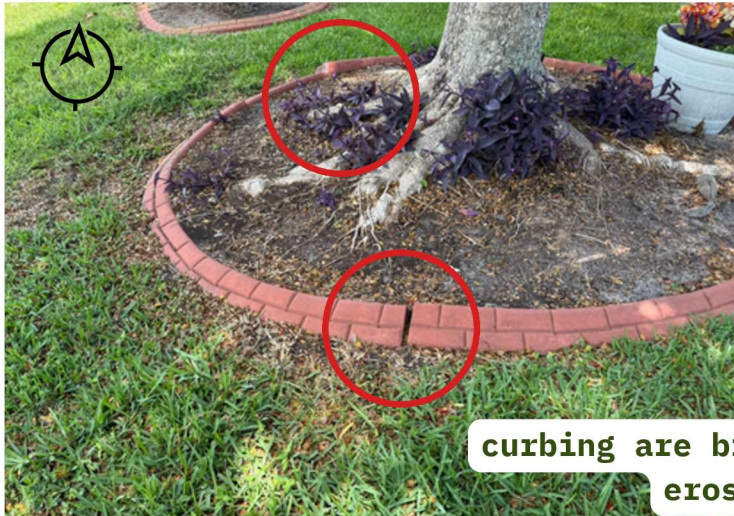
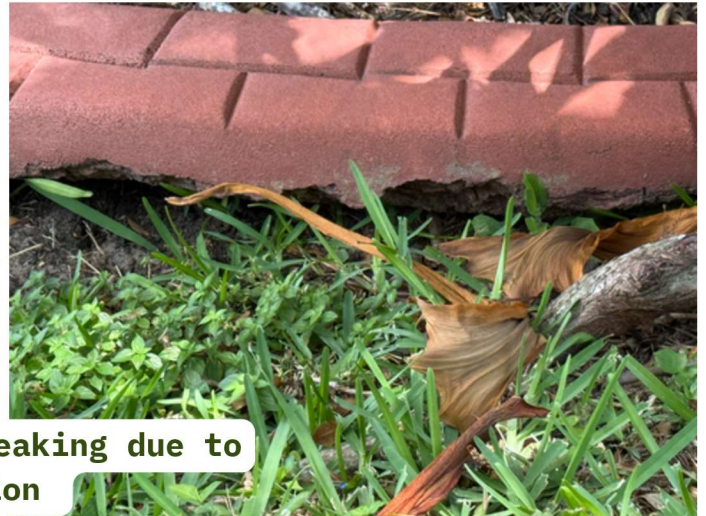
April 9, 2026 - Behind 8227 Stirling

curbing are breaking due to erosion

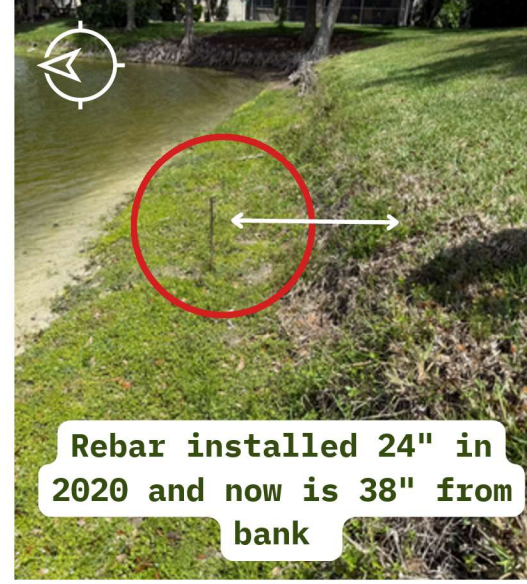
April 9, 2026 - Behind 8231 Stirling

Rebar installed 24" in 2020 and now is 38" from bank

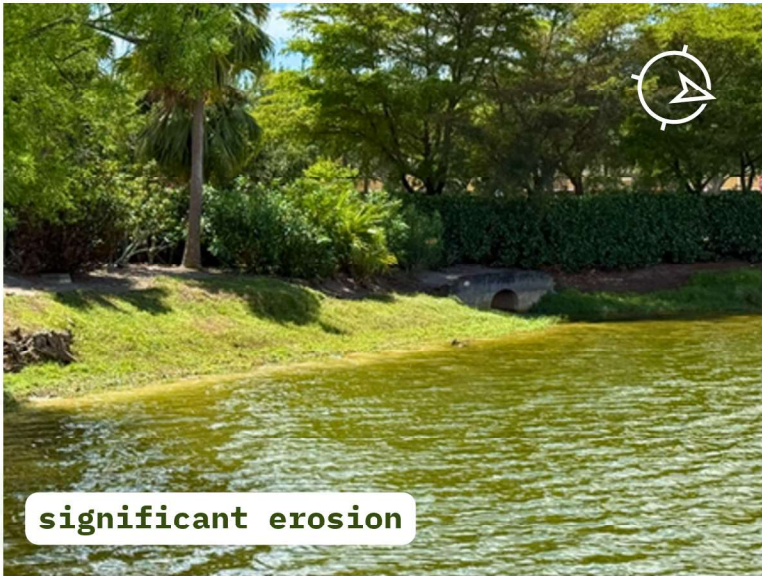
significant erosion

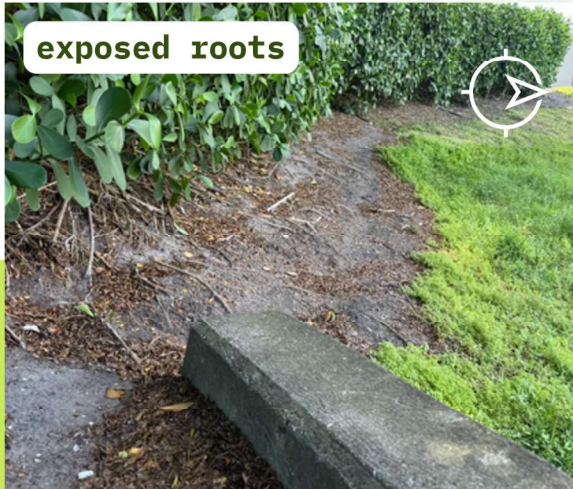
exposed roots

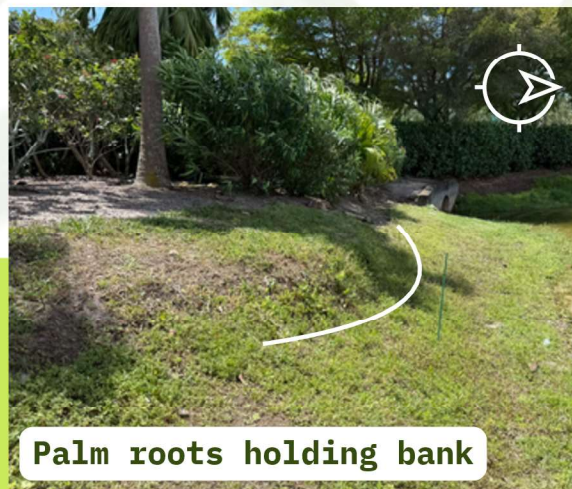
April 9, 2026

Palm roots holding bank

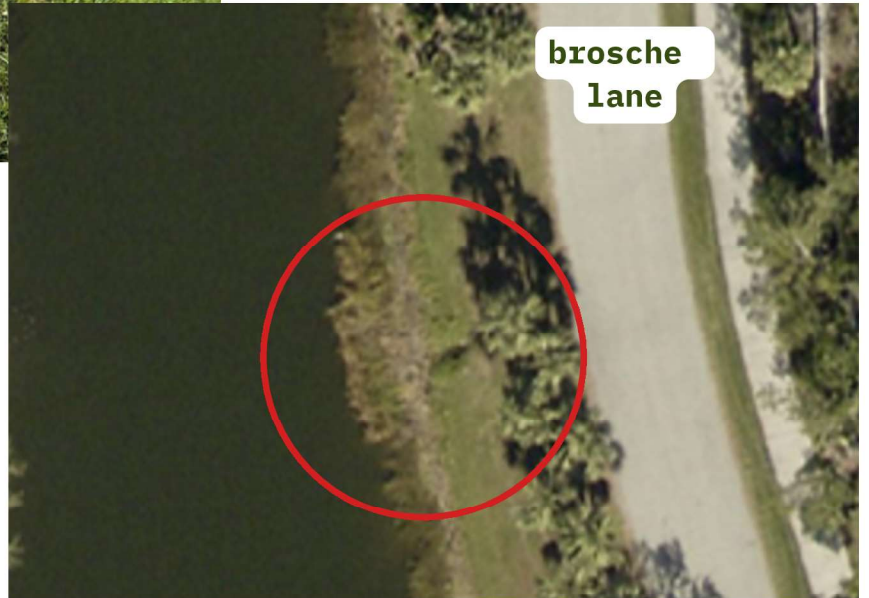
brosche lane

swale at the west side of the pond

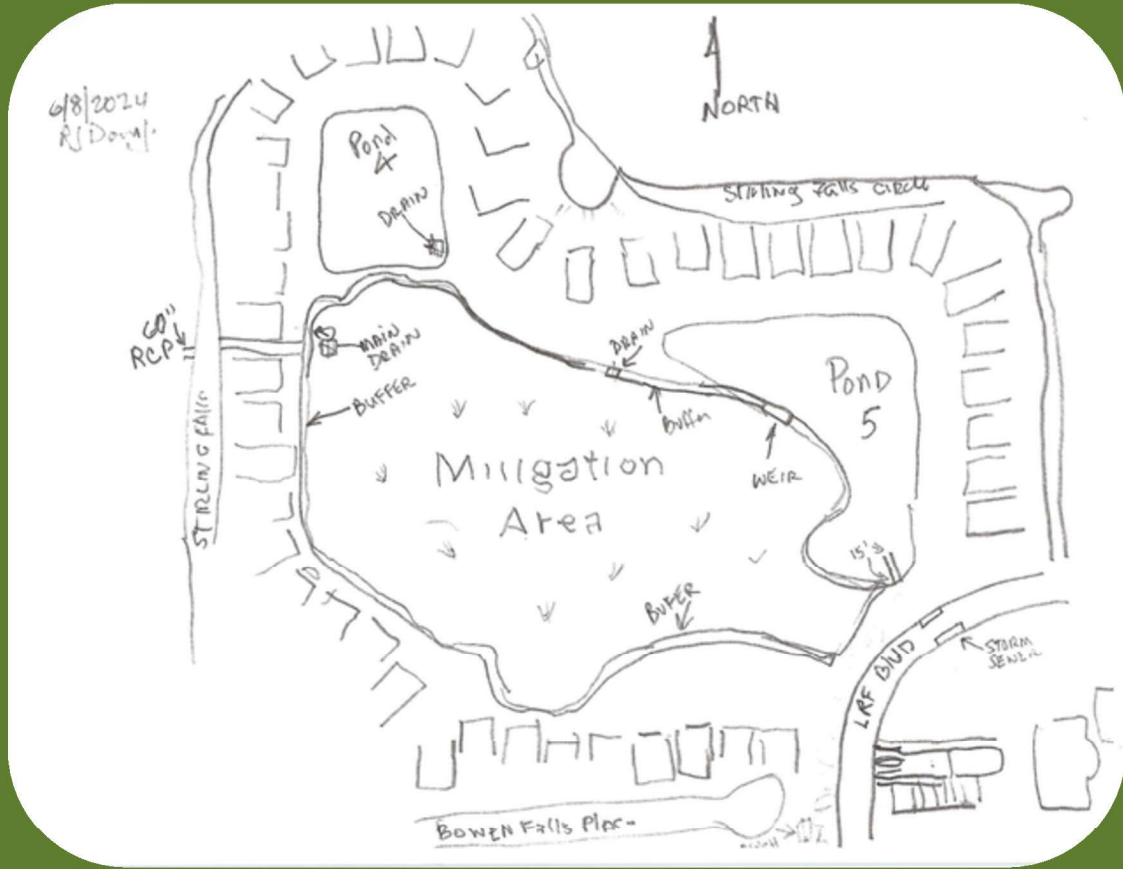
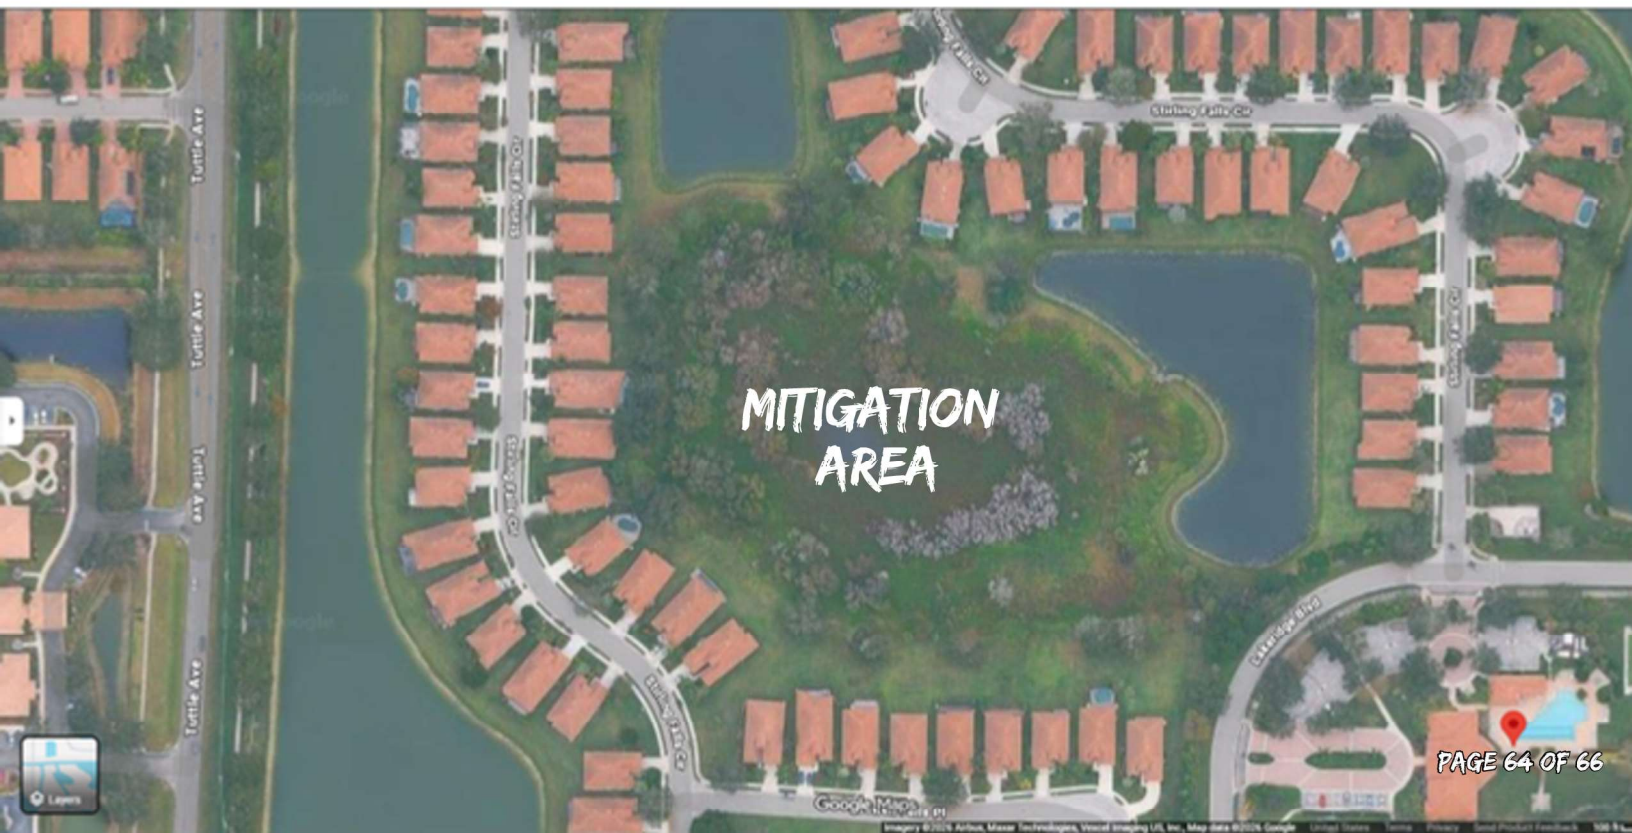
Mitigation Area

We surveyed the area and drew the attached rough map. We plan to revisit this area in the next (6) six months, and make an evaluation as to the initial loss of new plantings, and make a recommendation at that time. We will also include the mitigation area in our every 6-month survey and report as we will do with the ponds.

We noted that several large overgrown trees were recently culled from the buffer. The drains shown on the attached map were clear of any problematic live or dead foliage, and open and working.

***No action to be taken at this time.
